PUBLIC PRESENTATION

VERONA EMERGENCY SERVICES

POLICE DEPARTMENT, FIRE DEPARTMENT - CO. #2, RESCUE SQUAD

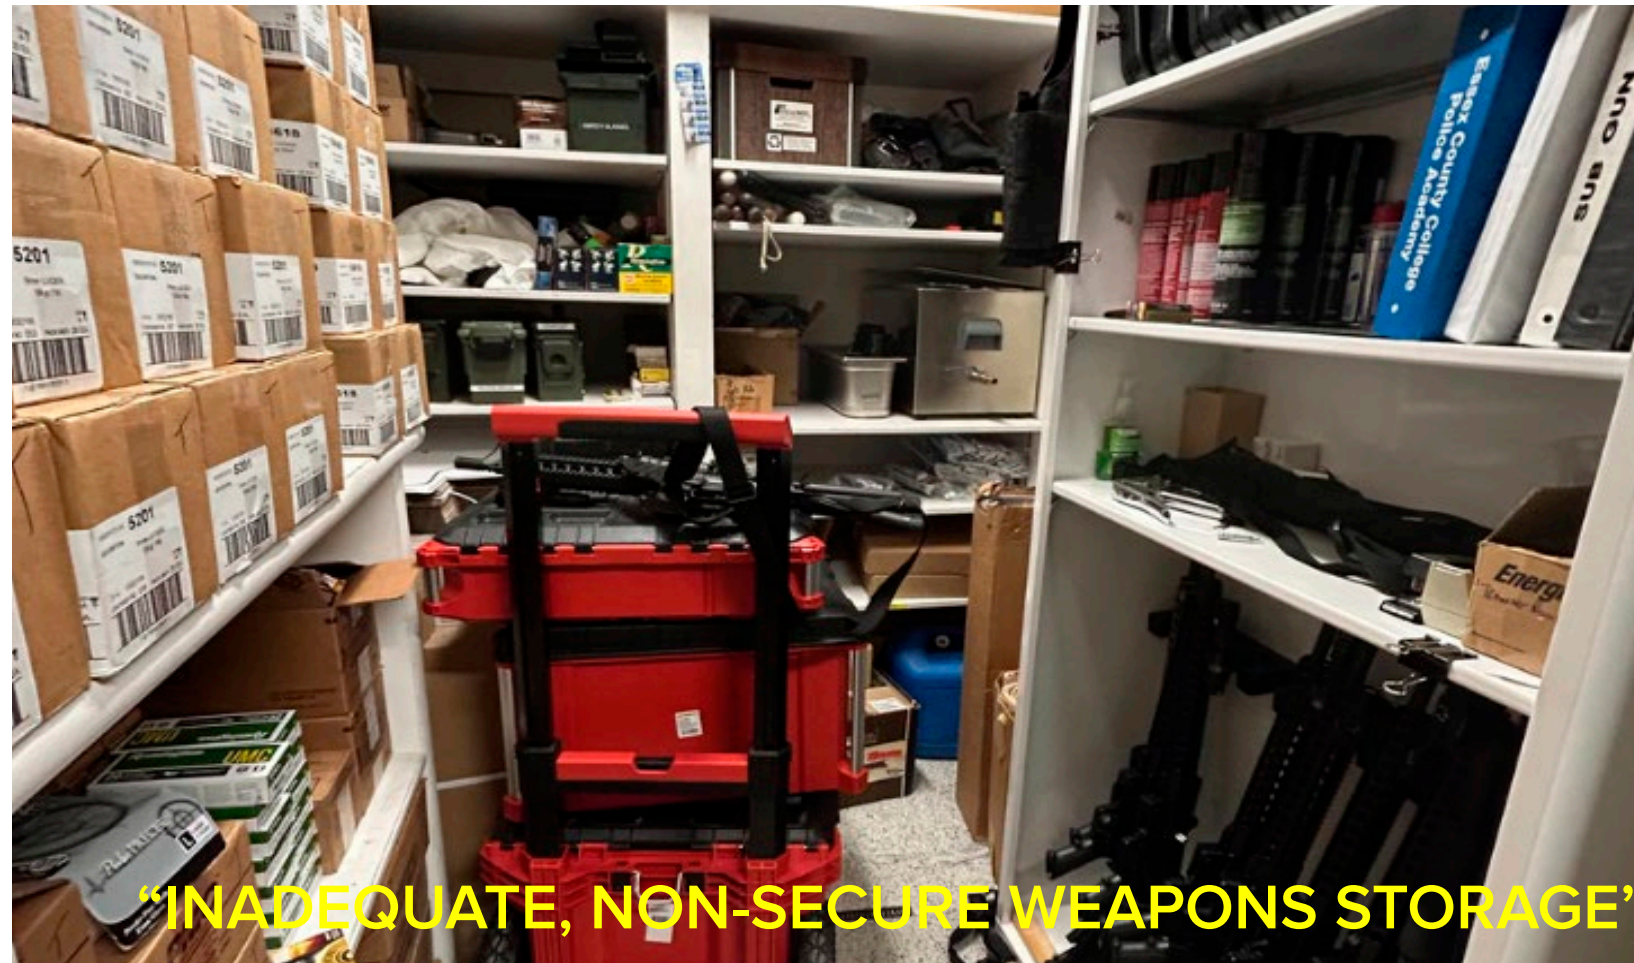
"INADEQUATE, NON-SECURE WEAPONS STORAGE"

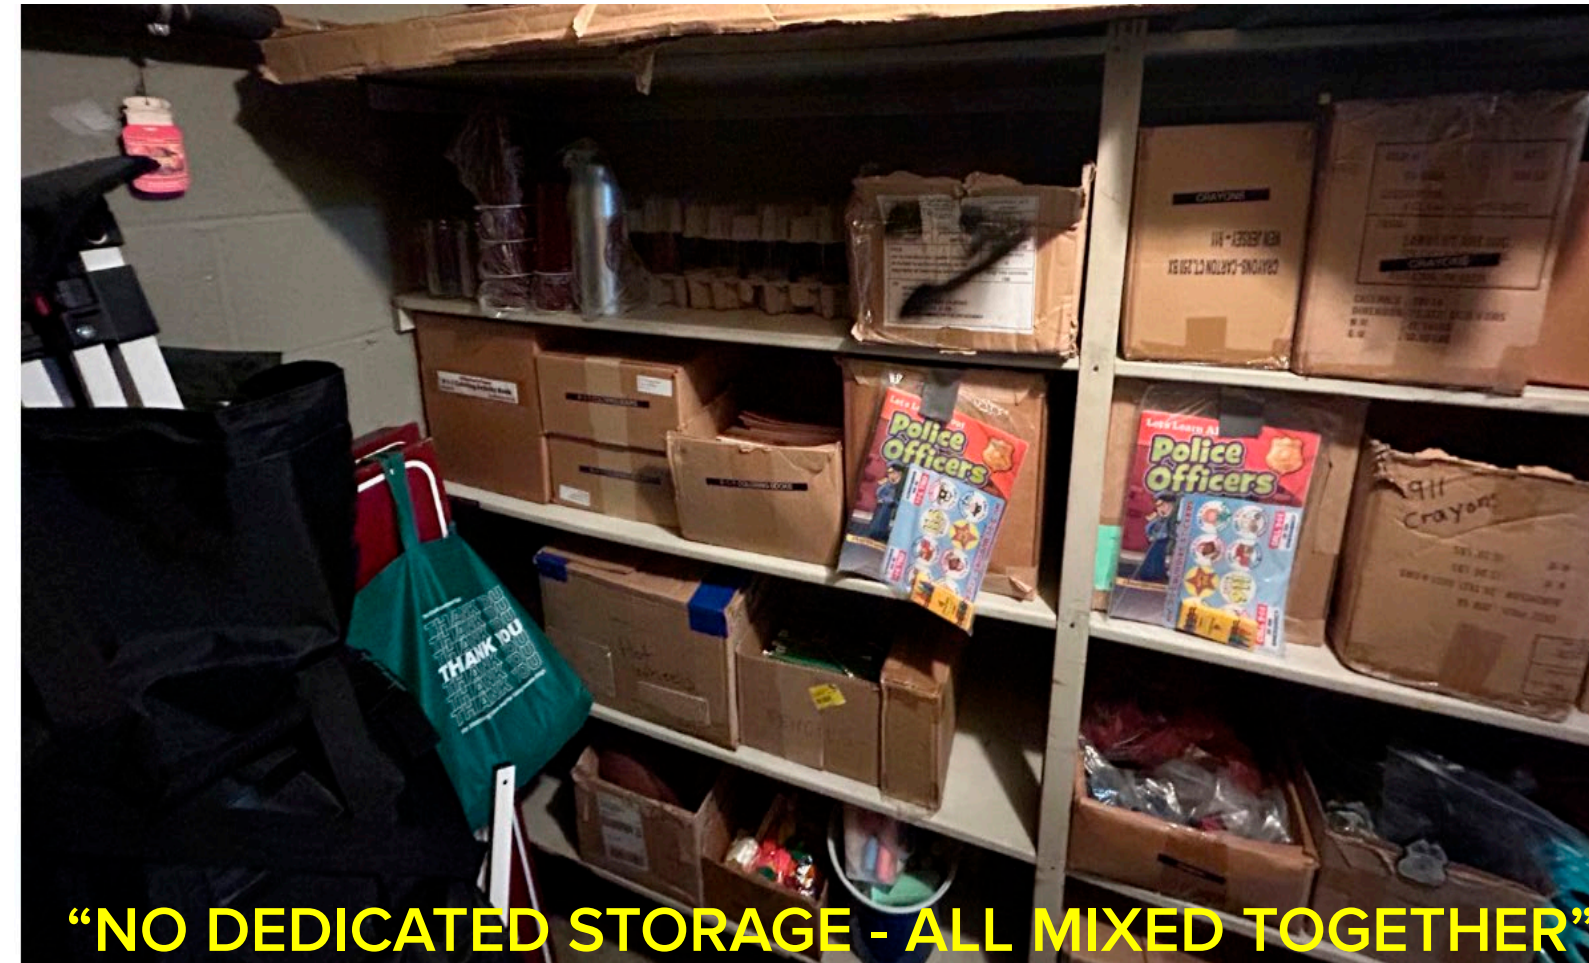
"NO DEDICATED STORAGE - ALL MIXED TOGETHER"

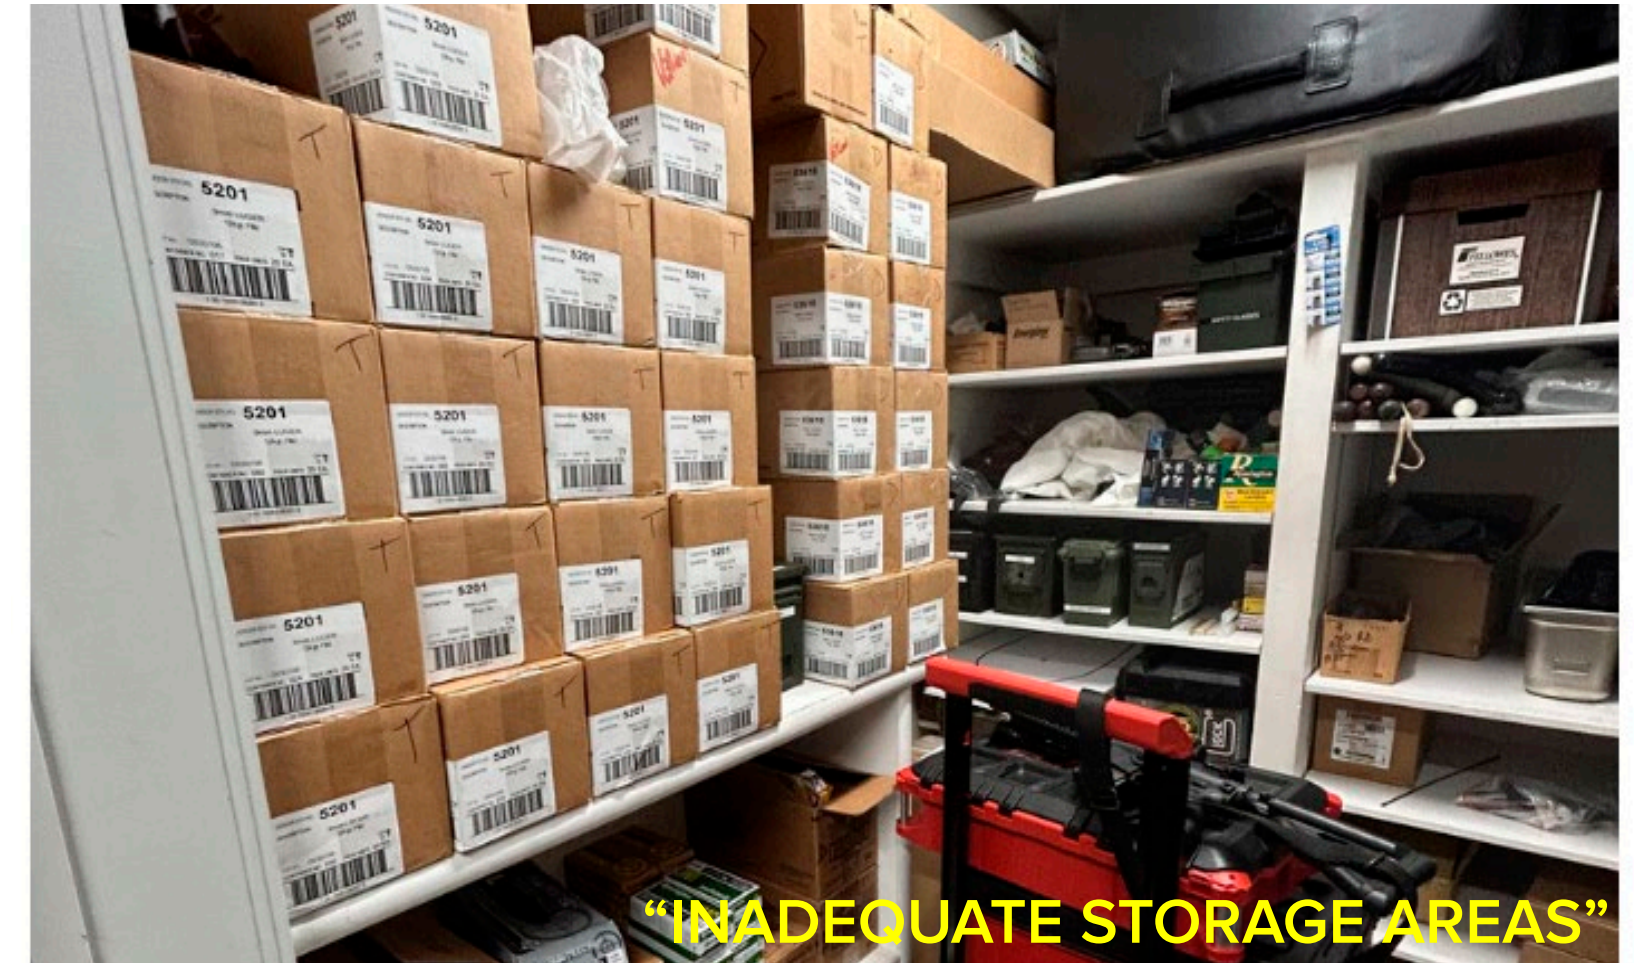
"INADEQUATE STORAGE AREAS"

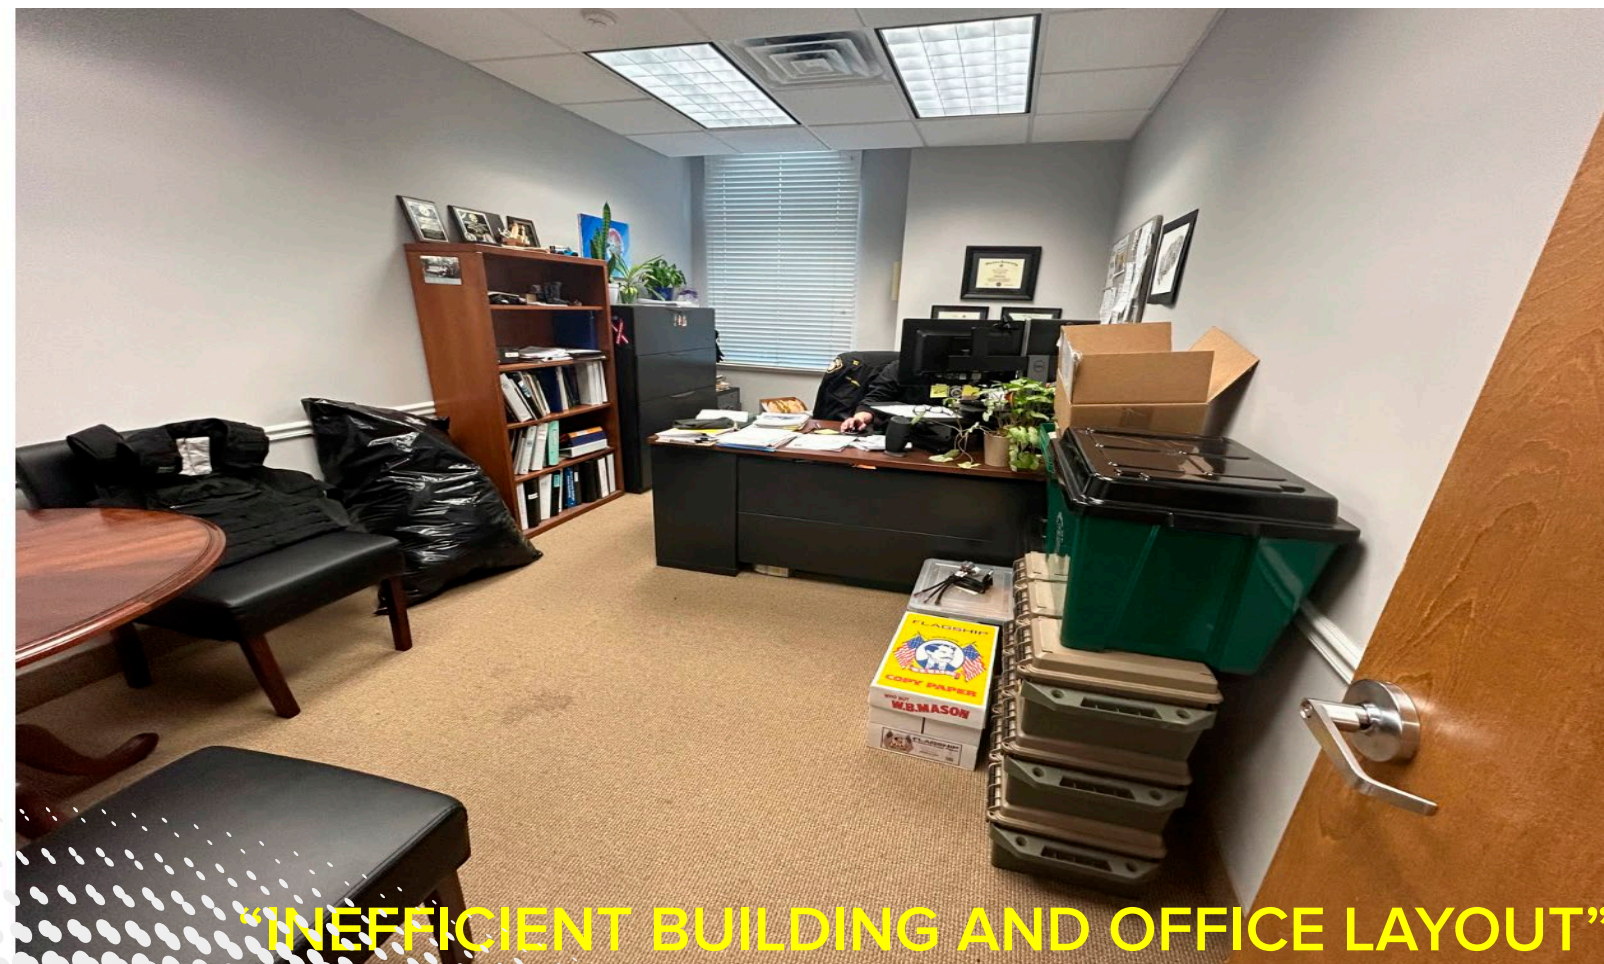
"INEFFICIENT BUILDING AND OFFICE LAYOUT"

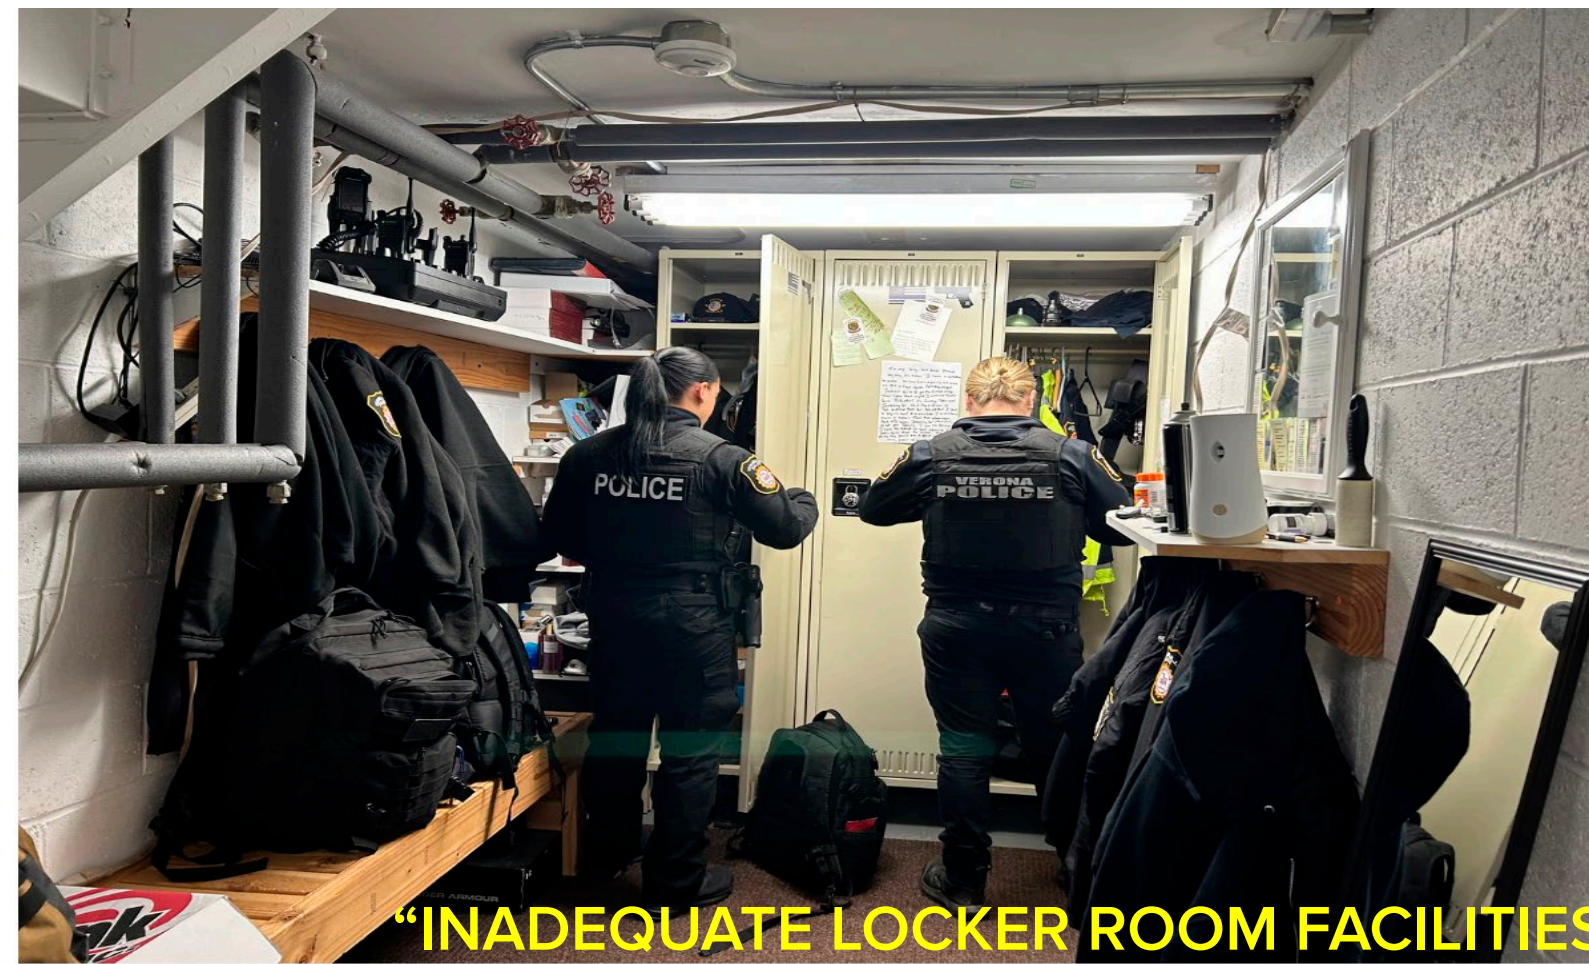
"INADEQUATE LOCKER ROOM FACILITIES"

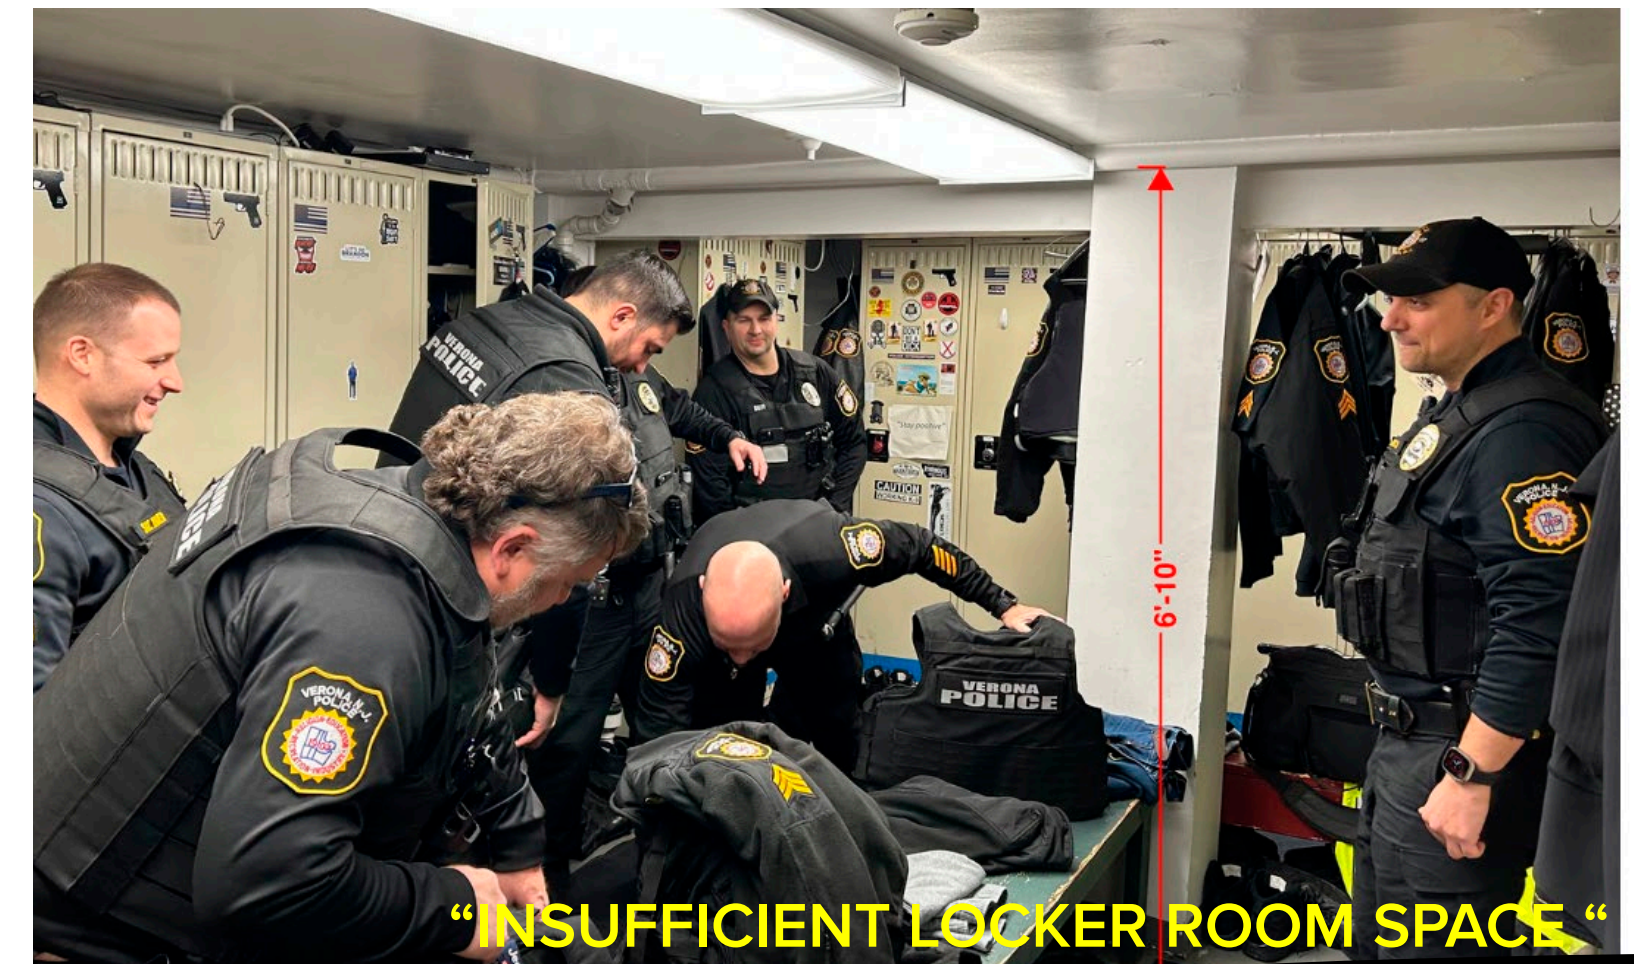
"INSUFFICIENT LOCKER ROOM SPACE"

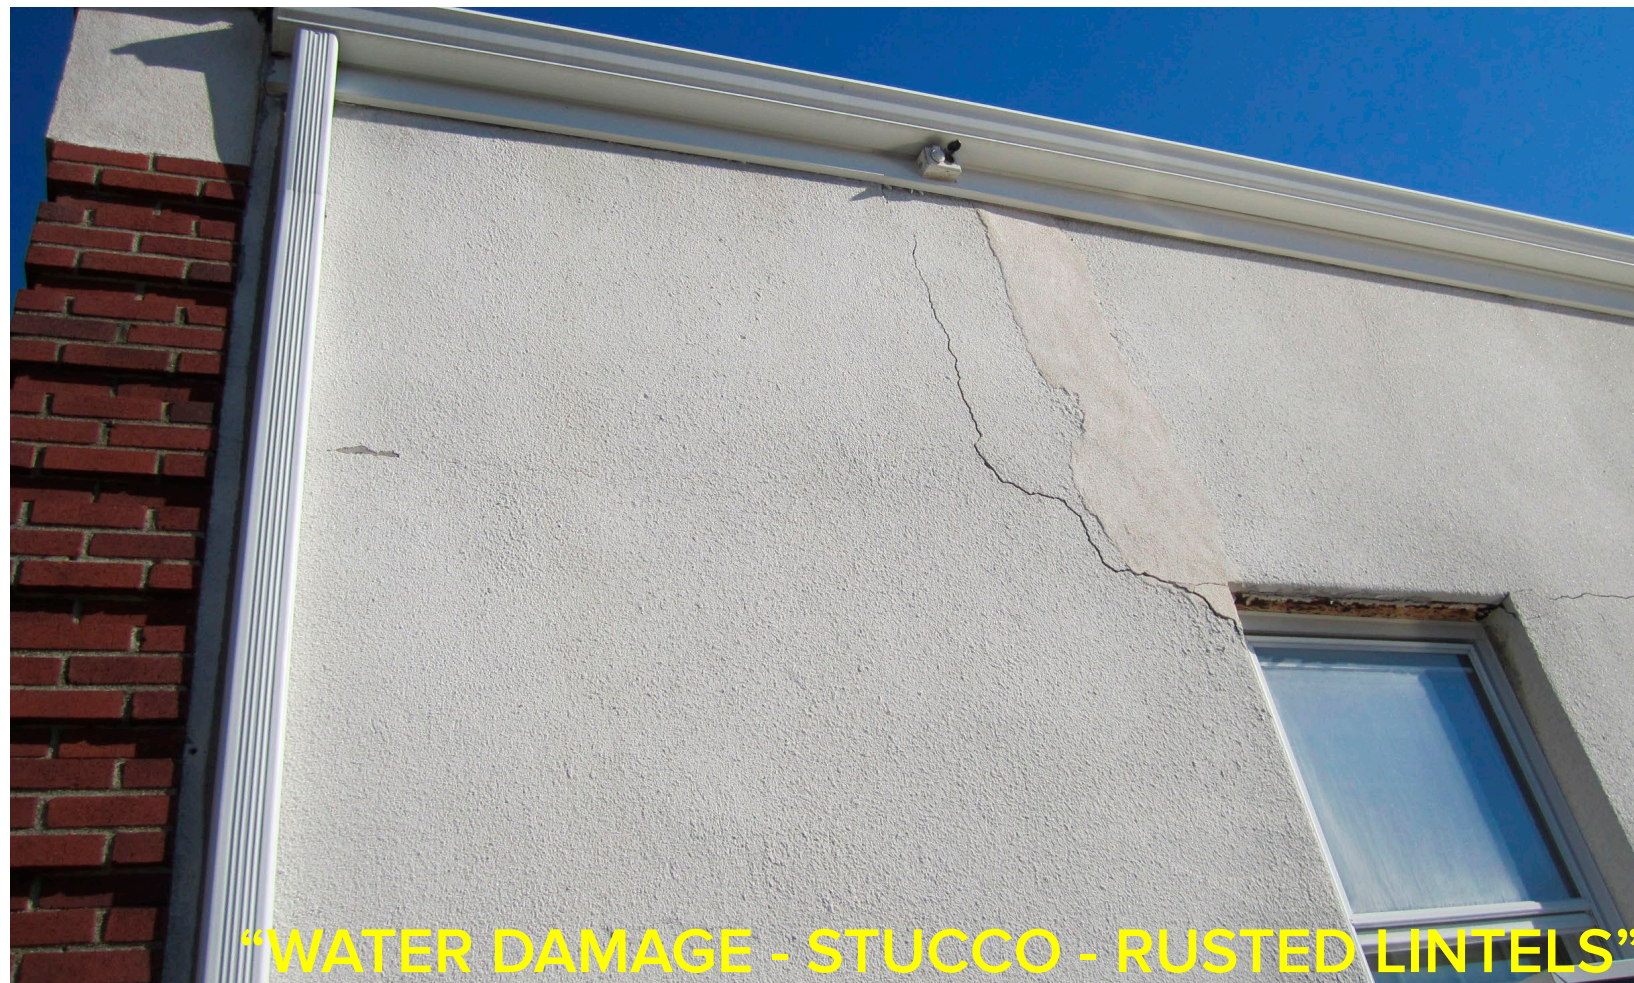
- » Major roofing/flashing issues allowing water infiltration causing exterior wall, window and door issues/ cracking + stucco/plaster damage.
- » Major structural issues due to building settling. Walls cracking and masonry facade separation. Steel lintels are rusted and bowing.
- » Floor tiles popping, wood floors warping, window frames at meeting room / basement are rotted/leaking.
- » Two sump pumps in basement are inadequate to keep up during heavy rain storms resulting in more water infiltration. Basement door-deteriorated / does not open, posing a safety problem. Basement cannot be used.

"WATER DAMAGE - STUCCO - RUSTED LINTELS"

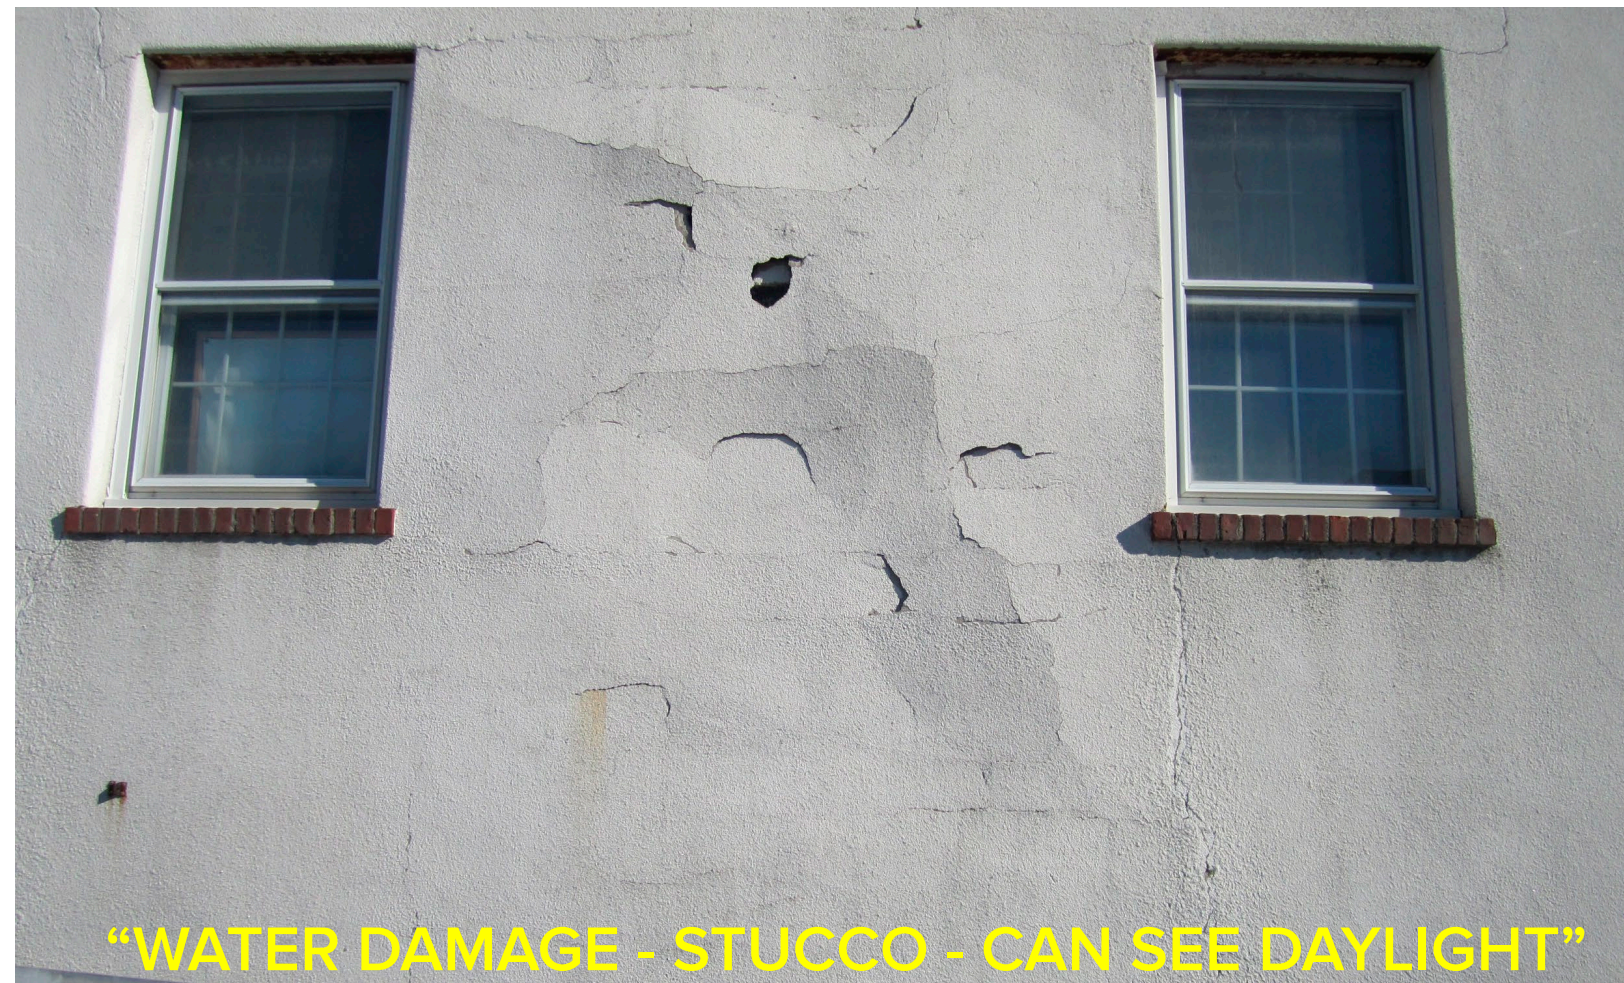
"WATER DAMAGE - STUCCO - CAN SEE DAYLIGHT"

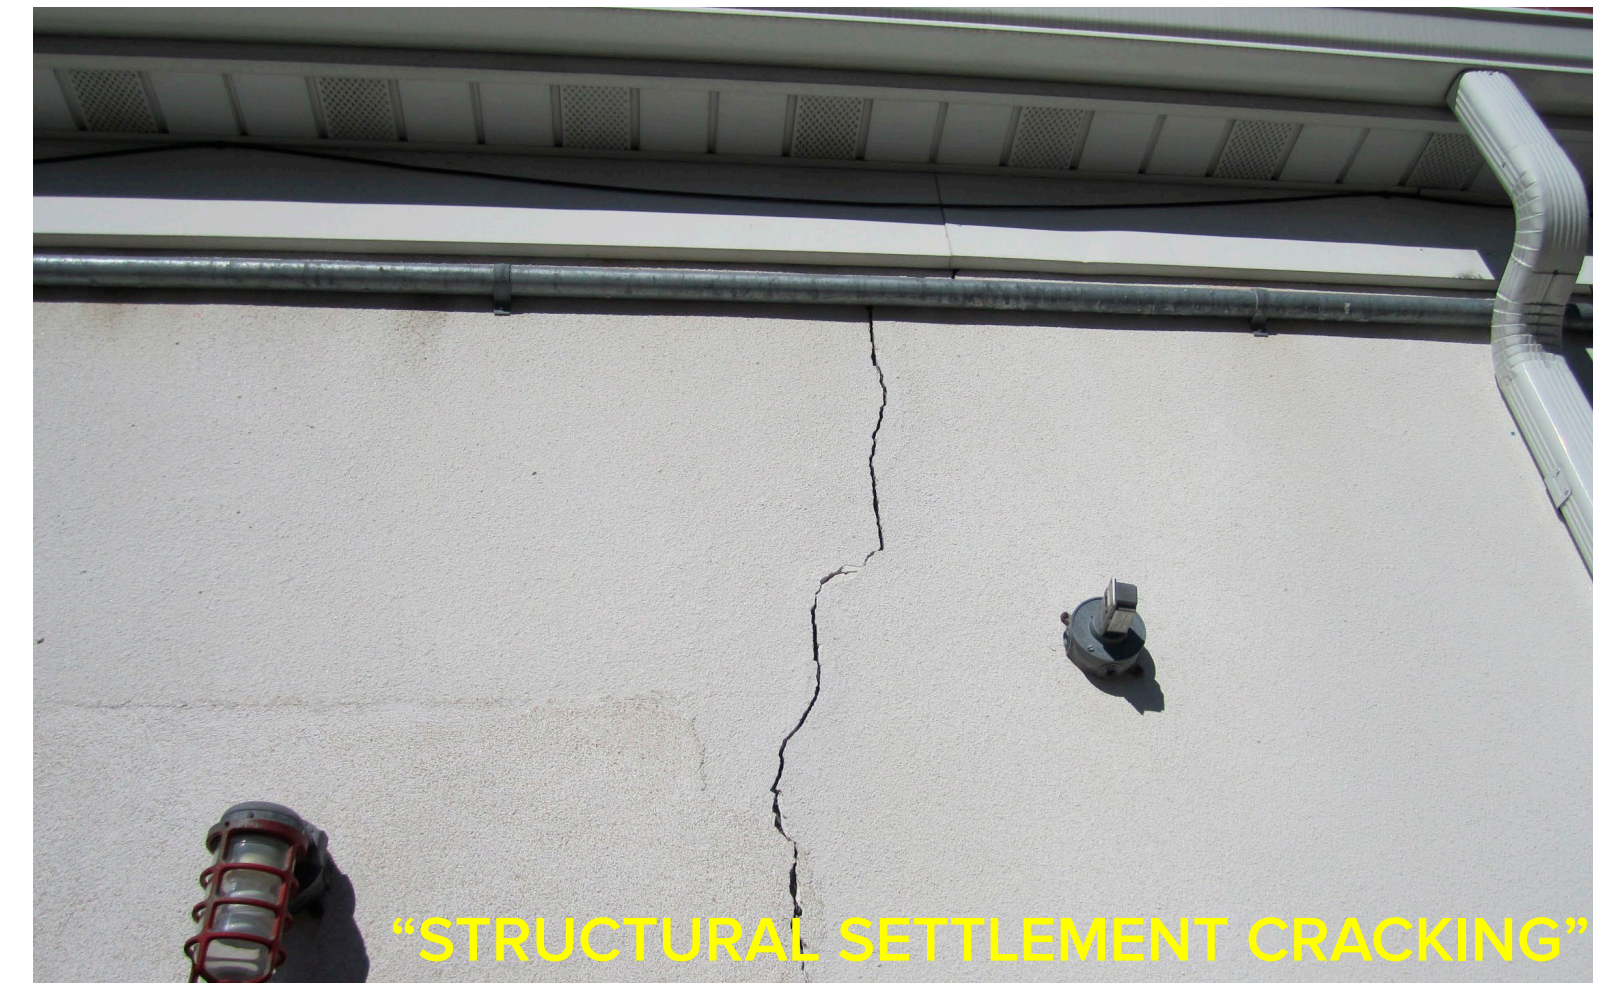
"STRUCTURAL SETTLEMENT CRACKING"

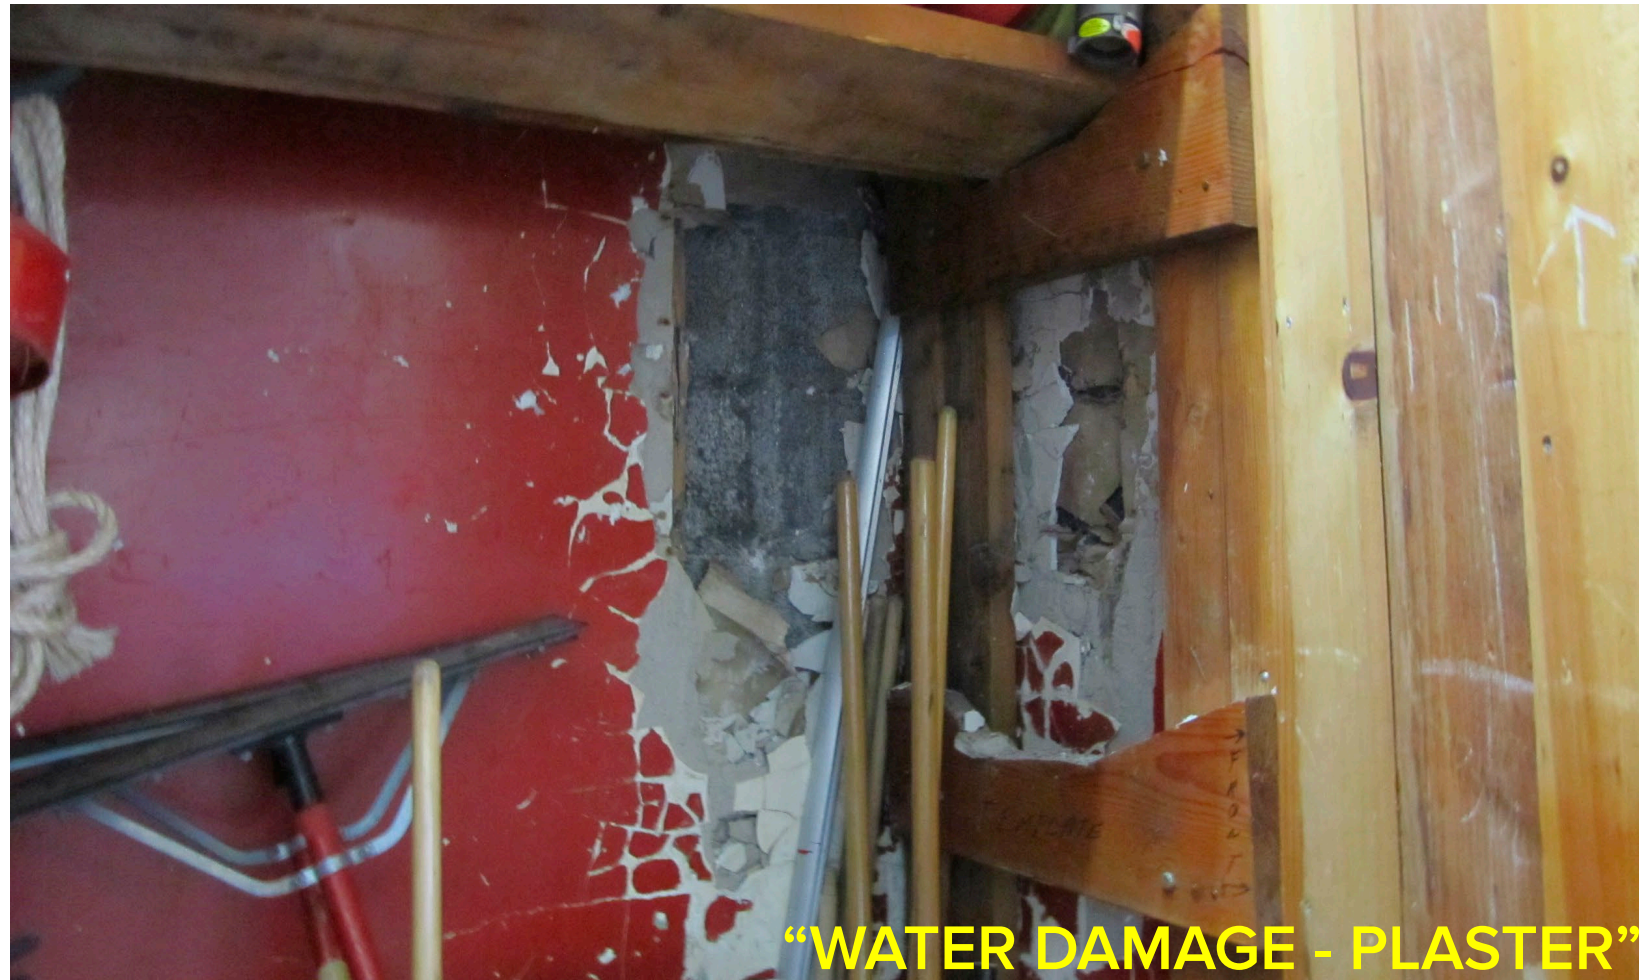
“WATER DAMAGE - PLASTER”

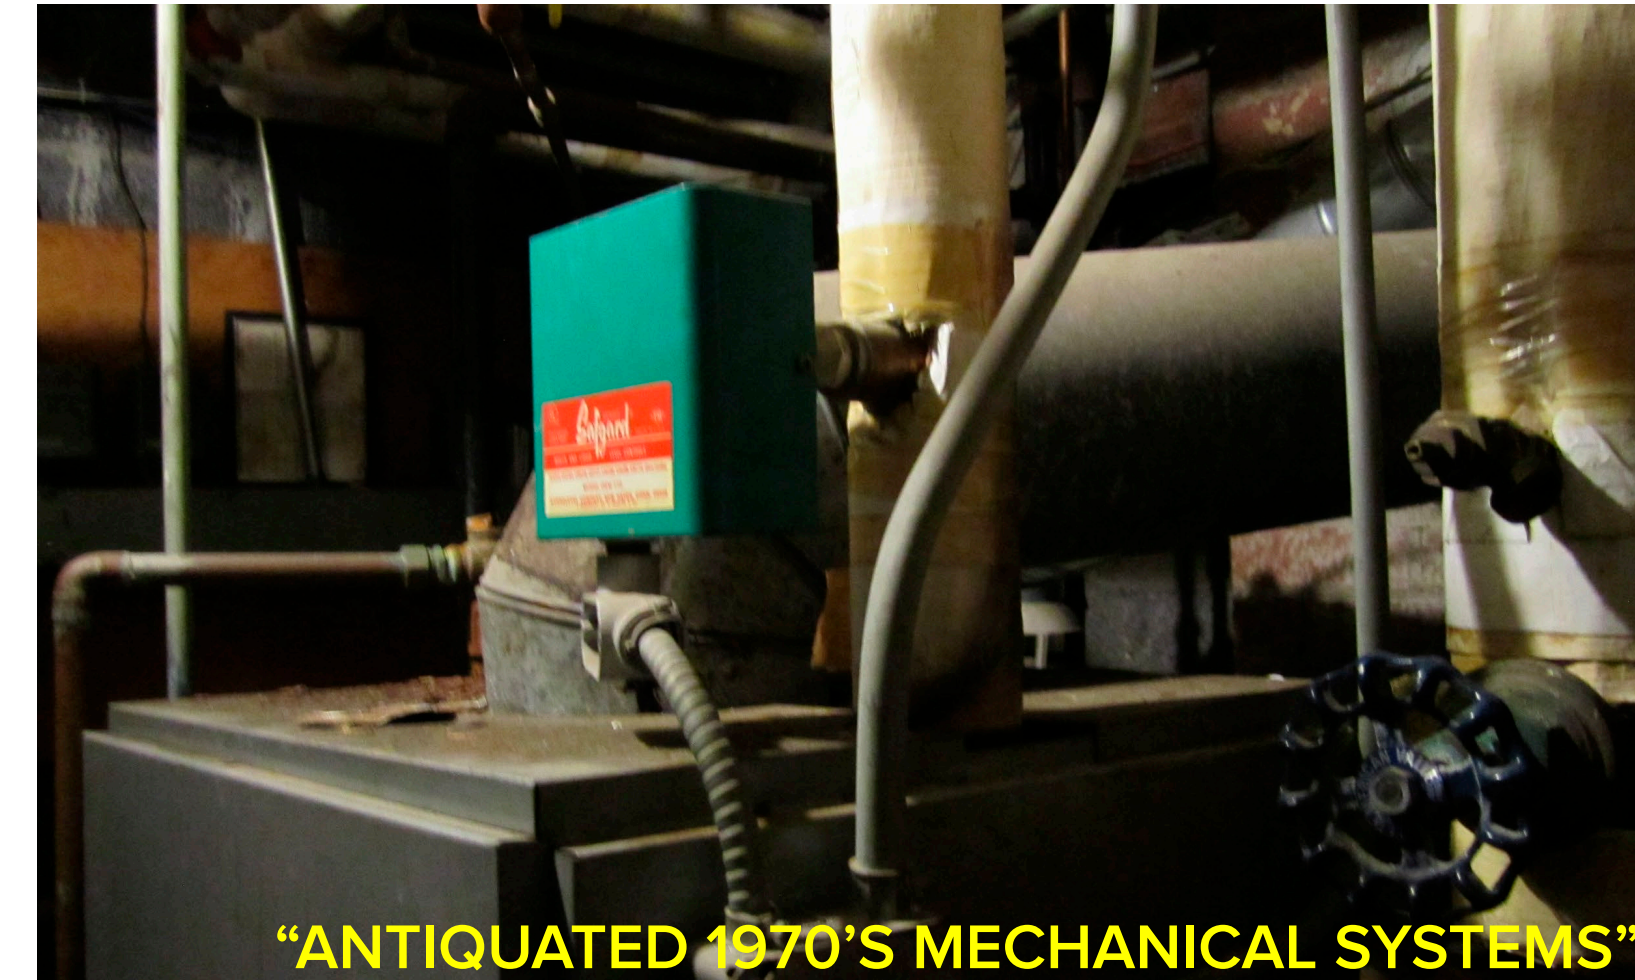
“ANTIQUATED 1970'S MECHANICAL SYSTEMS”

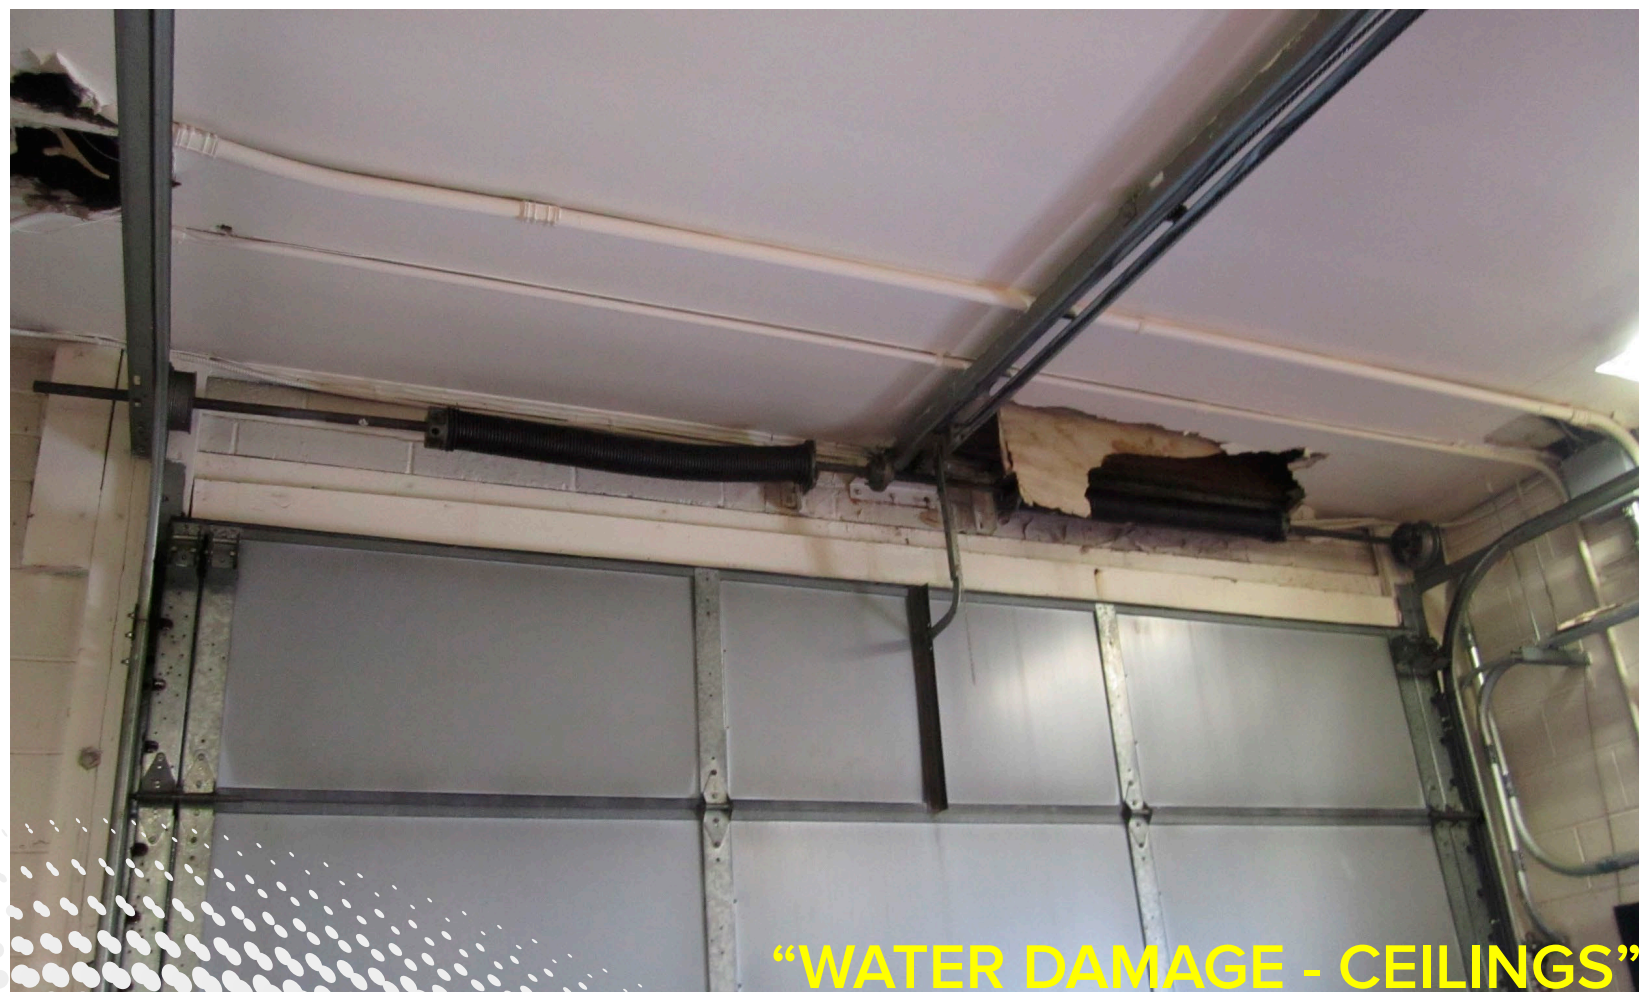
“WATER DAMAGE - CEILINGS”

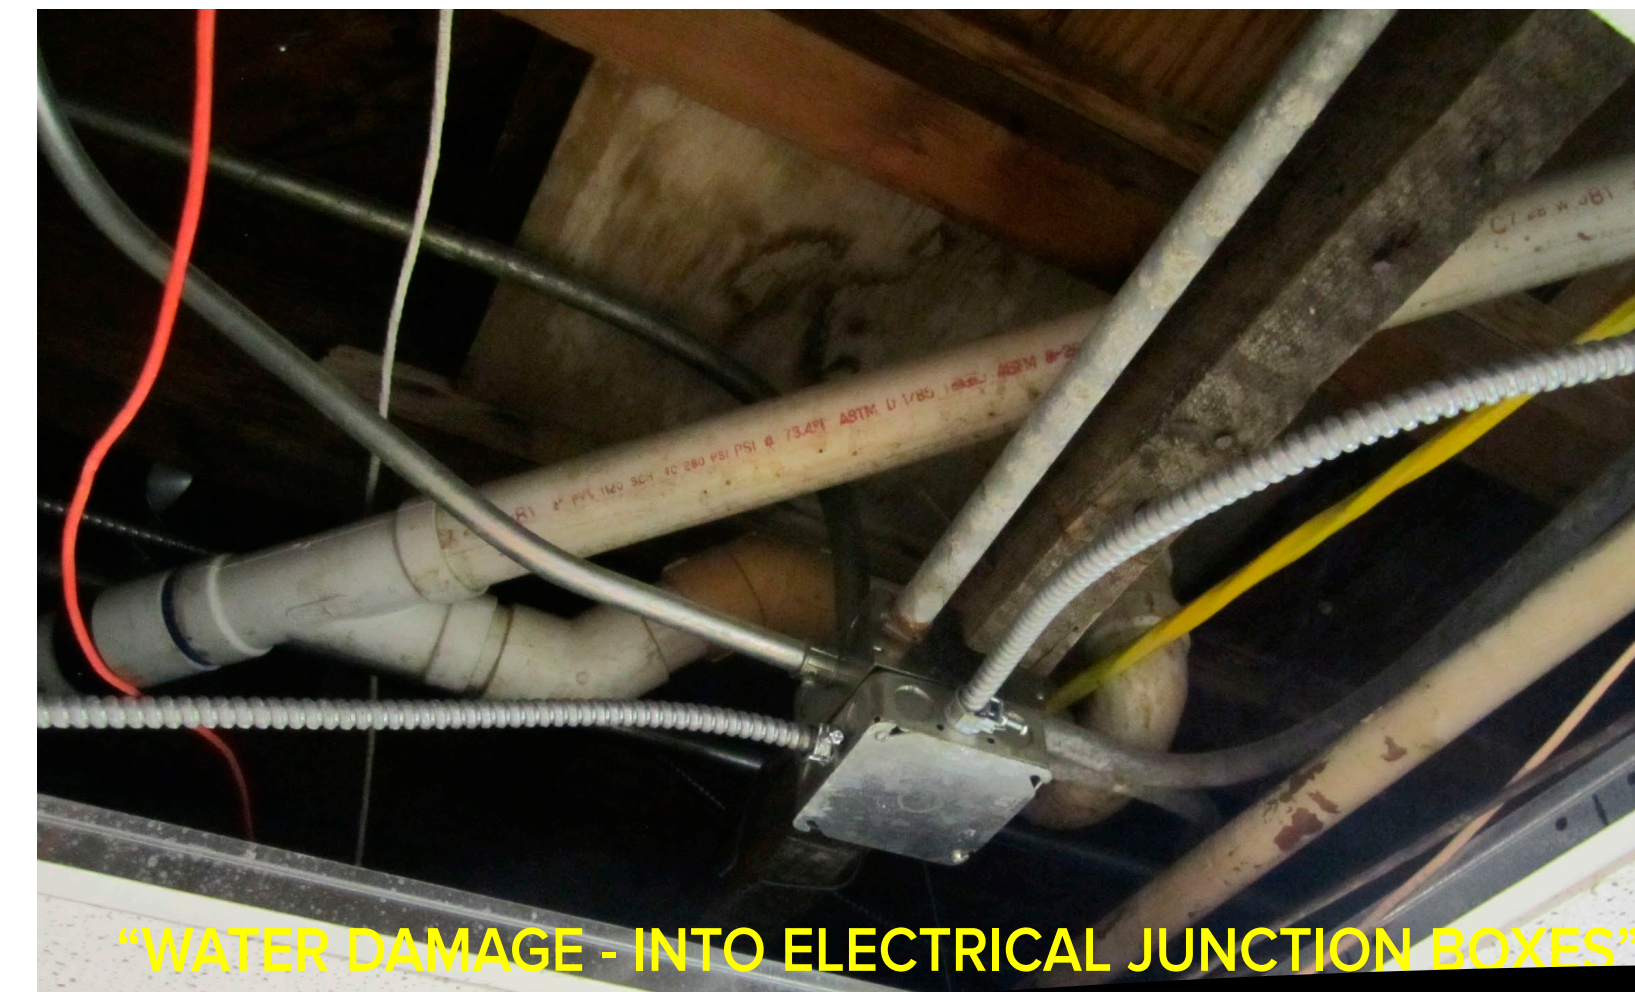
“WATER DAMAGE - INTO ELECTRICAL JUNCTION BOXES”

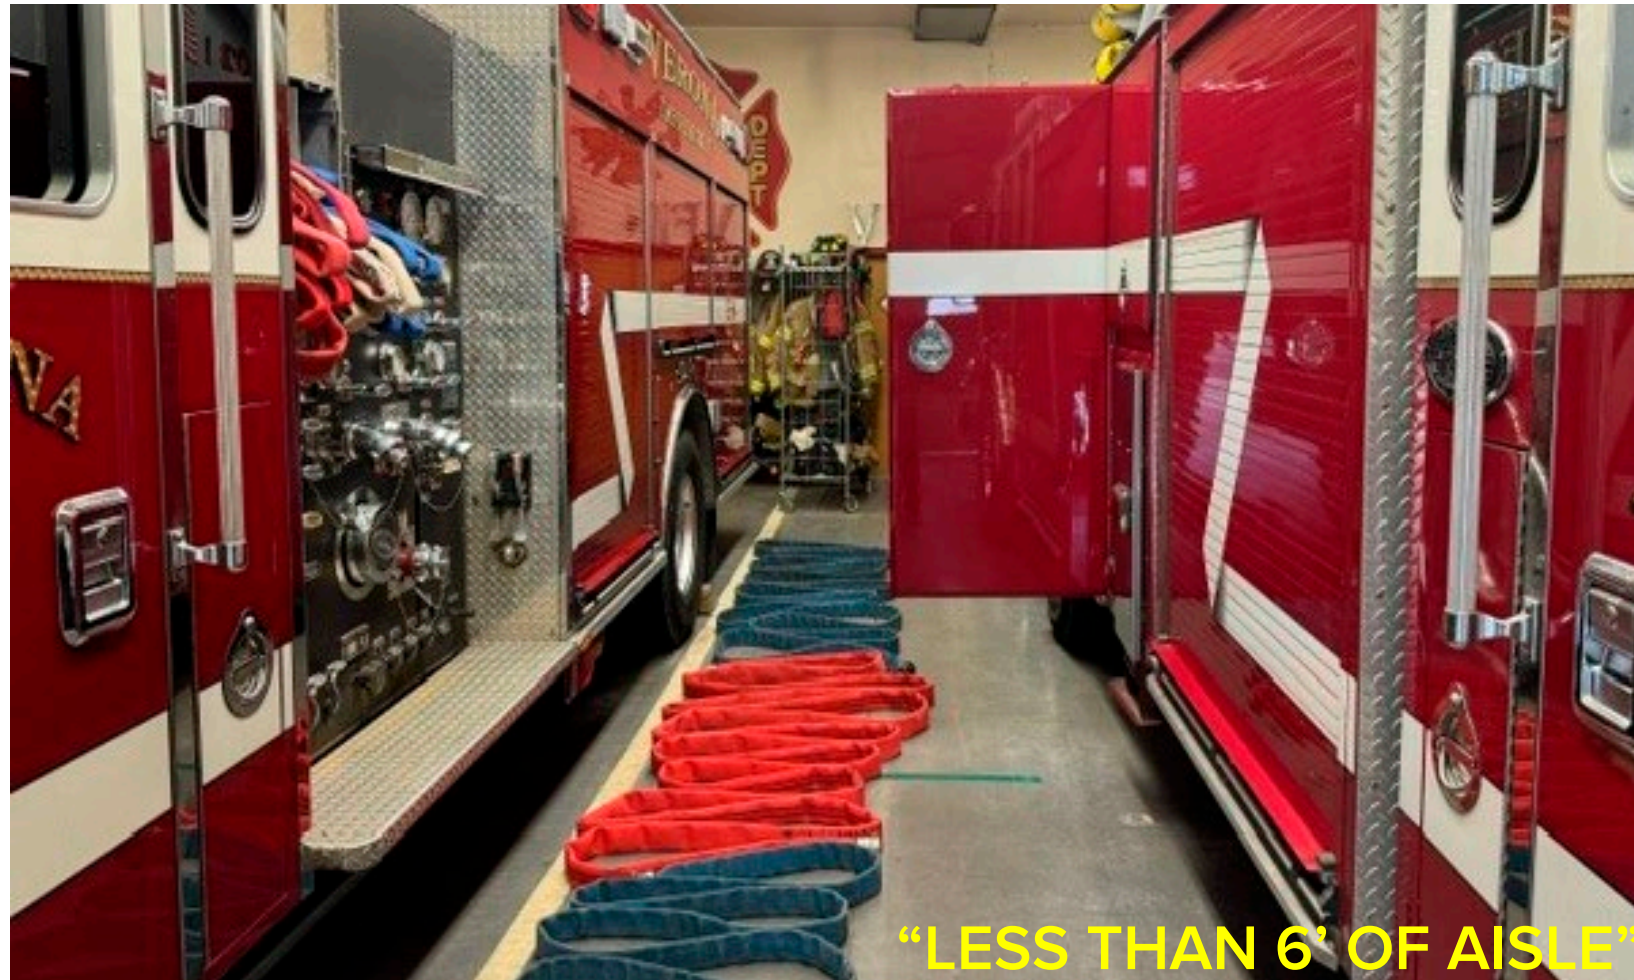
"LESS THAN 6' OF AISLE"
