PUBLIC PRESENTATION

VERONA EMERGENCY SERVICES

POLICE DEPARTMENT, FIRE DEPARTMENT - CO. #2, RESCUE SQUAD

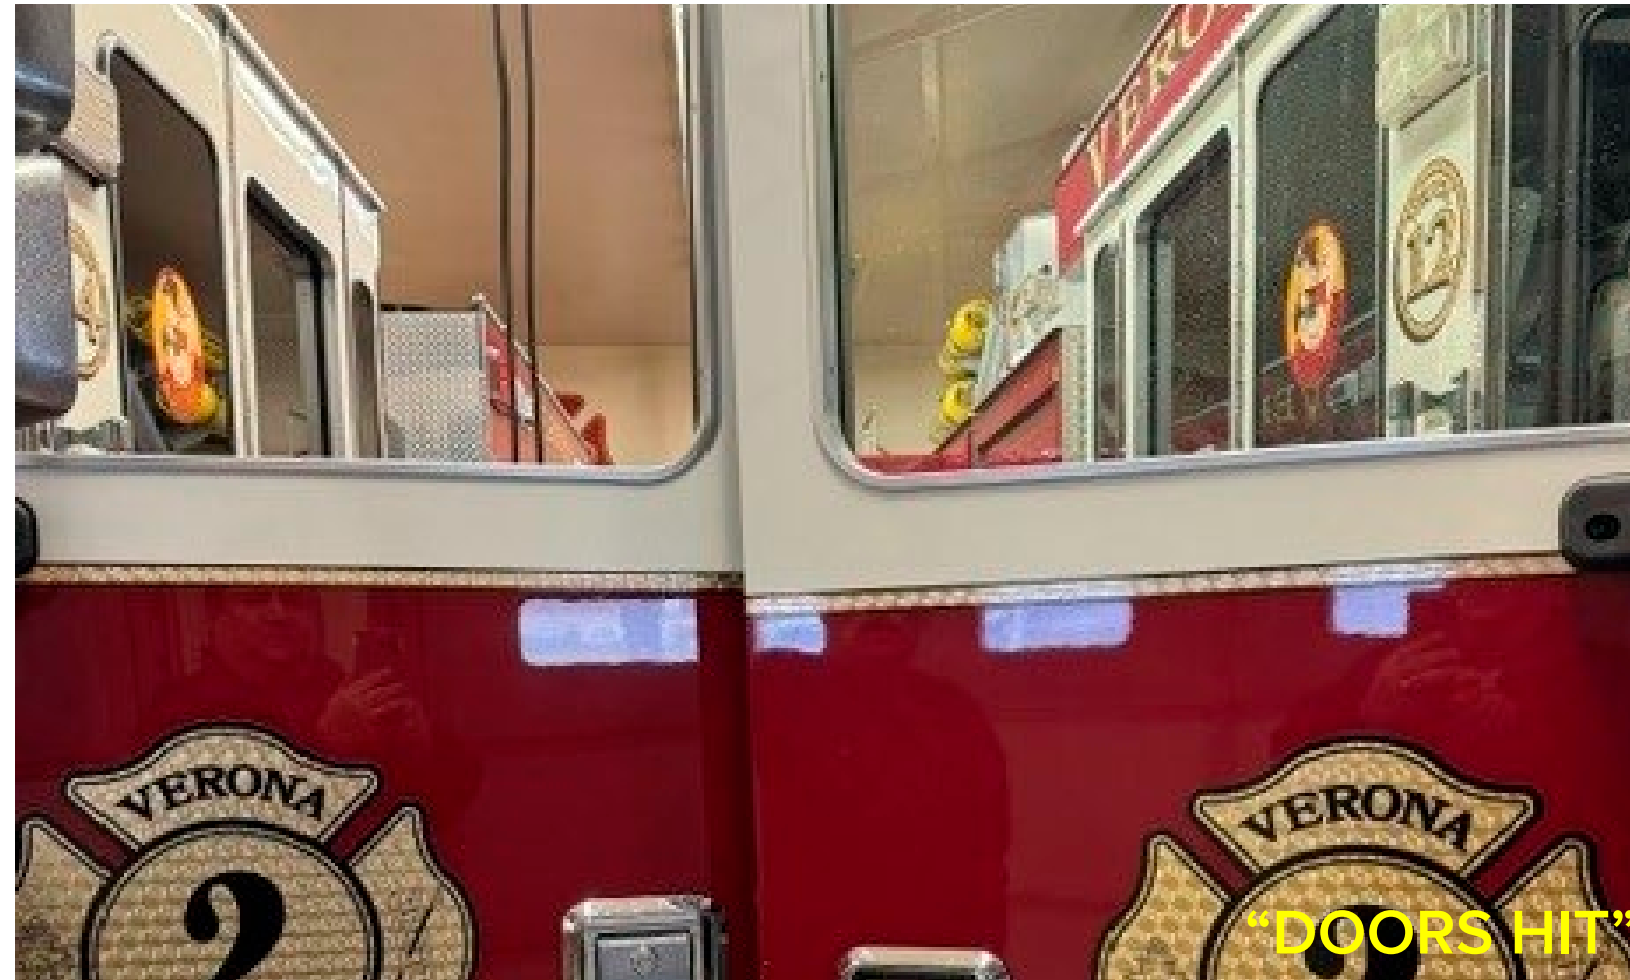
"DOORS HIT"

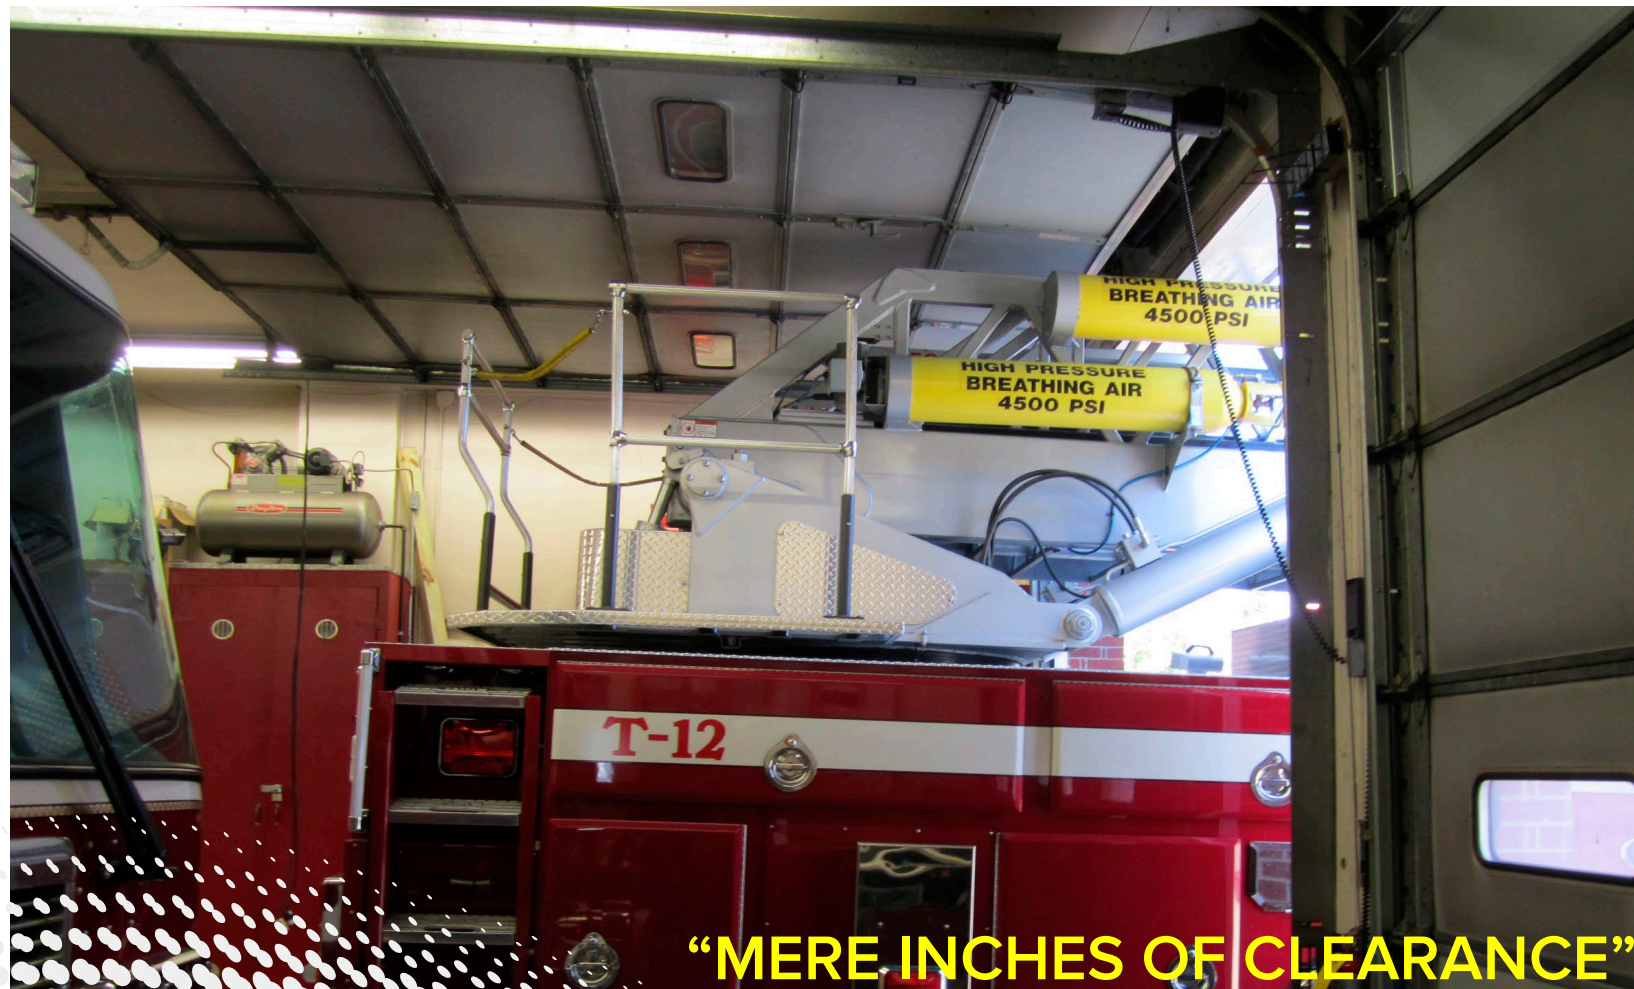
"MERE INCHES OF CLEARANCE"

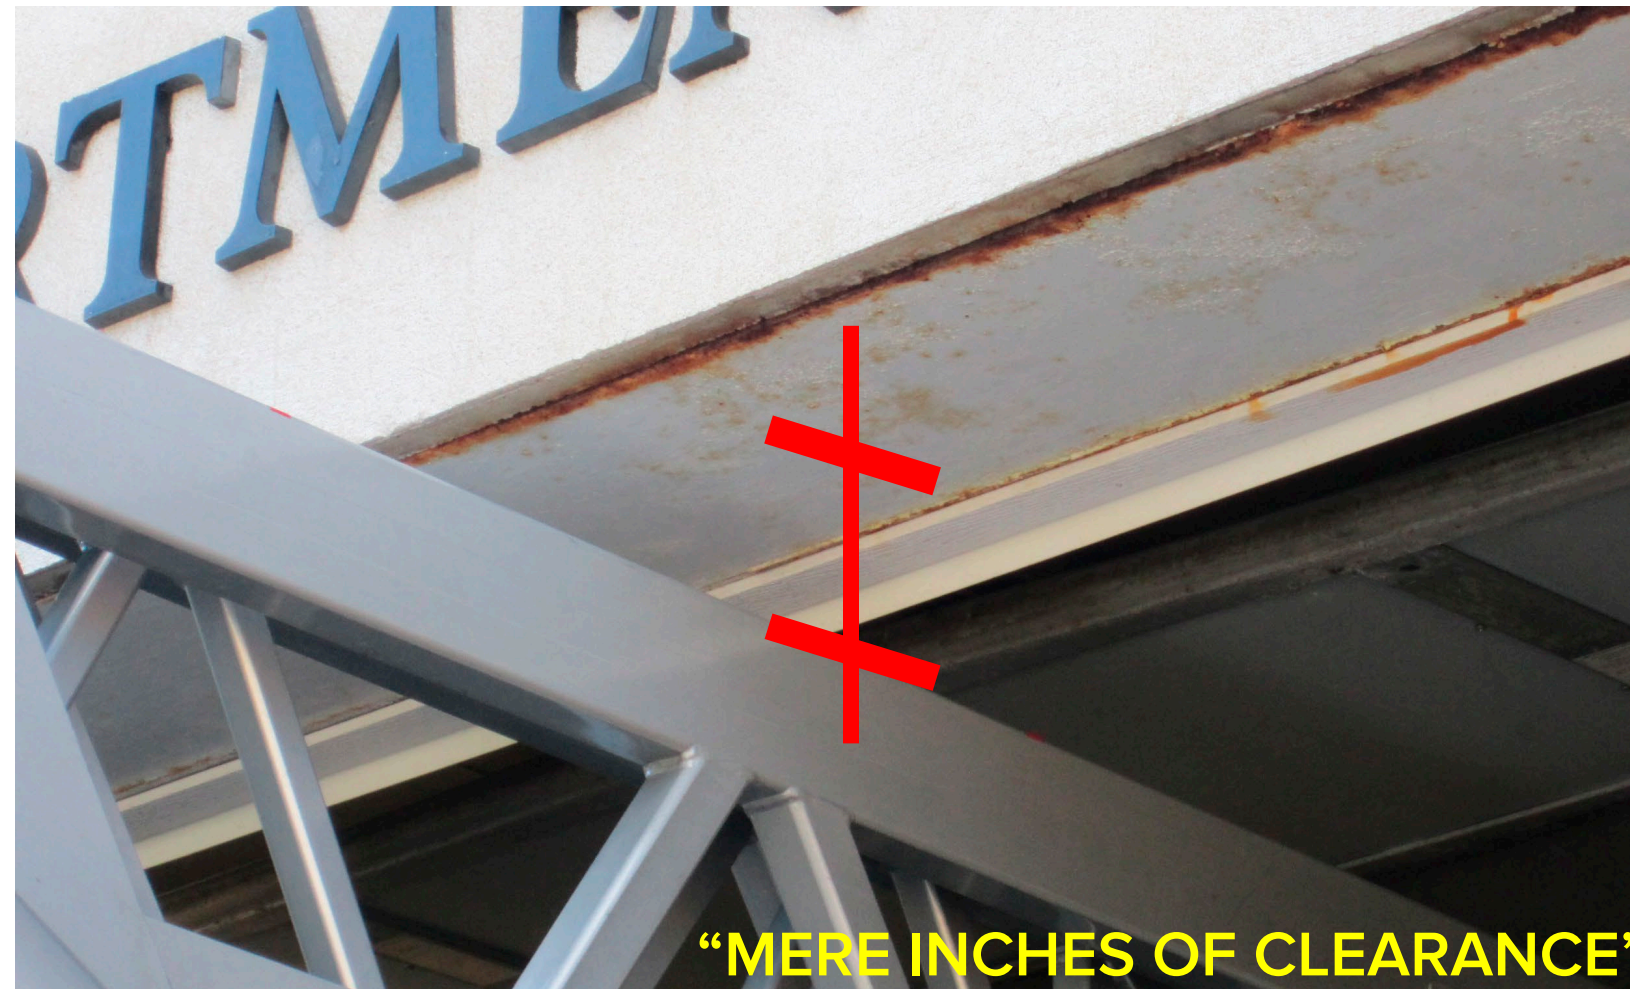
"MERE INCHES OF CLEARANCE"

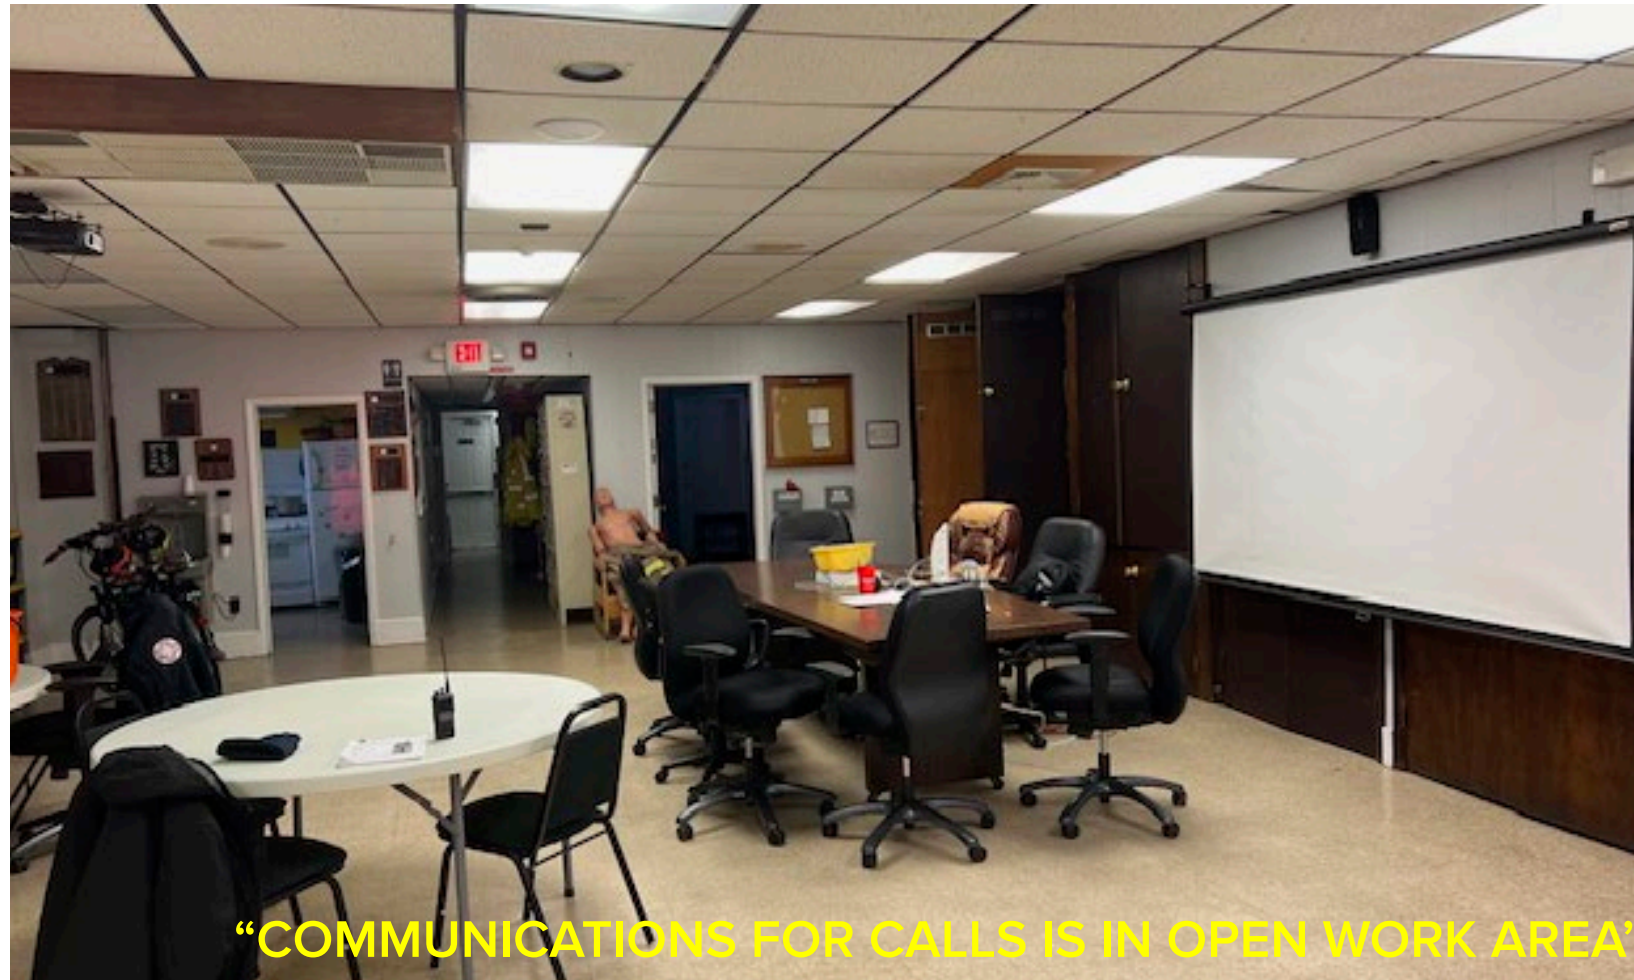
"COMMUNICATIONS FOR CALLS IS IN OPEN WORK AREA"

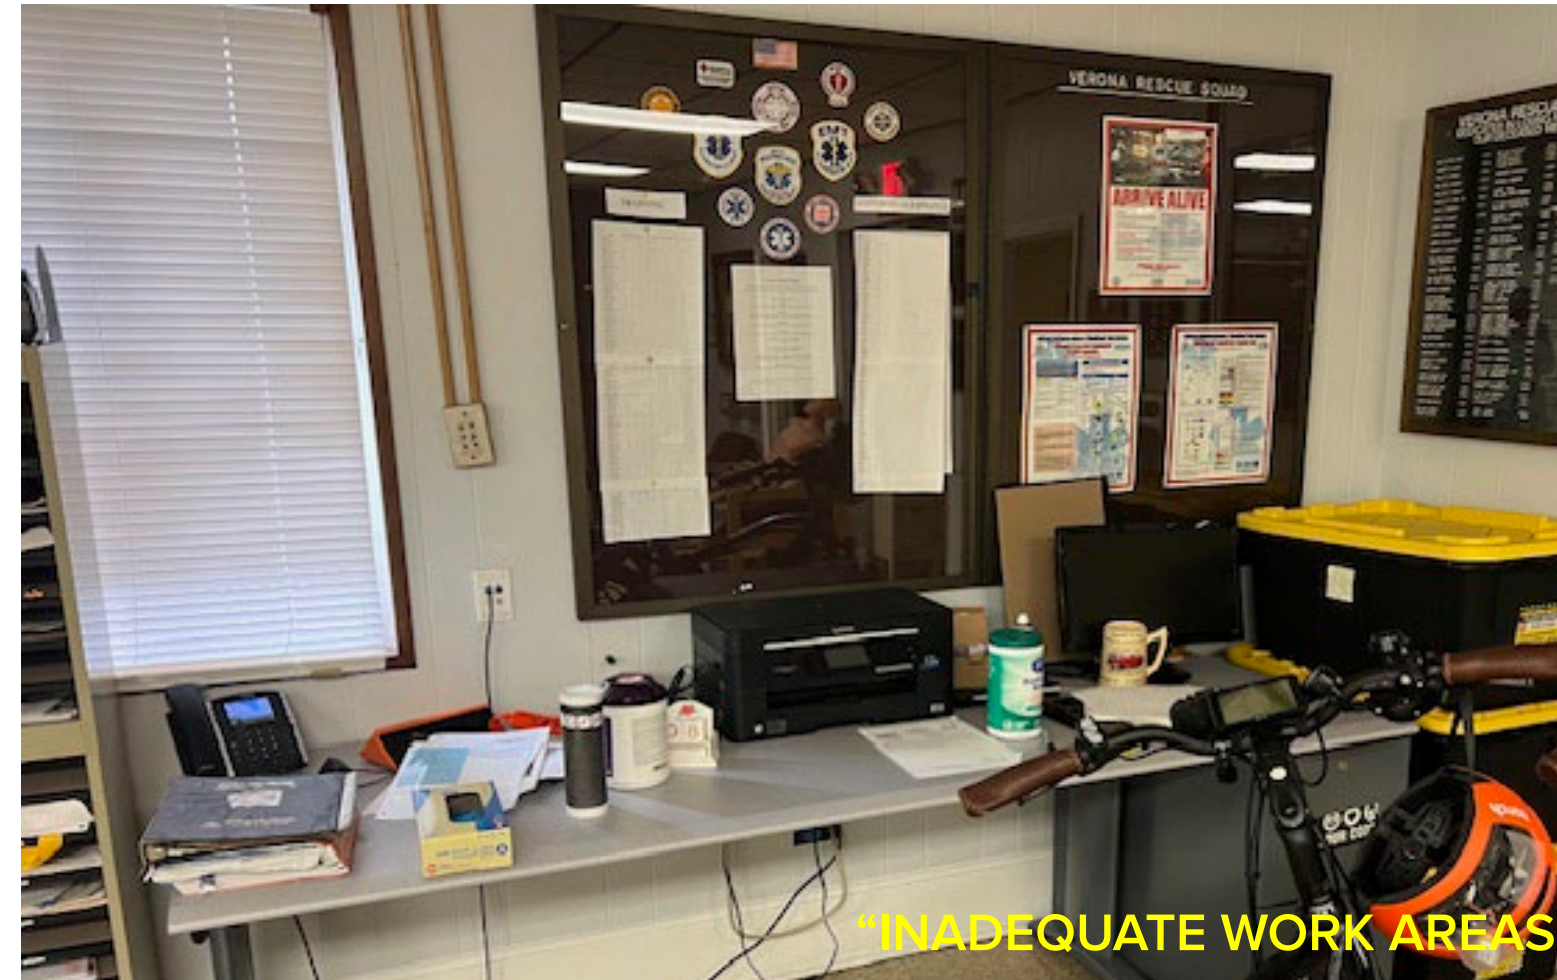
"INADEQUATE WORK AREAS"

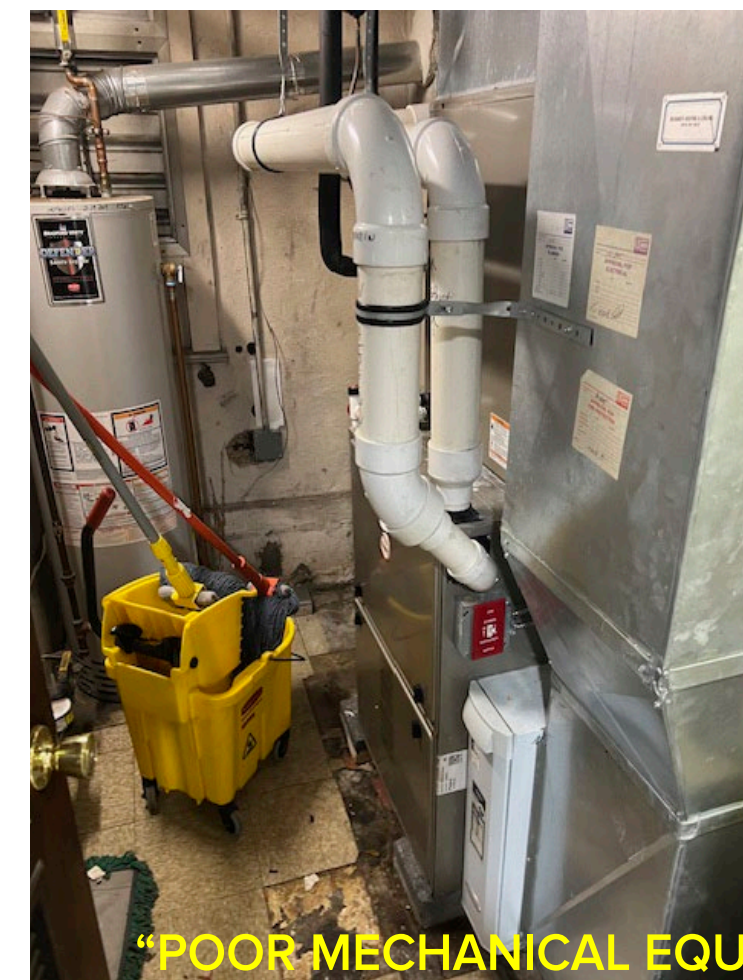
"POOR MECHANICAL EQUIP"

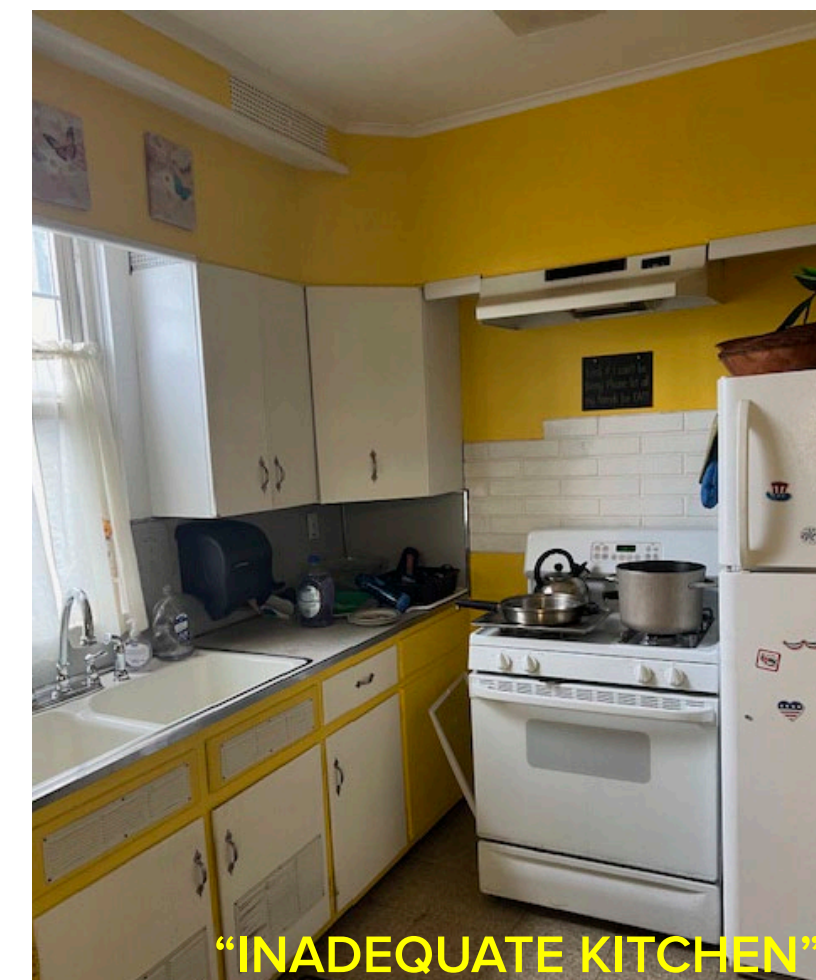
"INADEQUATE KITCHEN"

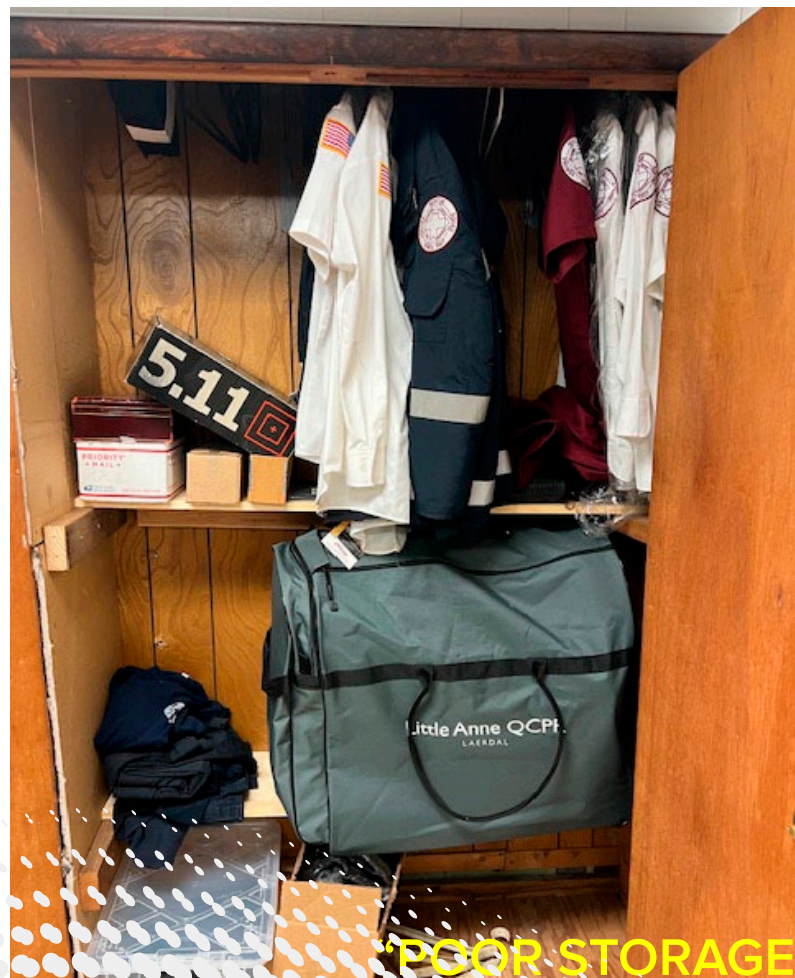
"POOR STORAGE"

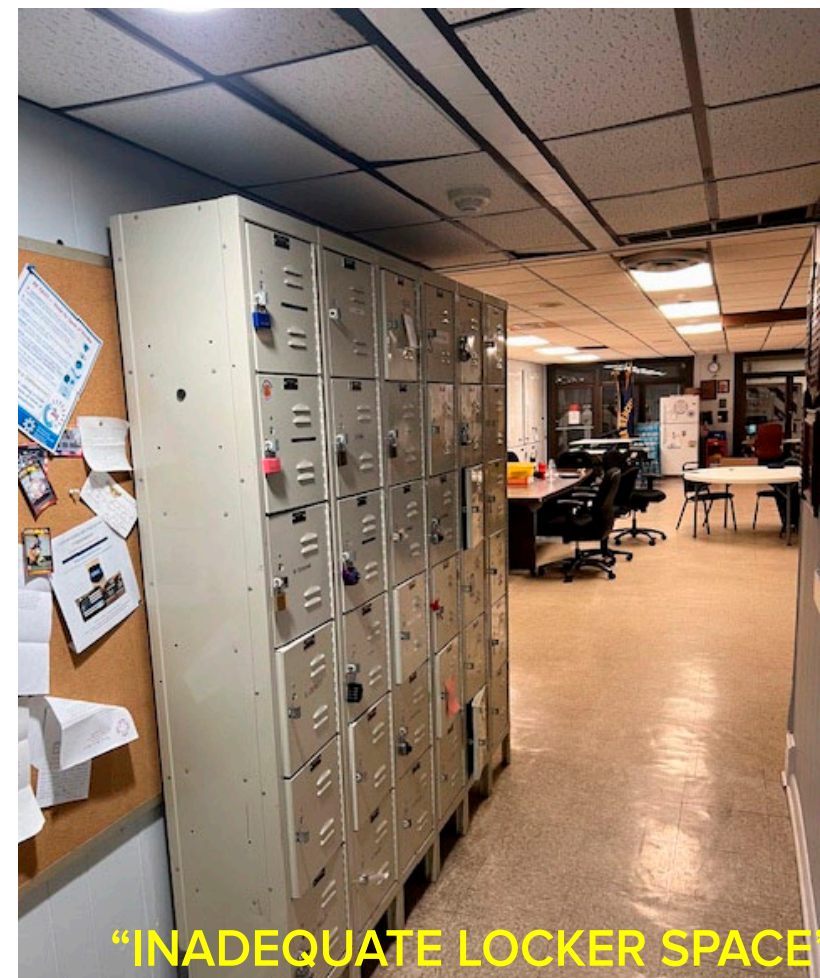
"INADEQUATE LOCKER SPACE"

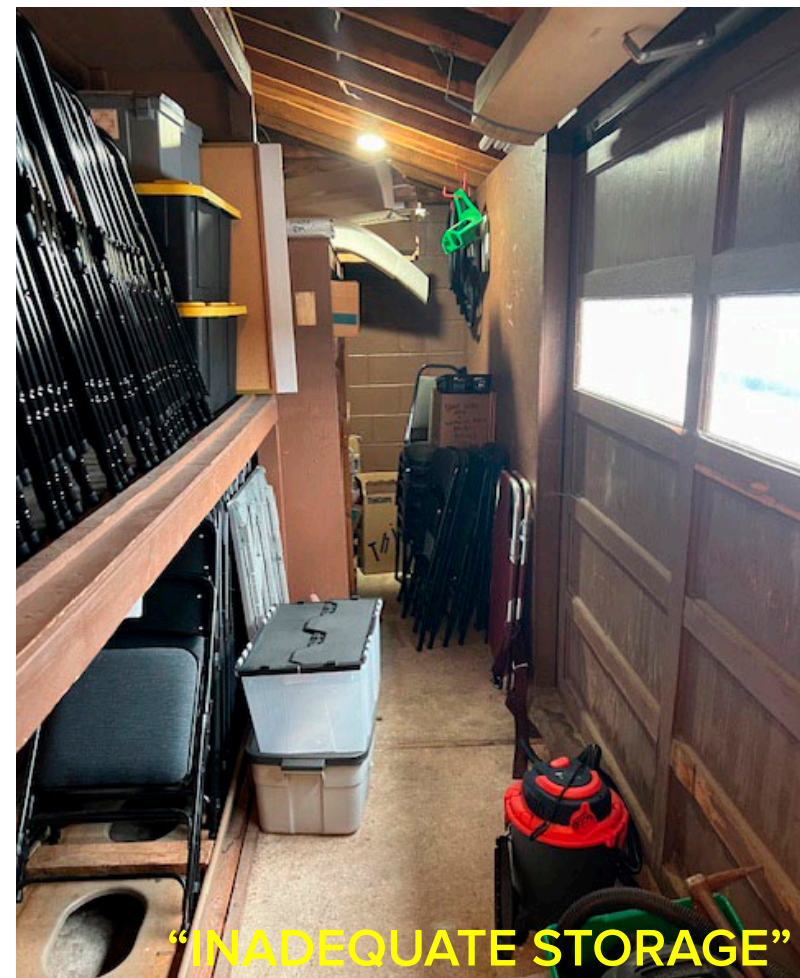
"INADEQUATE STORAGE"

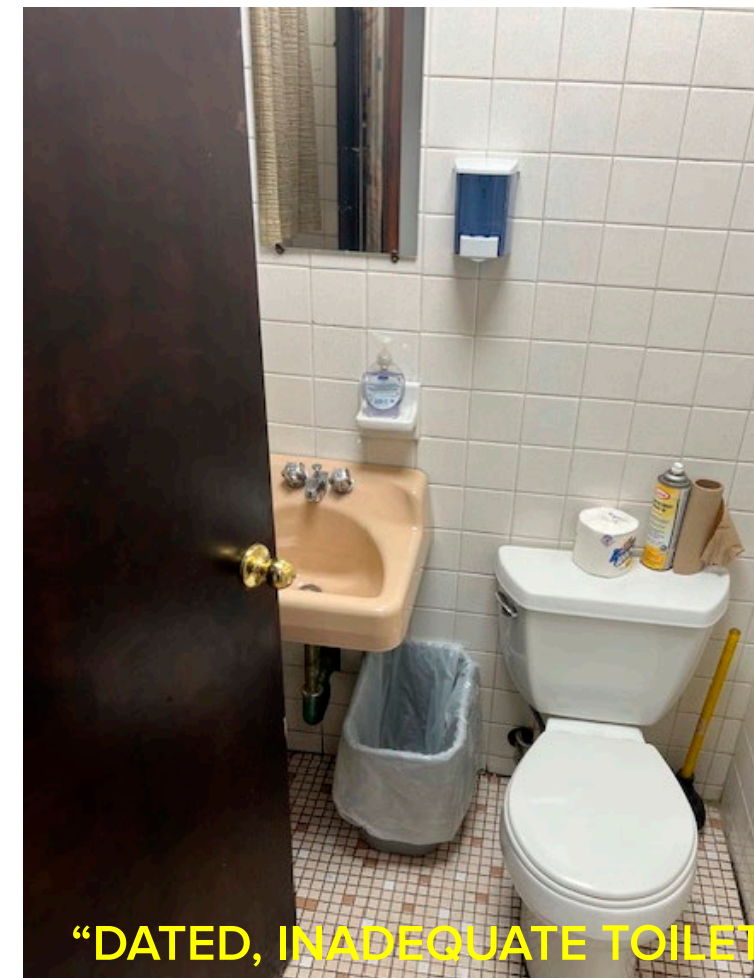
"DATED, INADEQUATE TOILET"

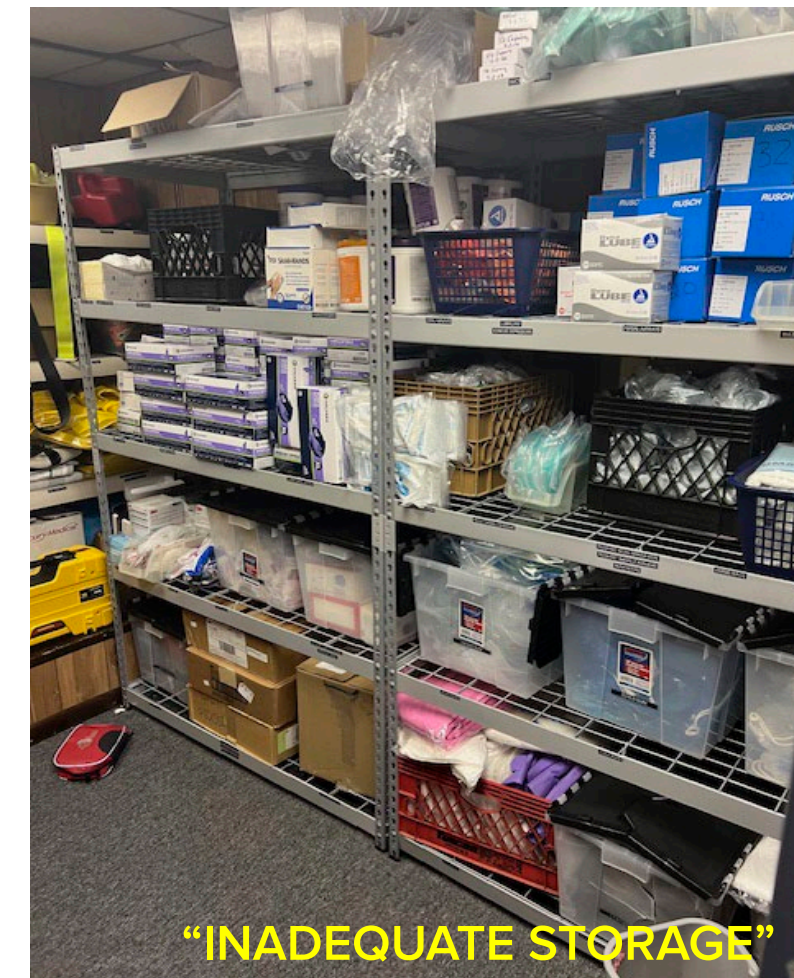
"INADEQUATE STORAGE"

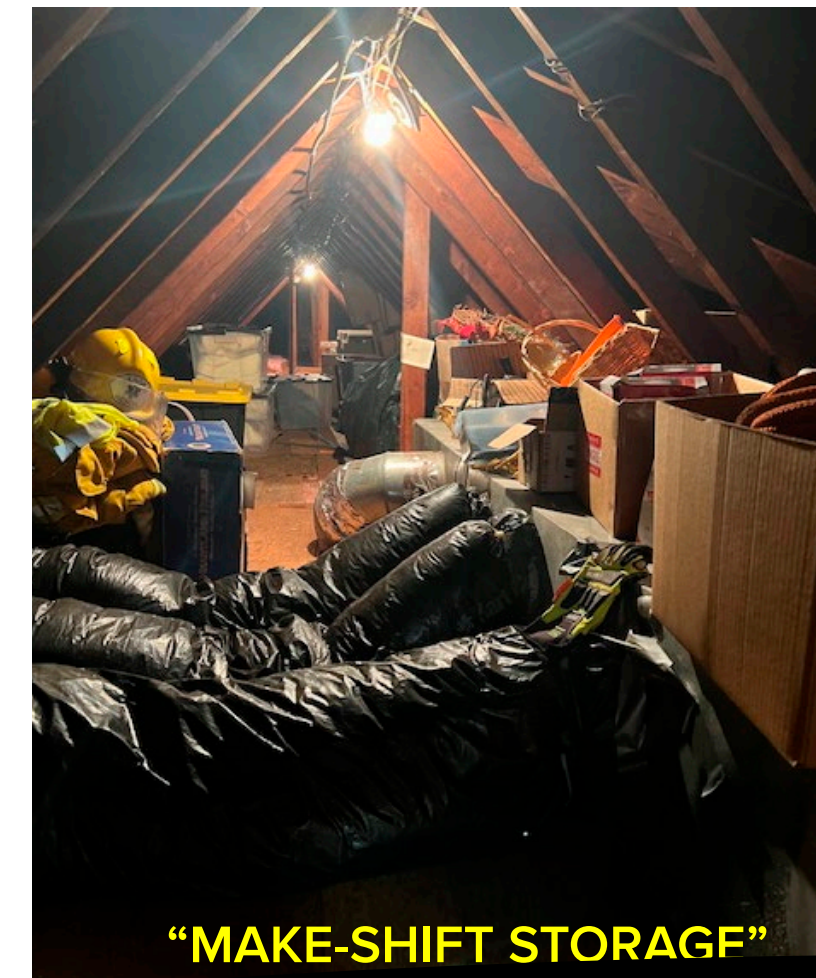
"MAKE-SHIFT STORAGE"
