Township of Verona

383 Bloomfield Avenue

AREA IN NEED OF REDEVELOPMENT

**PRELIMINARY INVESTIGATION
REPORT**

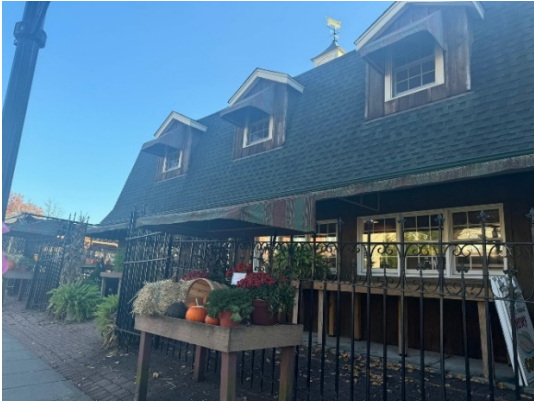
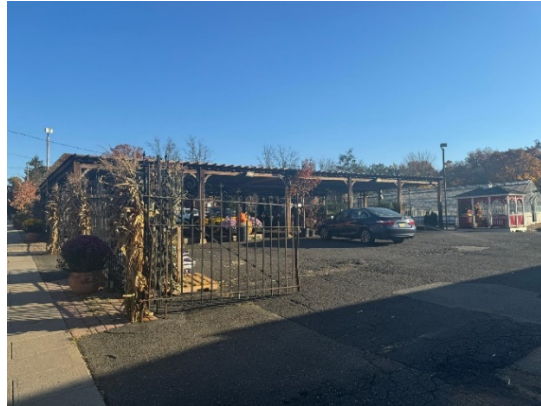
View of the principal building from Bloomfield Avenue (above left). View of the wood trellis plant display from Bloomfield Avenue (above right).

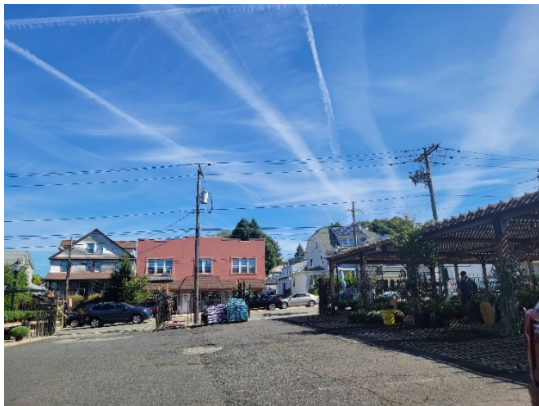
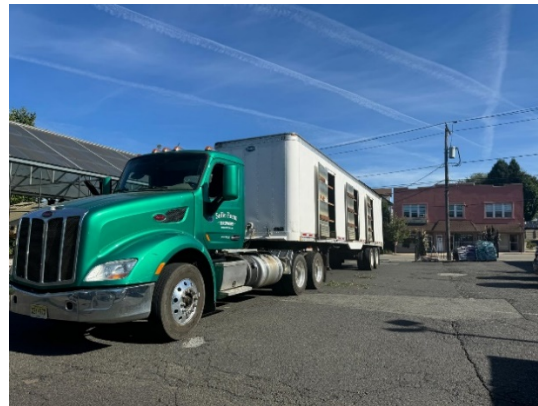
View of the two ingress and egress points from Bloomfield Avenue, and the parking between the principal building and the plant display area under the wood trellis. The parking lot shows lack of repair and is undefined.

View looking towards the two ingress and egress points from Bloomfield Avenue. This lacks a designated loading area, with a tractor trailer parked proximate to the ingress point.

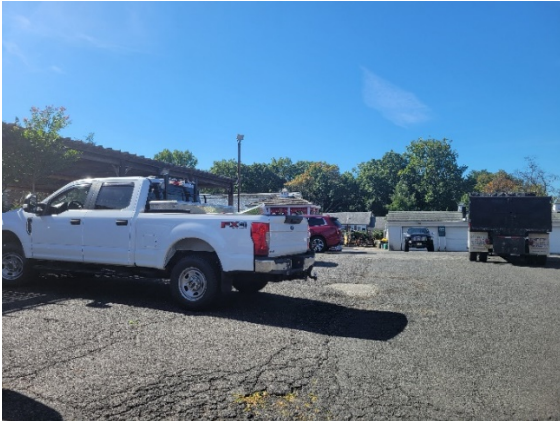
View of the parking lot looking inwards from Bloomfield Avenue, with the principal building to the right (not seen in the image) and the standalone plant display to the left. The parking lot is undefined as there is no differentiation between the access drive and the parking spaces. Lack of a loading space as seen by the truck parked to the right, proximate to the vehicles parked in the undefined parking spaces.

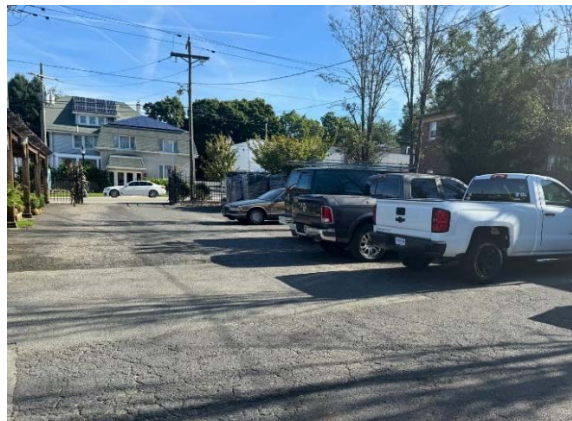
View of the third ingress and egress point along Bloomfield Avenue. This access drive and parking area is on the eastern side of the large wood trellis that divides the parking lot into two areas. Like the other parking areas, the parking spaces are undefined.

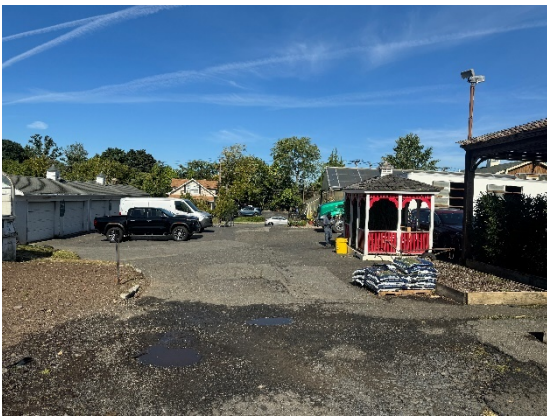
View from the rear of the standalone plant display area with a wood trellis, looking towards Park Avenue. The driveway, to the right, leads to the third ingress/egress point on Bloomfield Avenue.

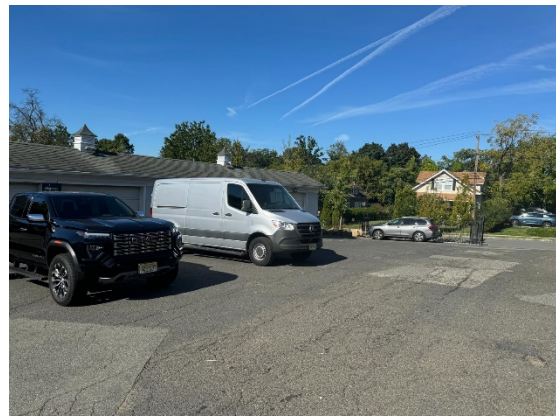
View of the ingress and egress along Park Avenue and the parking lot.

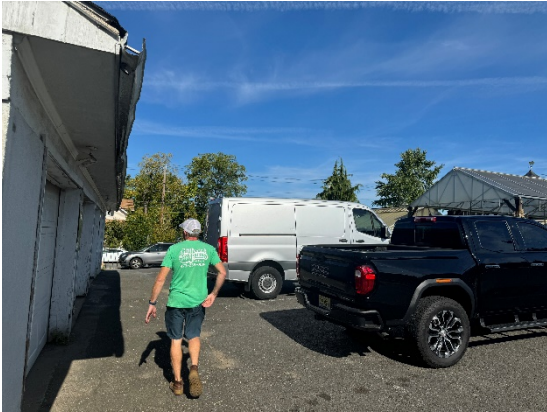
View from the five-door garage (to the left), behind the parked cars, looking towards Park Avenue.

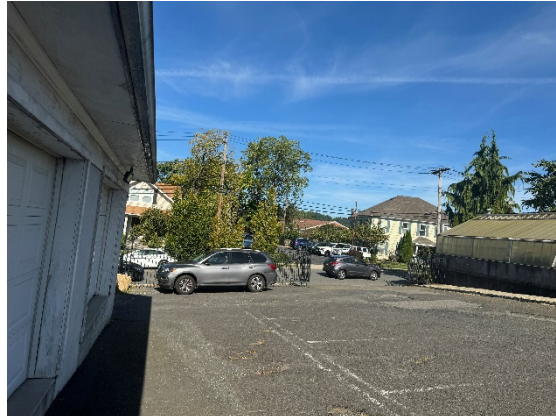
View from the five-door garage (to the left) looking towards Park Avenue.

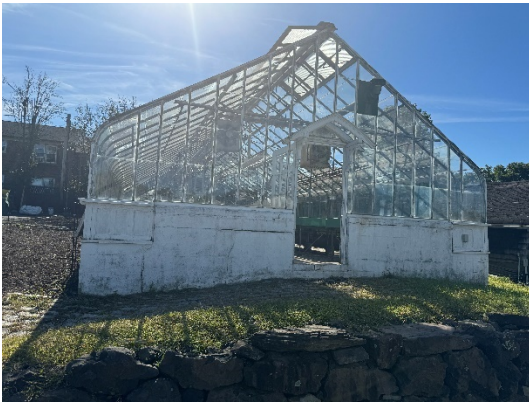
To the southeast of the principal commercial building, there is a 120-year-old glass paneled greenhouse that was moved from another location and was relocated to the property in the 1980s as per the property owners. The greenhouse is located on the former footing of a house that was demolished. Based on the discussions with the property owner, the greenhouse is not regularly used because it was constructed with antique non-tempered glass panels which are functionally obsolete and difficult to replace. The original water connections for the demolished house are still present beneath the glass paneled greenhouse but have been abandoned. The glass greenhouse shows signs of deterioration such as peeling paint, missing glass panels, water infiltration, and rotting wood. The other greenhouses and structures on the property have collapsed roofs, damaged flooring, overgrown vegetation, and exhibit an overall lack of maintenance. The principal building along Bloomfield Avenue is attractive, which is misleading as this is a small portion of the property. Overall, the majority of the site shows signs of deterioration with dilapidated accessory buildings, improperly stored materials and debris, discarded equipment, lack of proper loading areas, and cracks and potholes in the parking areas.

View of the front and side of the glass paneled greenhouse showing visible signs of deterioration.

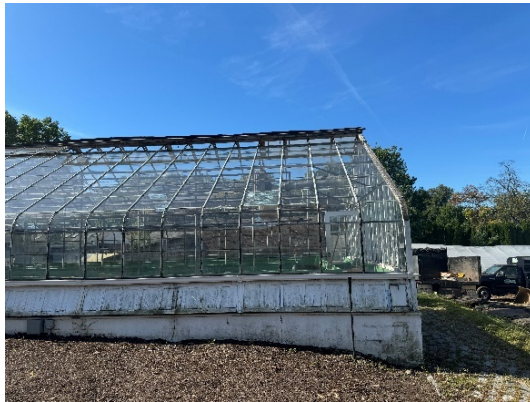
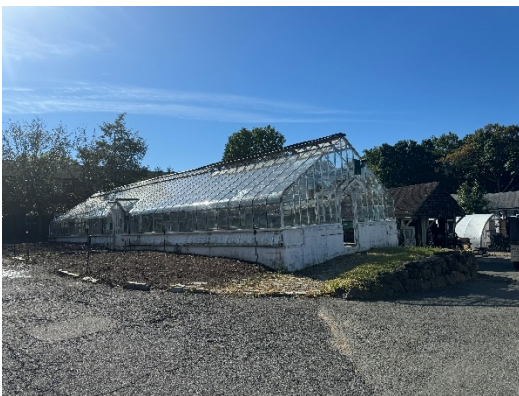
View of the glass paneled greenhouse located to the east of the five-door garage and south of the standalone plant display under a wood trellis.

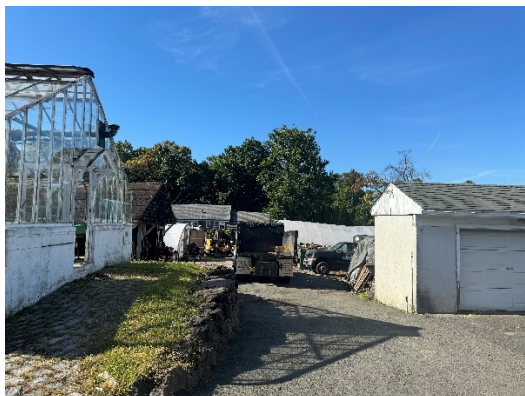
View of the rear yard with the glass greenhouse and five-door garage in the foreground and overlooking the backyard containing an assortment of greenhouses, shed, trailer, and storage materials.

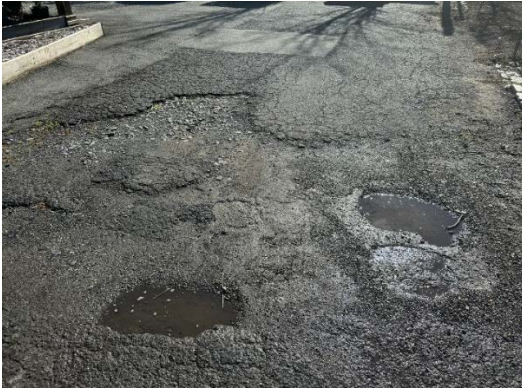
View of the parking lot, proximate to the glass paneled greenhouse, showing signs of decline with cracked pavement and potholes.

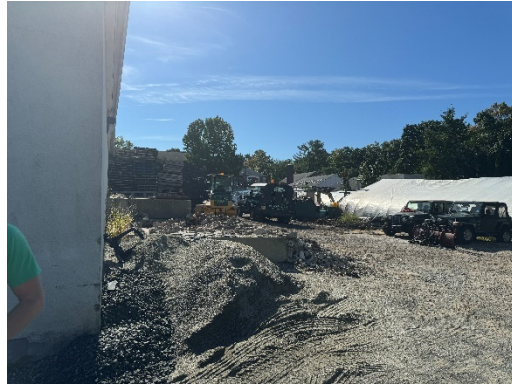
View to the rear of the five-door garage looking towards the greenhouses and the southeasterly portion of the rear property.

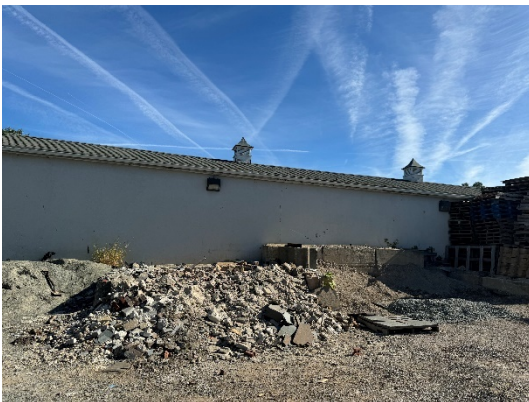
View looking towards the rear of the five-door garage. The site is strewn with debris.

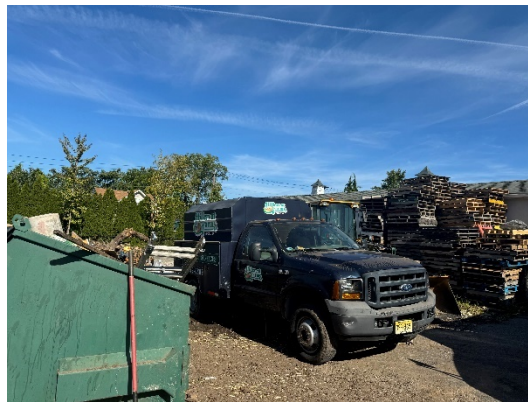
View of the yard between the five-door garage and the greenhouse on the southwestern portion of the site showing open storage and debris.

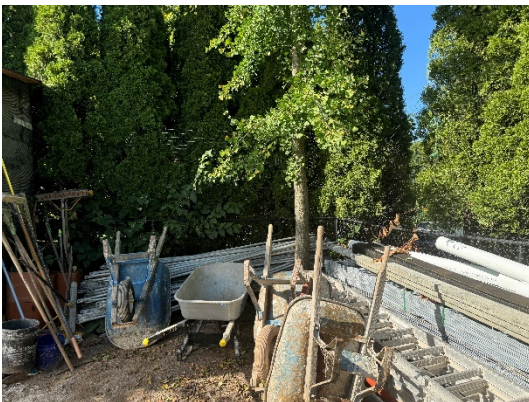
The property lacks stormwater management. It appears that there is only one stormwater drain located in the southwestern corner of the property. From our discussion with the property owner, the rear of the property floods periodically due to the inadequate drainage. The excessive impervious coverage on the property exacerbates the drainage and stormwater management issues. As mentioned earlier in the Study, there are abandoned underground storage tanks and above ground storage tanks that will be removed as part of the redevelopment.

View of the southwestern corner of the property (above left), which is the lowest point from the highest along the northeastern corner. It appears that water has eroded a channel into the gravel and soil over time. There is only one storm drain on the property (above right) which is partially obscured by junk and equipment. Based on our discussions with the property owner, this area floods periodically due to insufficient drainage.

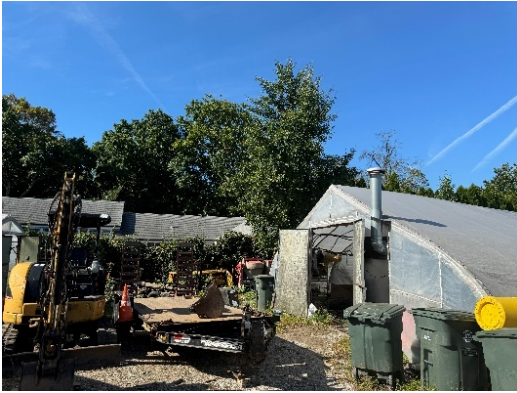
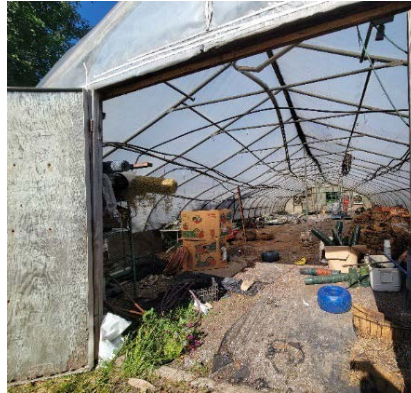
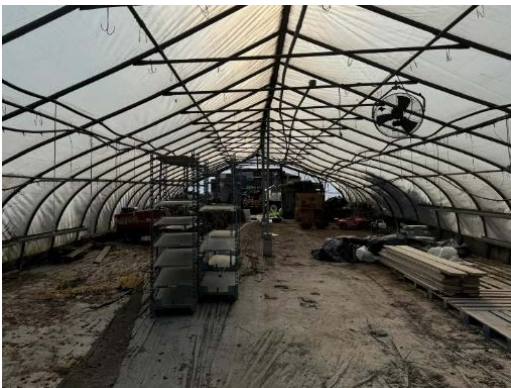
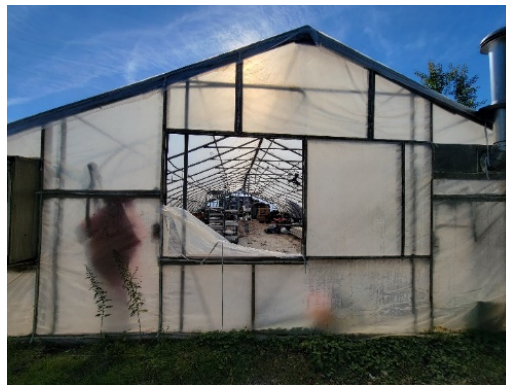
View of the greenhouse located to the southwestern portion of the property. As seen in the above four photographs, the greenhouse is in a decrepit condition. The informal storage of building materials, gardening materials, and accumulation of dirt indicate lack of maintenance.

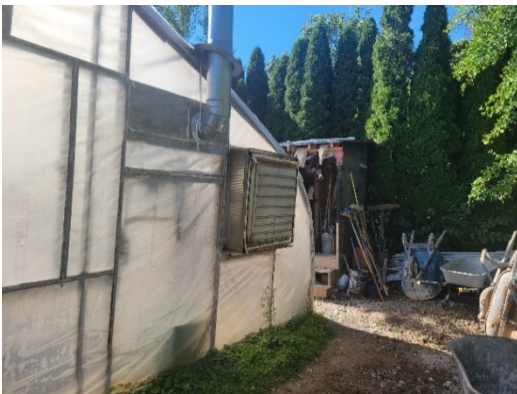
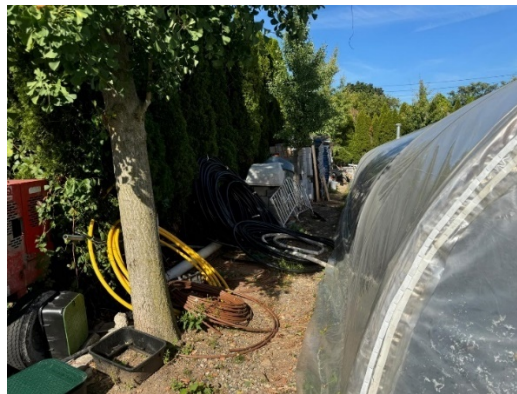
More views of the greenhouse in the southwestern corner. Trash and equipment are stored on the side of the greenhouse along the southerly property line.

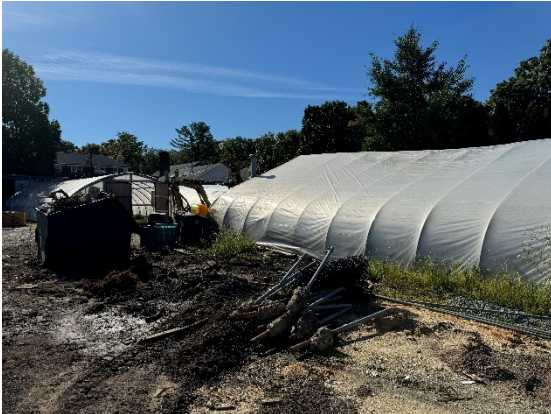
View towards the southeasterly portion of the property, showing the two greenhouses in the background. The property is strewn with debris.

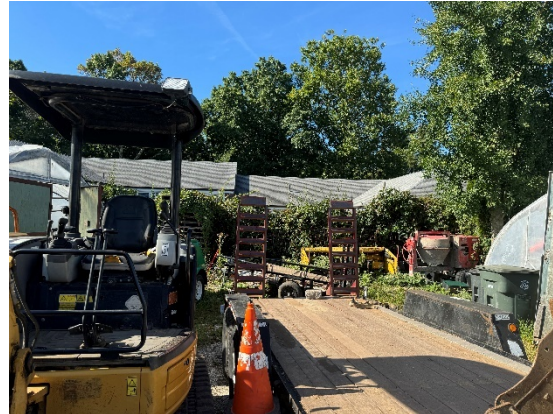
View towards the southerly property line showing the area between the three greenhouses to the rear.

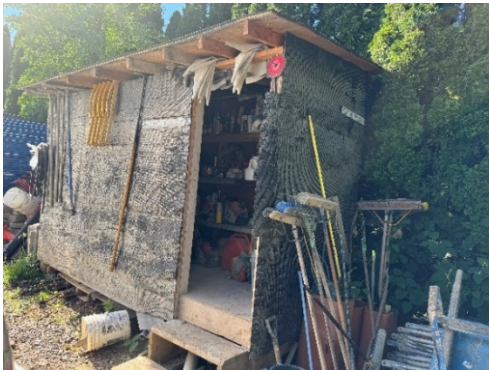
View of the dilapidated wooden storage shed to the rear of the greenhouse in the southwest corner of the property and the surrounding debris.

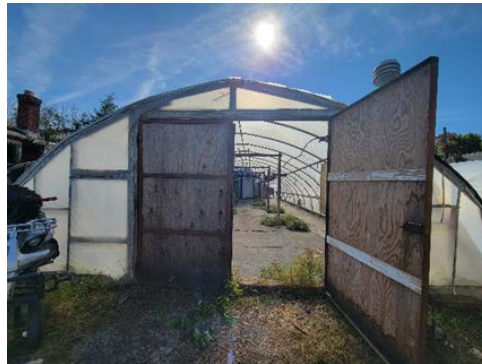
To the southeast corner of the property are two greenhouses parallel to the southerly property line. Pictured above is the entrance to one of these greenhouses. The area surrounding these greenhouses is characterized by overgrowth.

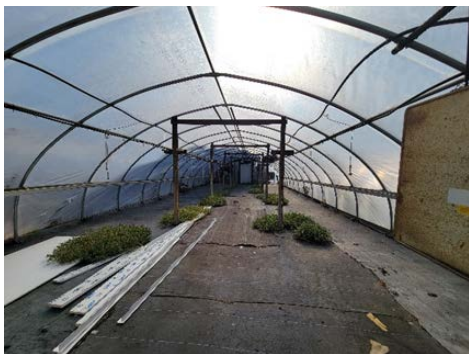
View of the interior of one of the green houses. There are large weeds growing through warped, make-shift plywood flooring. This indicates lack of maintenance.

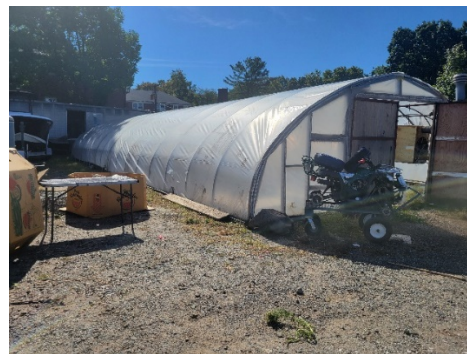
The condition of the exterior of the two greenhouses indicate issues caused by lack of maintenance. As seen above, junk and work equipment are strewn around haphazardly.

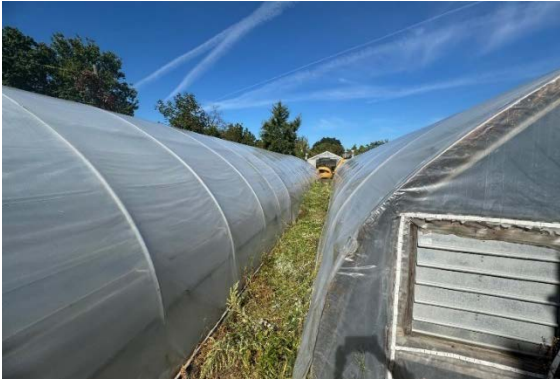
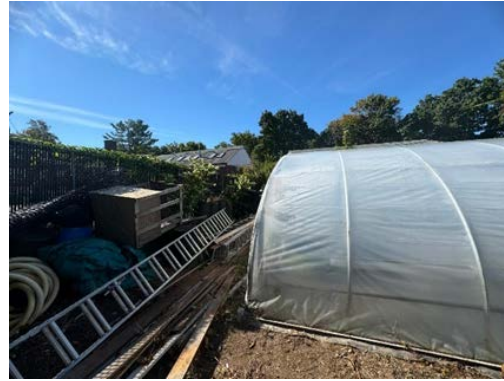
The area in between the the greenhouses is overgrown (above left). Behind the greenhouse closest to the property line are heaps of equipment and junk (above right).

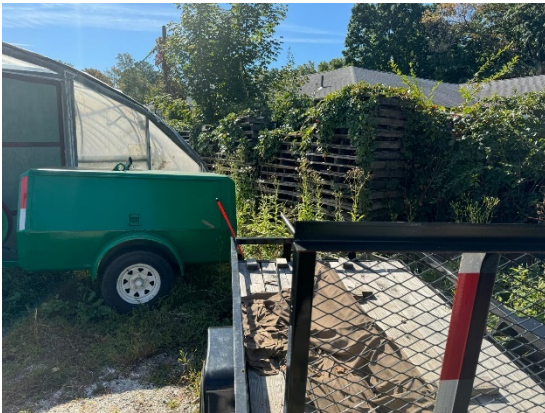
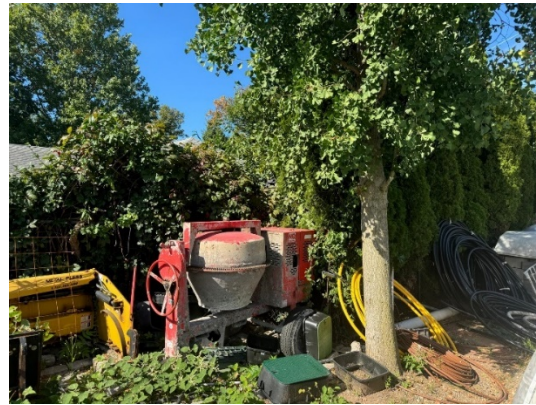
In the image above (left), vines have grown over wooden pallets that are piled against the fence that separates the site from a neighboring condominium complex. In both images, machinery and equipment is stored in between the greenhouses and the property line. The below photos, show a view of a one-story wood frame building with an attached greenhouse located to the south of the glass paneled greenhouse.

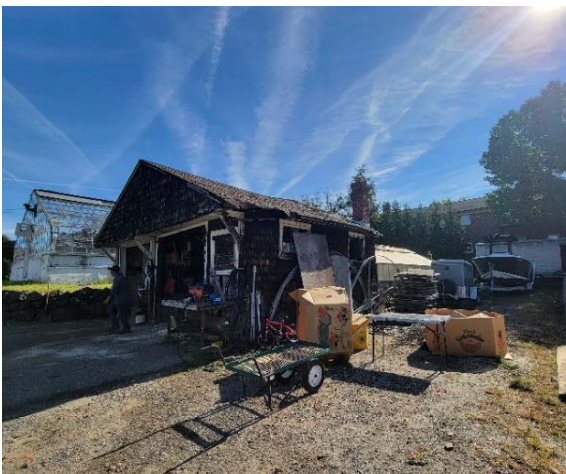
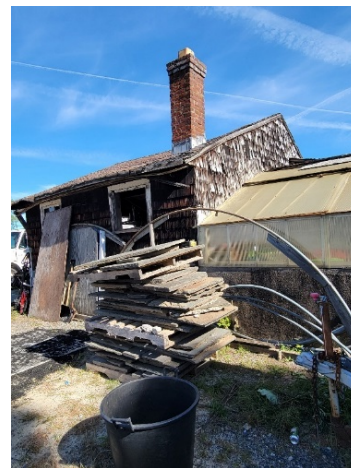
Photographs of the one-story wood frame building with an attached greenhouse located to the south of the glass paneled greenhouse (above left and right). Currently, this structure is used as a storage shed. Based on conversations with the property owner, this structure is one of the original ones on the property and predates many of the other existing structures. As illustrated in the above photos, the structure has significant deterioration—the wooden-shingle siding is warped and rotting; the roof of the structure is sagging; the exterior paint has peeled to expose bare wood; and windowpanes are missing or boarded up. Wooden pallets, junk, and equipment are improperly stored around it.

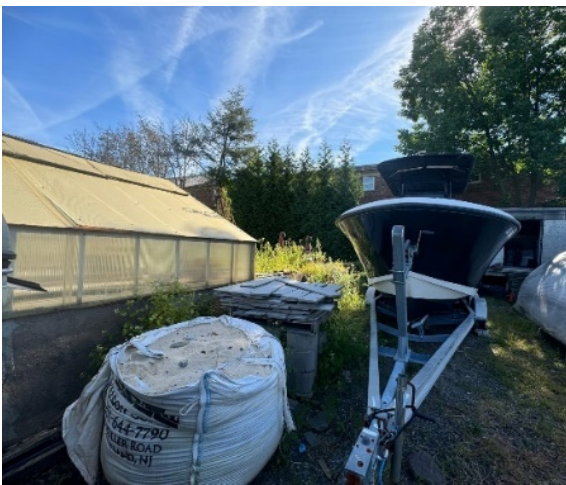
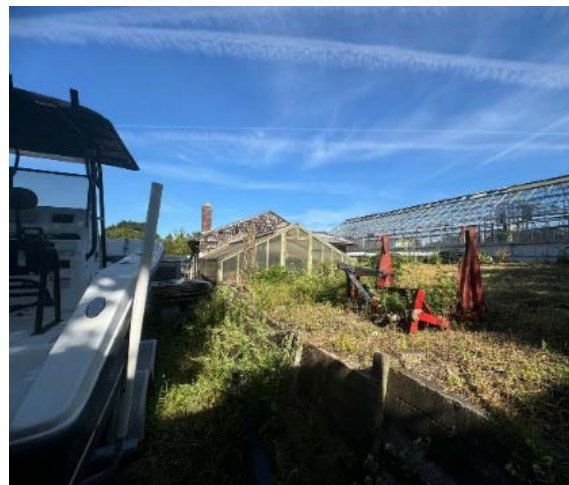
The area to the rear of the wood-frame building also shows lack of maintenance with improperly stored materials and vehicles. A boat is parked in front of the trailer located along the easterly property line (left). The grassy area to the rear of the structure is overgrown (right).

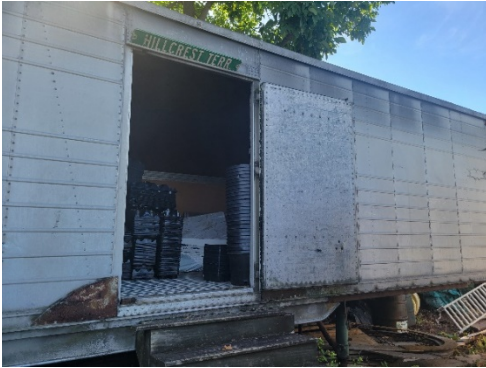
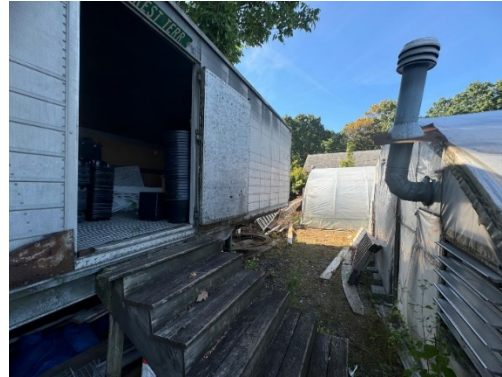
View of the trailer located to the rear of the property along the easterly property line (above left and right). The trailer is set about two feet from the property line and is in a derelict condition. The roof has collapsed (below left) and animal traps indicate that pests, rodents, or racoons may be an issue in this part of the property (below right). Based on discussion with the property owner, this trailer has been on the property since 1985 and is currently used for storage.
