Wastewater Treatment Plant Assessment Township of Verona, New Jersey

Condition Assessment

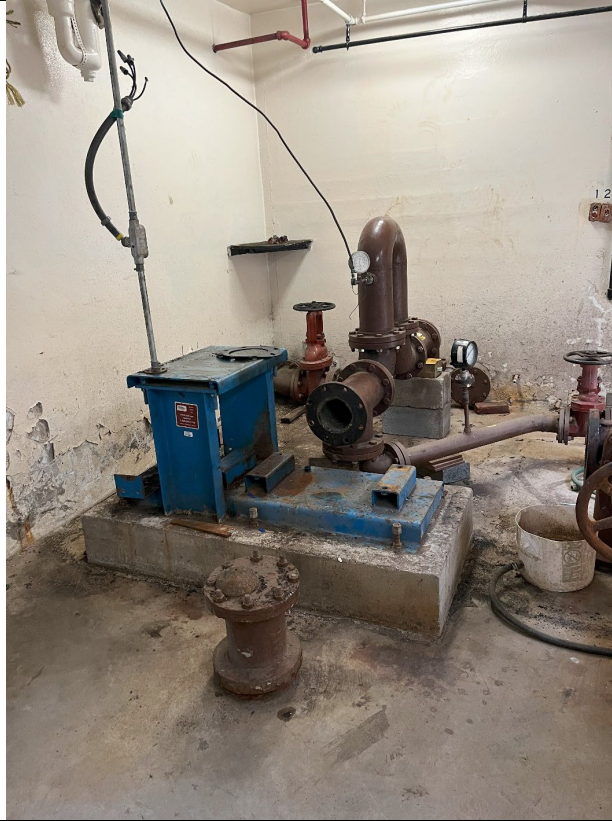
Asset: Secondary Clarifier Sludge Pumps

A quote for the pump replacement was obtained to replace the pump, which is an immediate need.

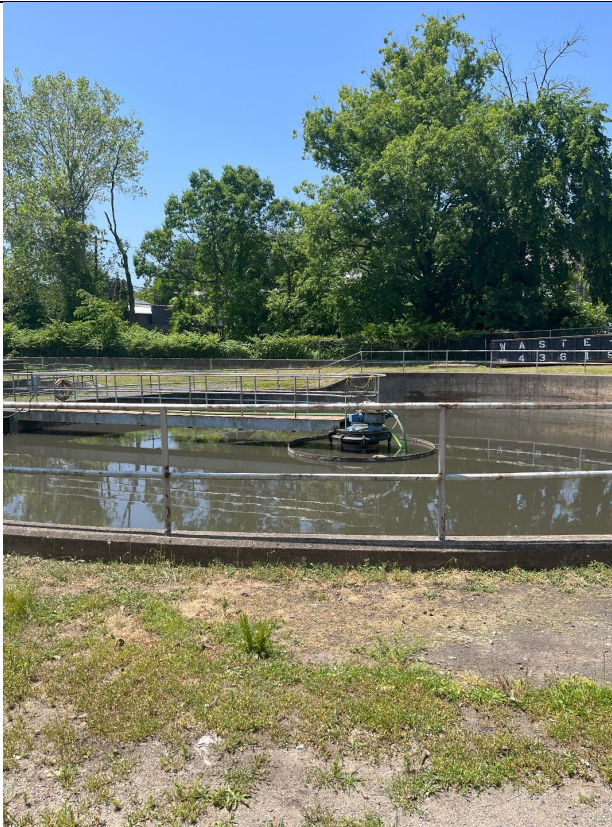
Photo No. 4

Asset: Primary Clarifiers

Subsequent inspections have revealed the need for further improvements, including required repairs for Clarifier No. 3 for the broken gear and drive motor. There is also visible rust at the diversion gate and weir plates. Additionally, Primary Clarifier No. 2 requires the installation of a new drive unit to address ongoing leaks.

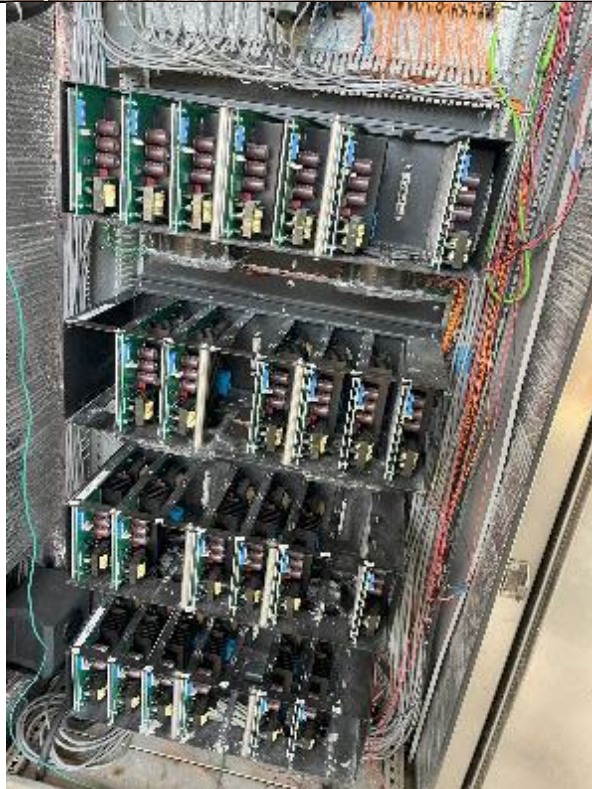
Photo No. 26

Asset: UV Disinfection

After installation, the existing system experienced electronic ballast overheating. An air conditioning unit was installed by the manufacturer, which caused moisture issues in the panel.

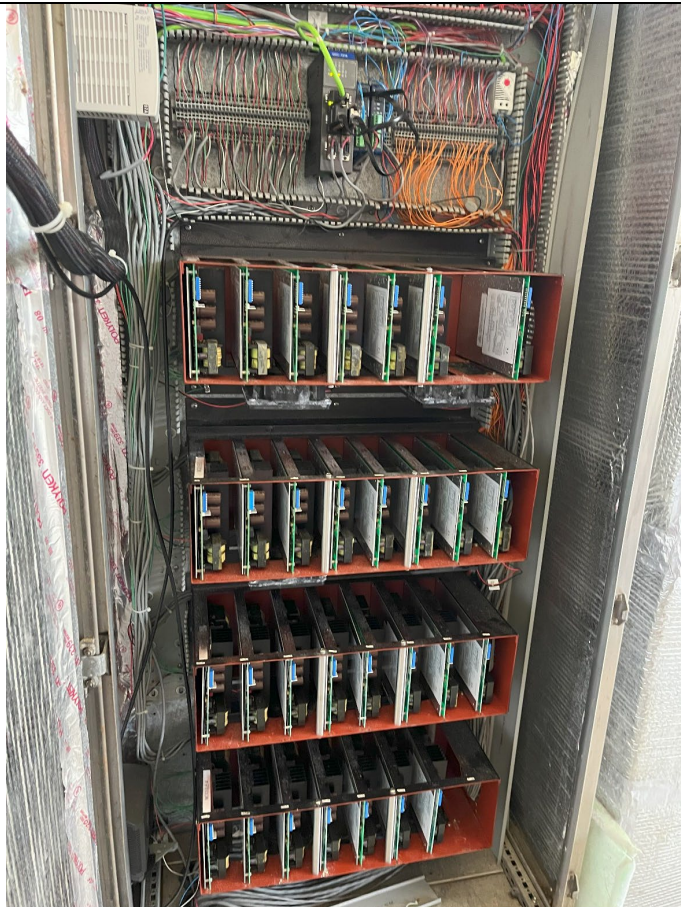
Asset: UV Disinfection

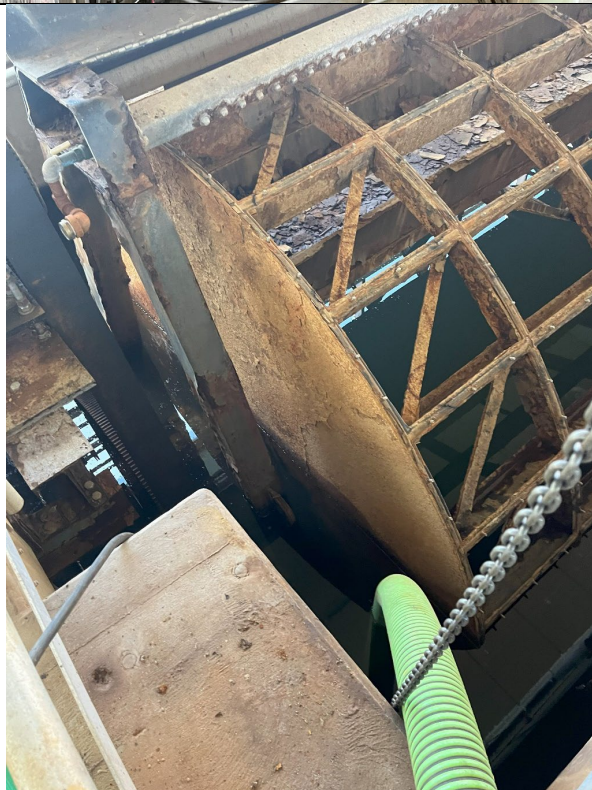
Photo No. 28

Asset: Microscreens

Microscreen No. 2, rehabilitated in 2008, is currently the most functional among the three. Microscreen No. 1 is out of service due to significant corrosion damage and Microscreen No. 3 is in a similar but less severe condition.

The mechanical system is obsolete and spare parts no longer readily available. Replacing the microscreens with a new filter system is a high priority. The existing microscreens must be repaired until newer options are selected.

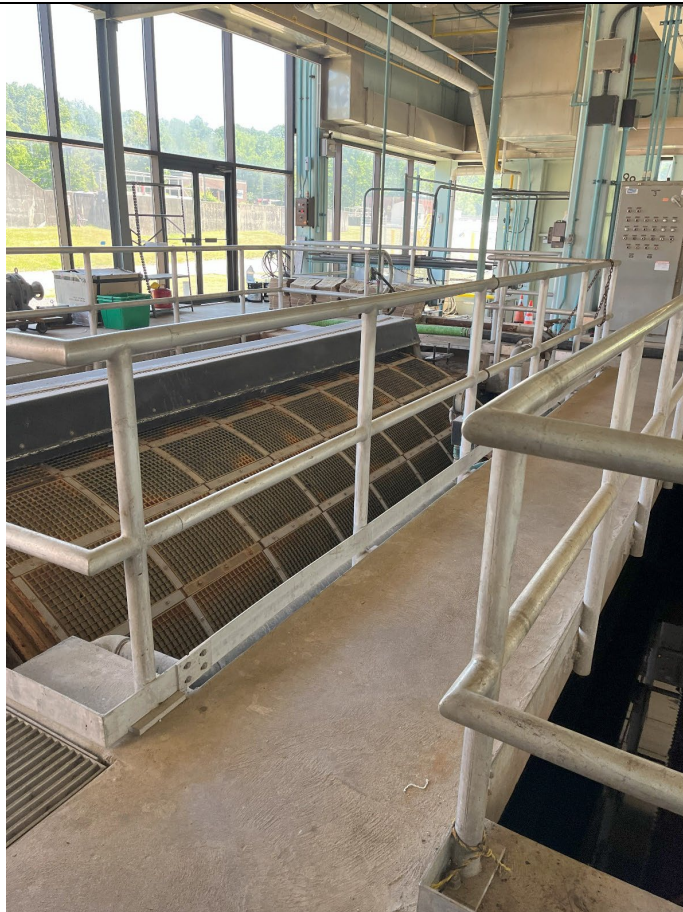
Asset: Microscreen

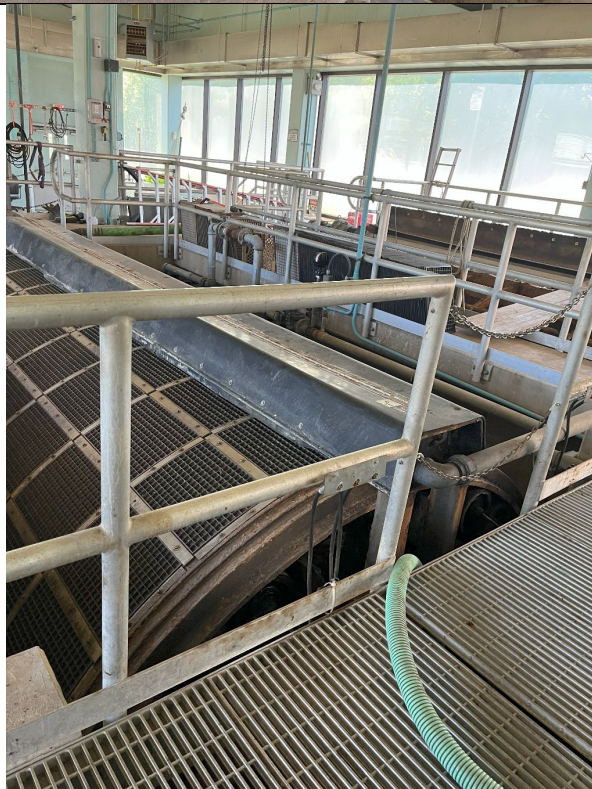
Photo No. 30

Asset: Microscreens
