PUBLIC PRESENTATION

VERONA EMERGENCY SERVICES

POLICE DEPARTMENT, FIRE DEPARTMENT - CO. #2, RESCUE SQUAD

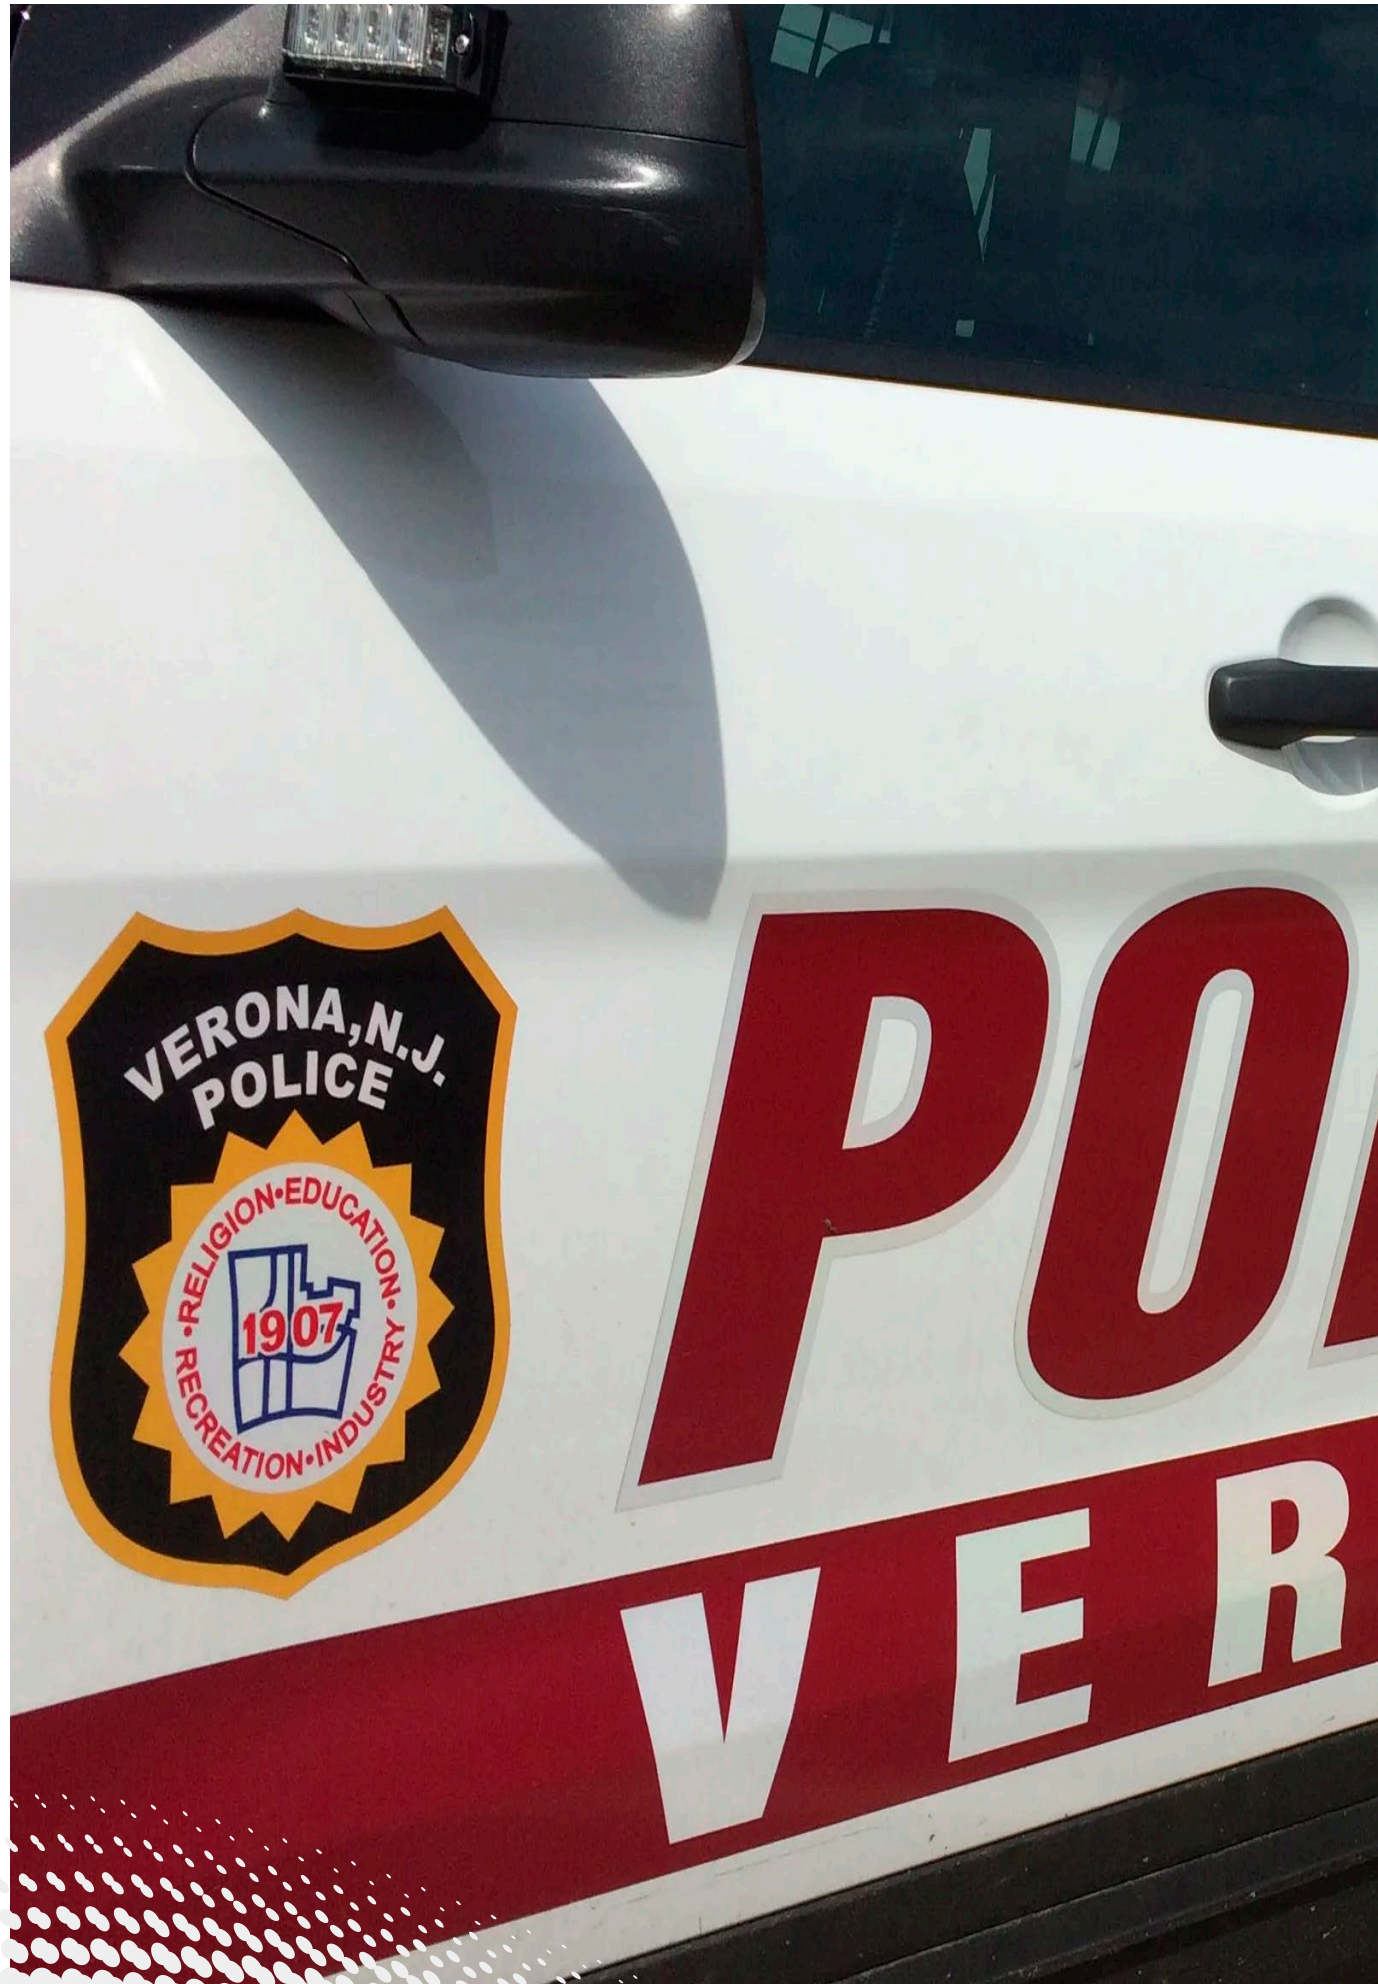
- » It is clear from our evaluations that the existing Police Department in its present condition, **falls short of meeting some very basic requirements** of the Police Facilities Planning Guidelines, that were prepared by the International Association of Chiefs of Police nor does it meet the requirements of the Department of Corrections.
- » Only so much can be done before **DOC mandates that the entire facility** be brought up to standards.
- » Even if the existing Police Building were gutted and renovated from top to bottom, the existing structure lacks the necessary square footage to accommodate the most basic of program elements.

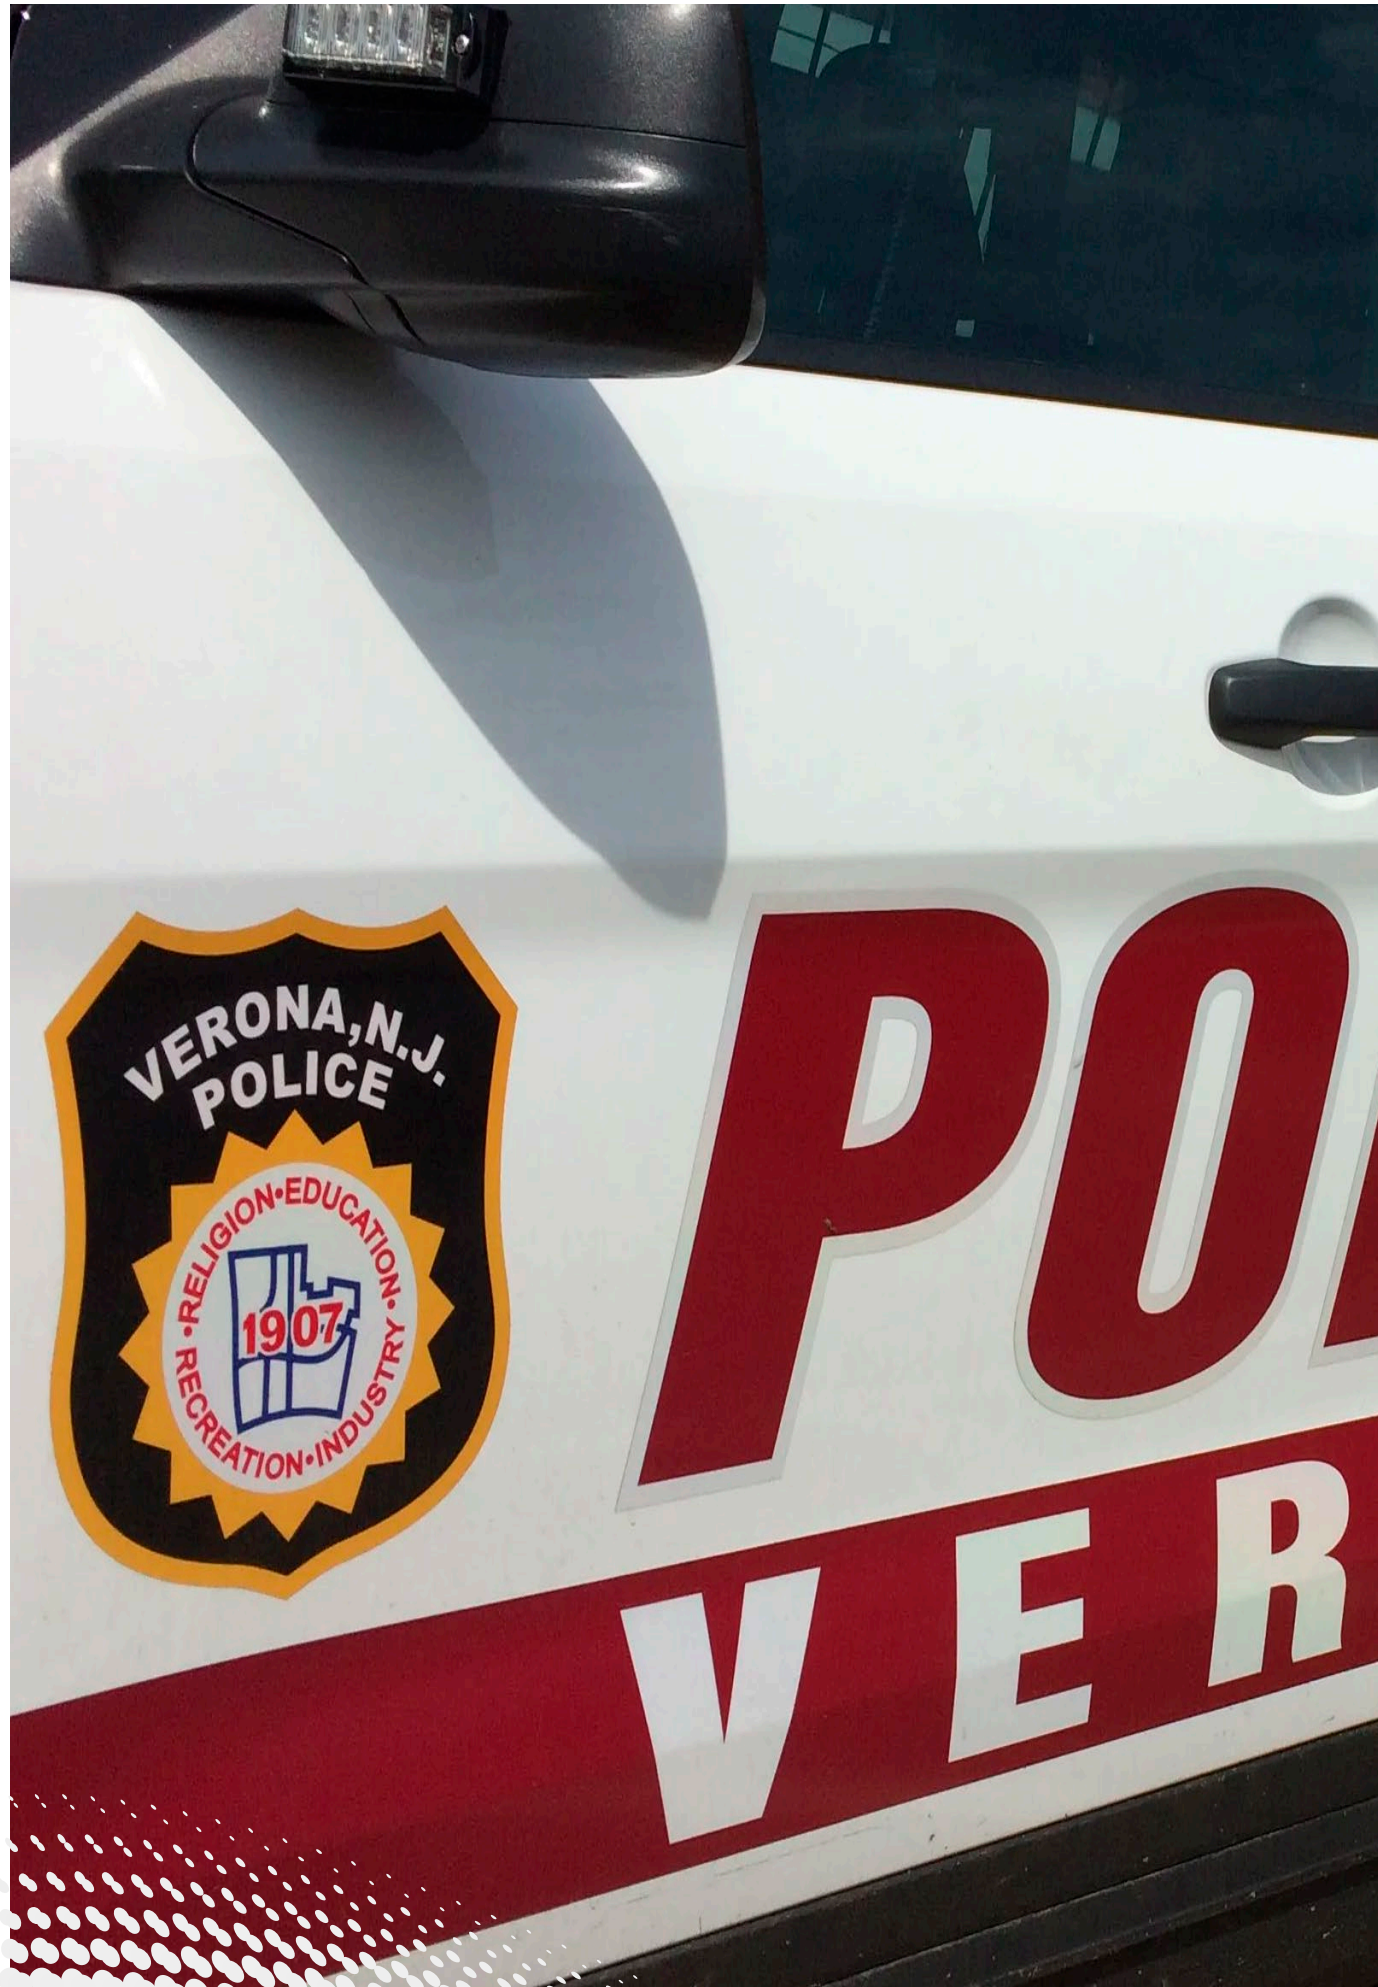
- » The existing police facility is **FAILING** on the criteria of adequate program space.
 - » Lacks a true sally port - secure detainee entrance.
 - » Lacks separation of detainee/staff or detainee/public.
 - » Lacks confidential interview rooms.
 - » Lacks secured prisoner processing/holding areas or cell block.
 - » Lacks fitness / training areas or adequate locker rooms.
 - » Inadequate space for department briefings or roll call.
 - » Inadequate space for an Emergency Operations Center.
 - » Inadequate report / administrative areas.
 - » Inadequate space for future growth.

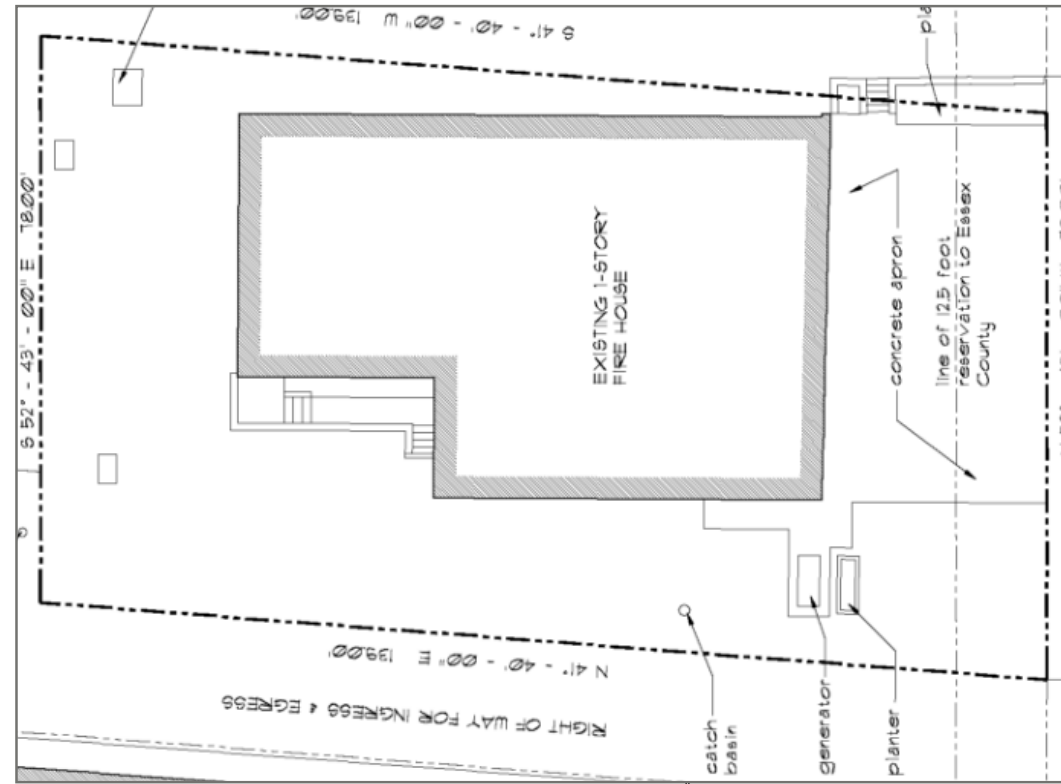
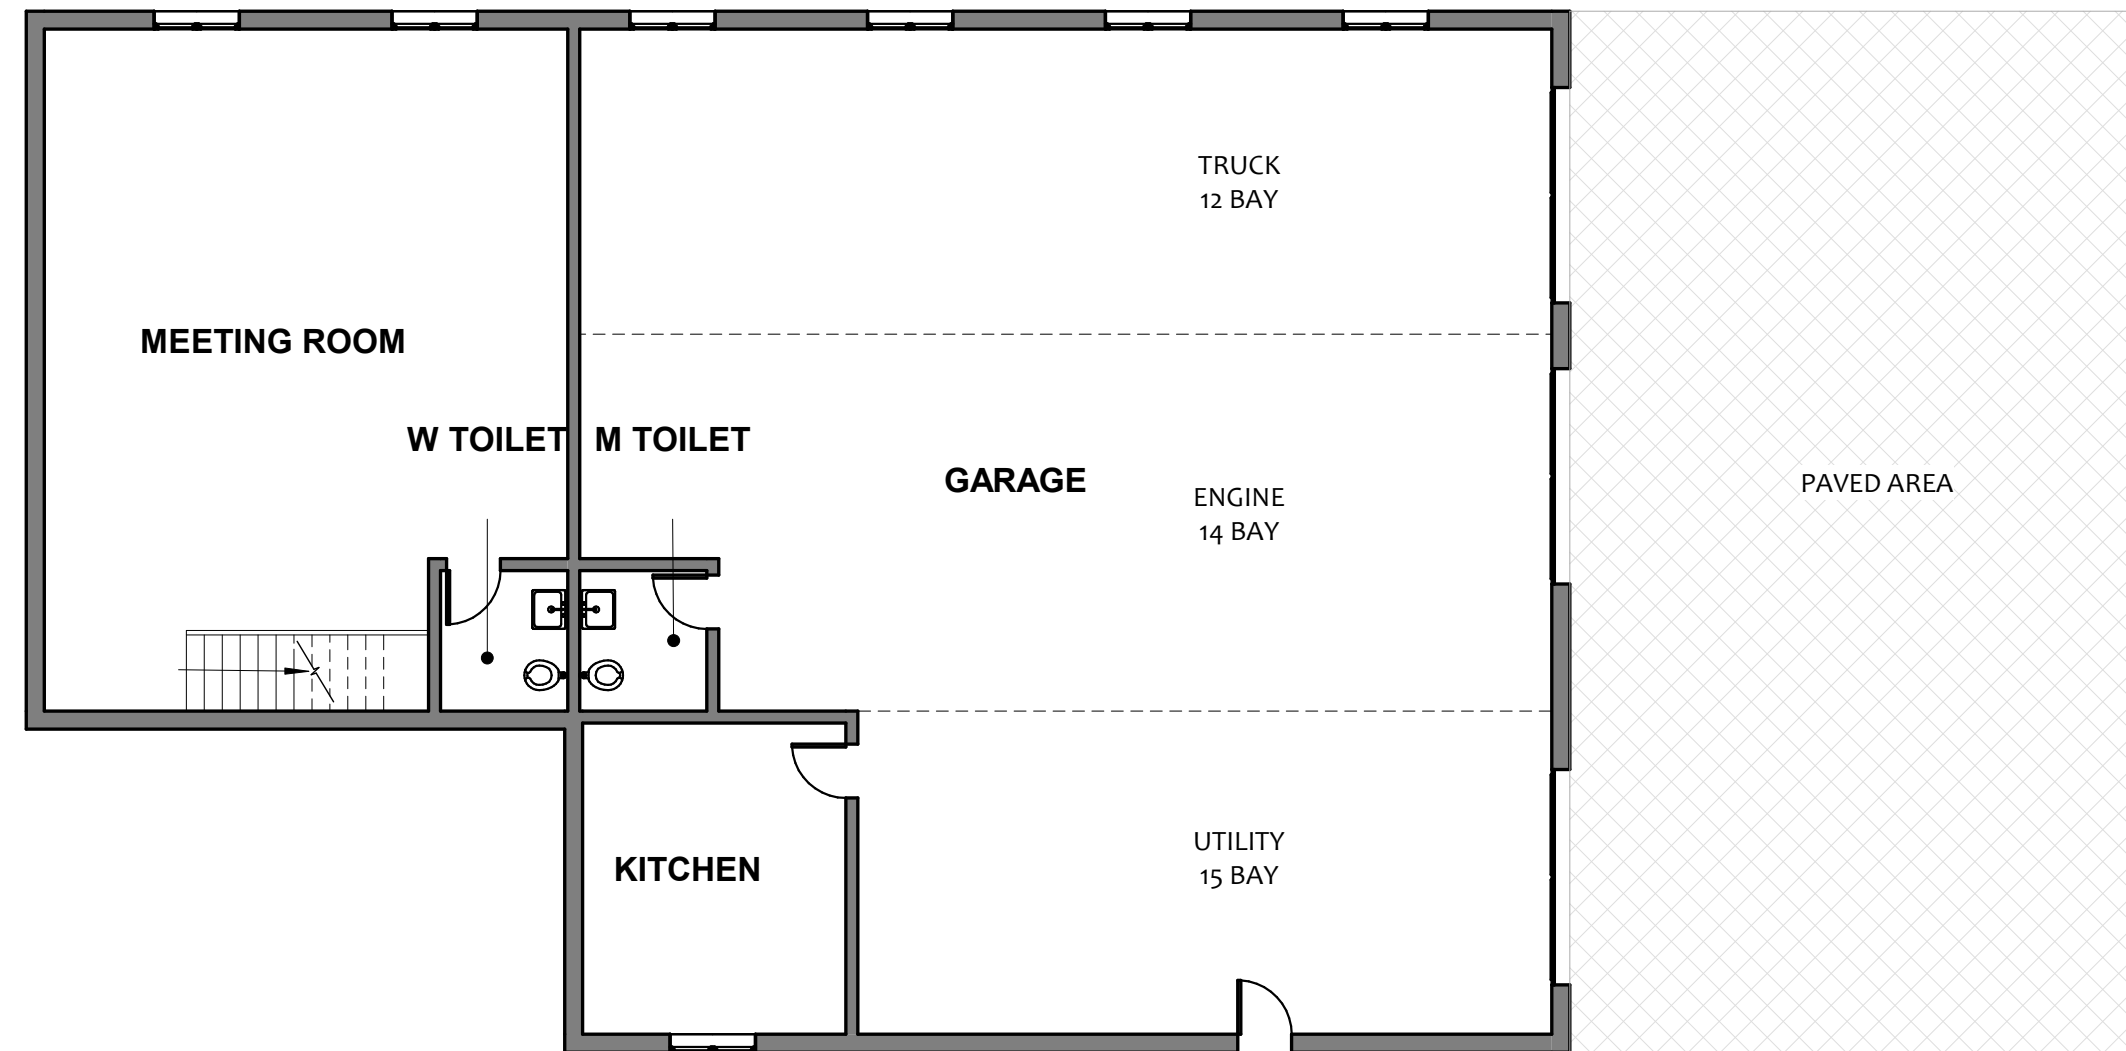
- » Existing Fire Company No.2 occupies 5,500+/- sq.ft. in its own facility on Bloomfield Ave.
- » Existing site is 1/4 acre
- » Lacks adequate program spaces
- » Lacks adequate clearances for apparatus
- » Lacks efficiency and safety protocols
- » Is significantly deteriorated

» Main Level - 5,500 sq.ft. - (3) Garage Bays, (2) Unisex Toilet Rooms, (1) Meeting Room (1) Kitchen, Access to lower level basement which is presently unusable

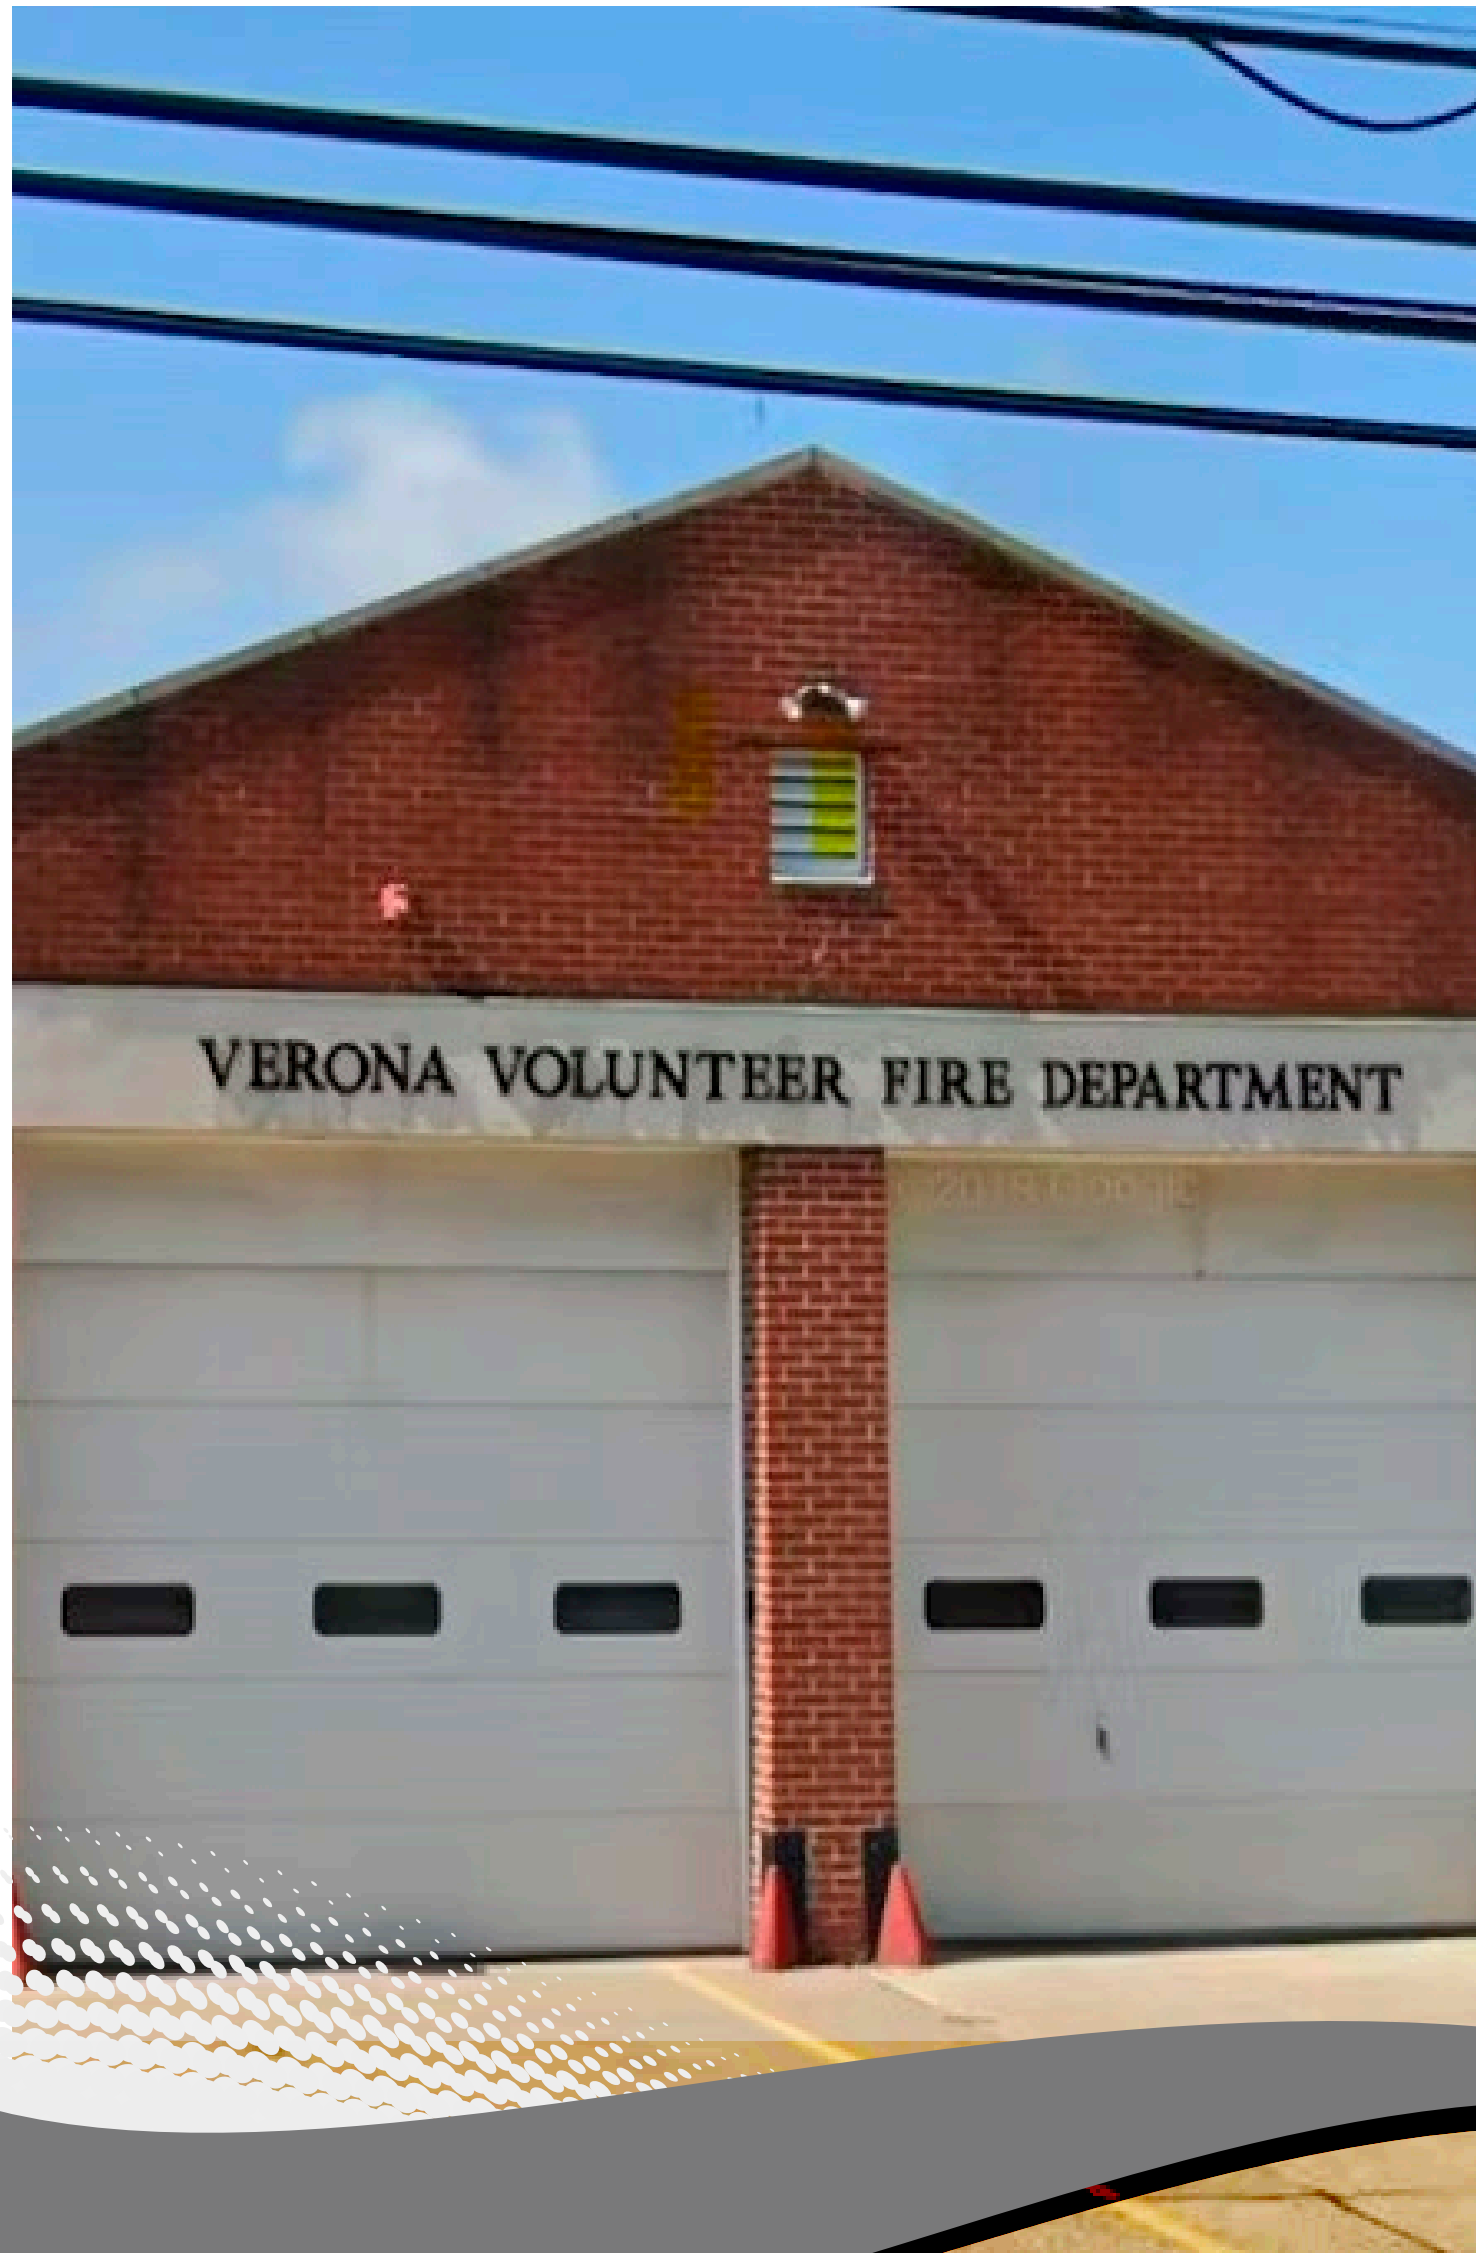
» Facility Issues:

- » Major roofing/flashing issues allowing water infiltration causing exterior wall, window and door issues/ cracking + stucco/plaster damage.
- » Major structural issues due to building settling. Walls cracking and masonry facade separation. Steel lintels are rusted and bowing.
- » Floor tiles popping, wood floors warping, window frames at meeting room / basement are rotted/leaking.
- » Two sump pumps in basement are inadequate to keep up during heavy rain storms resulting in more water infiltration. Basement door-deteriorated / does not open, posing a safety problem. Basement cannot be used.

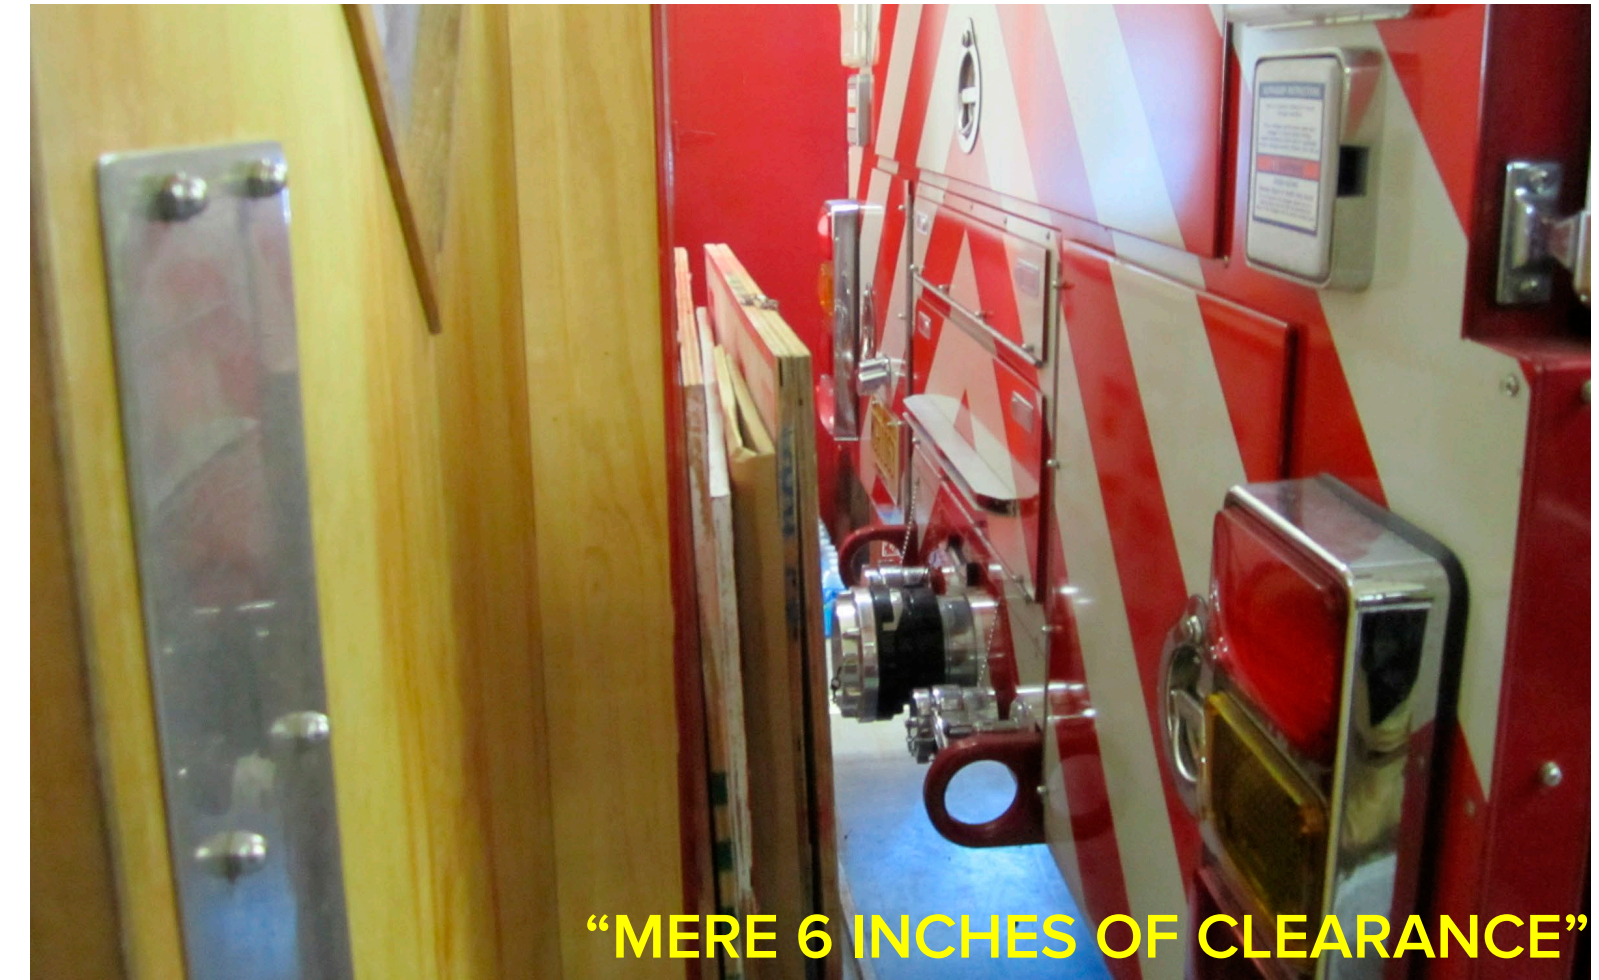
"MERE 6 INCHES OF CLEARANCE"

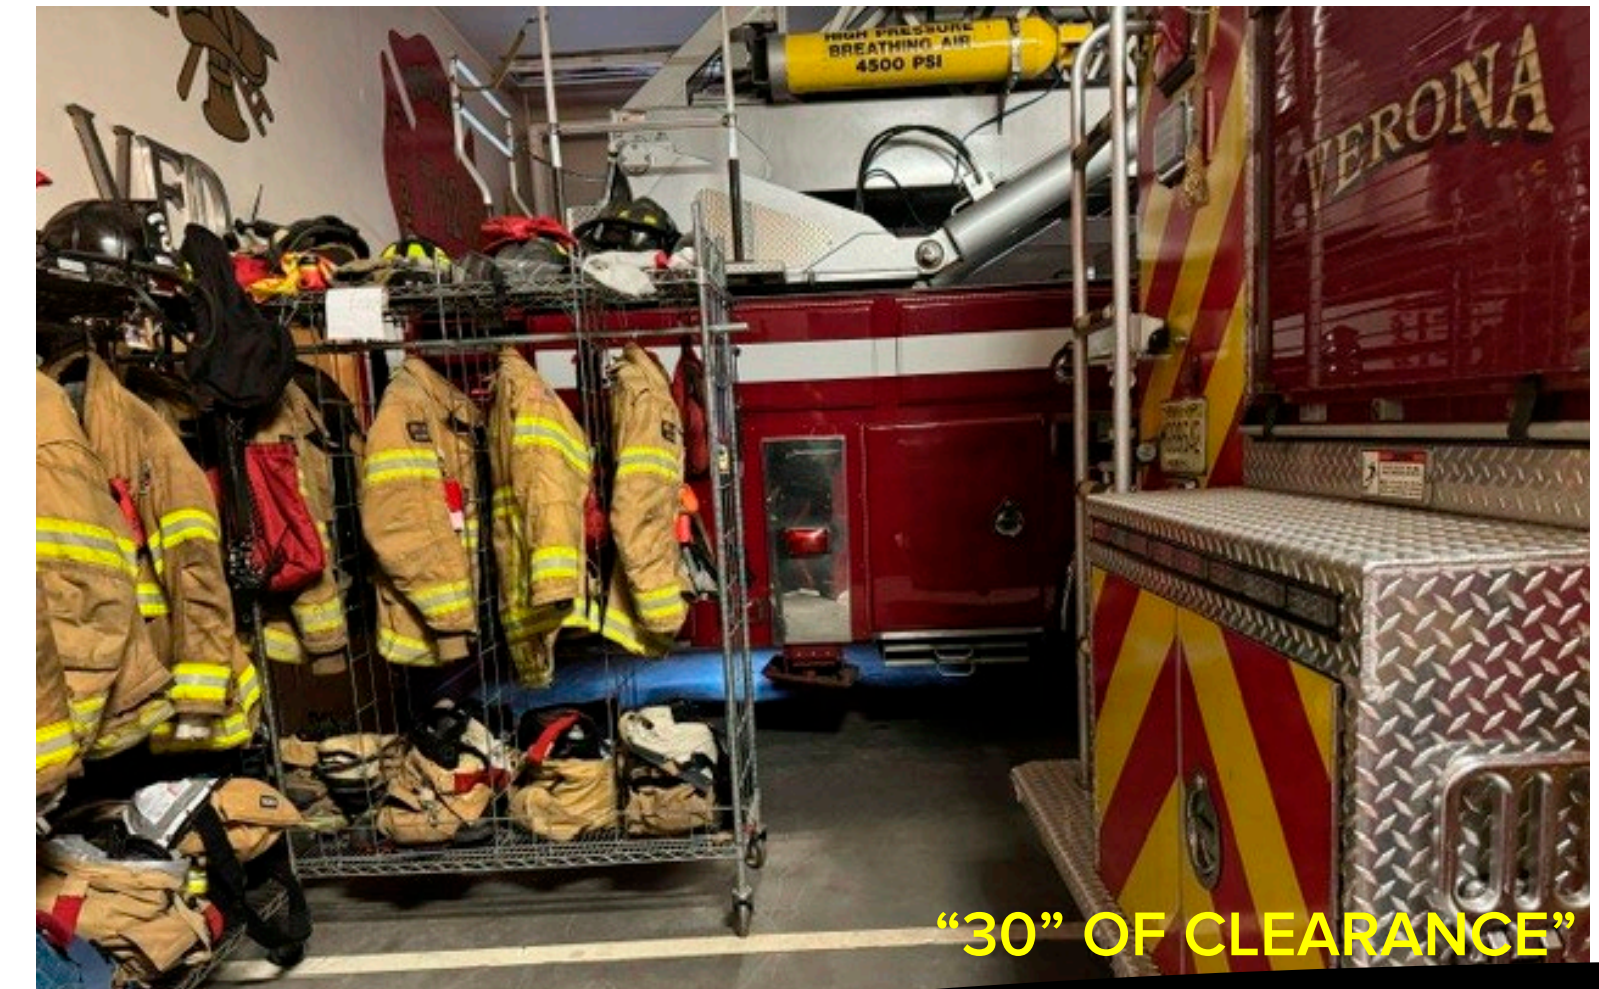
"30" OF CLEARANCE"

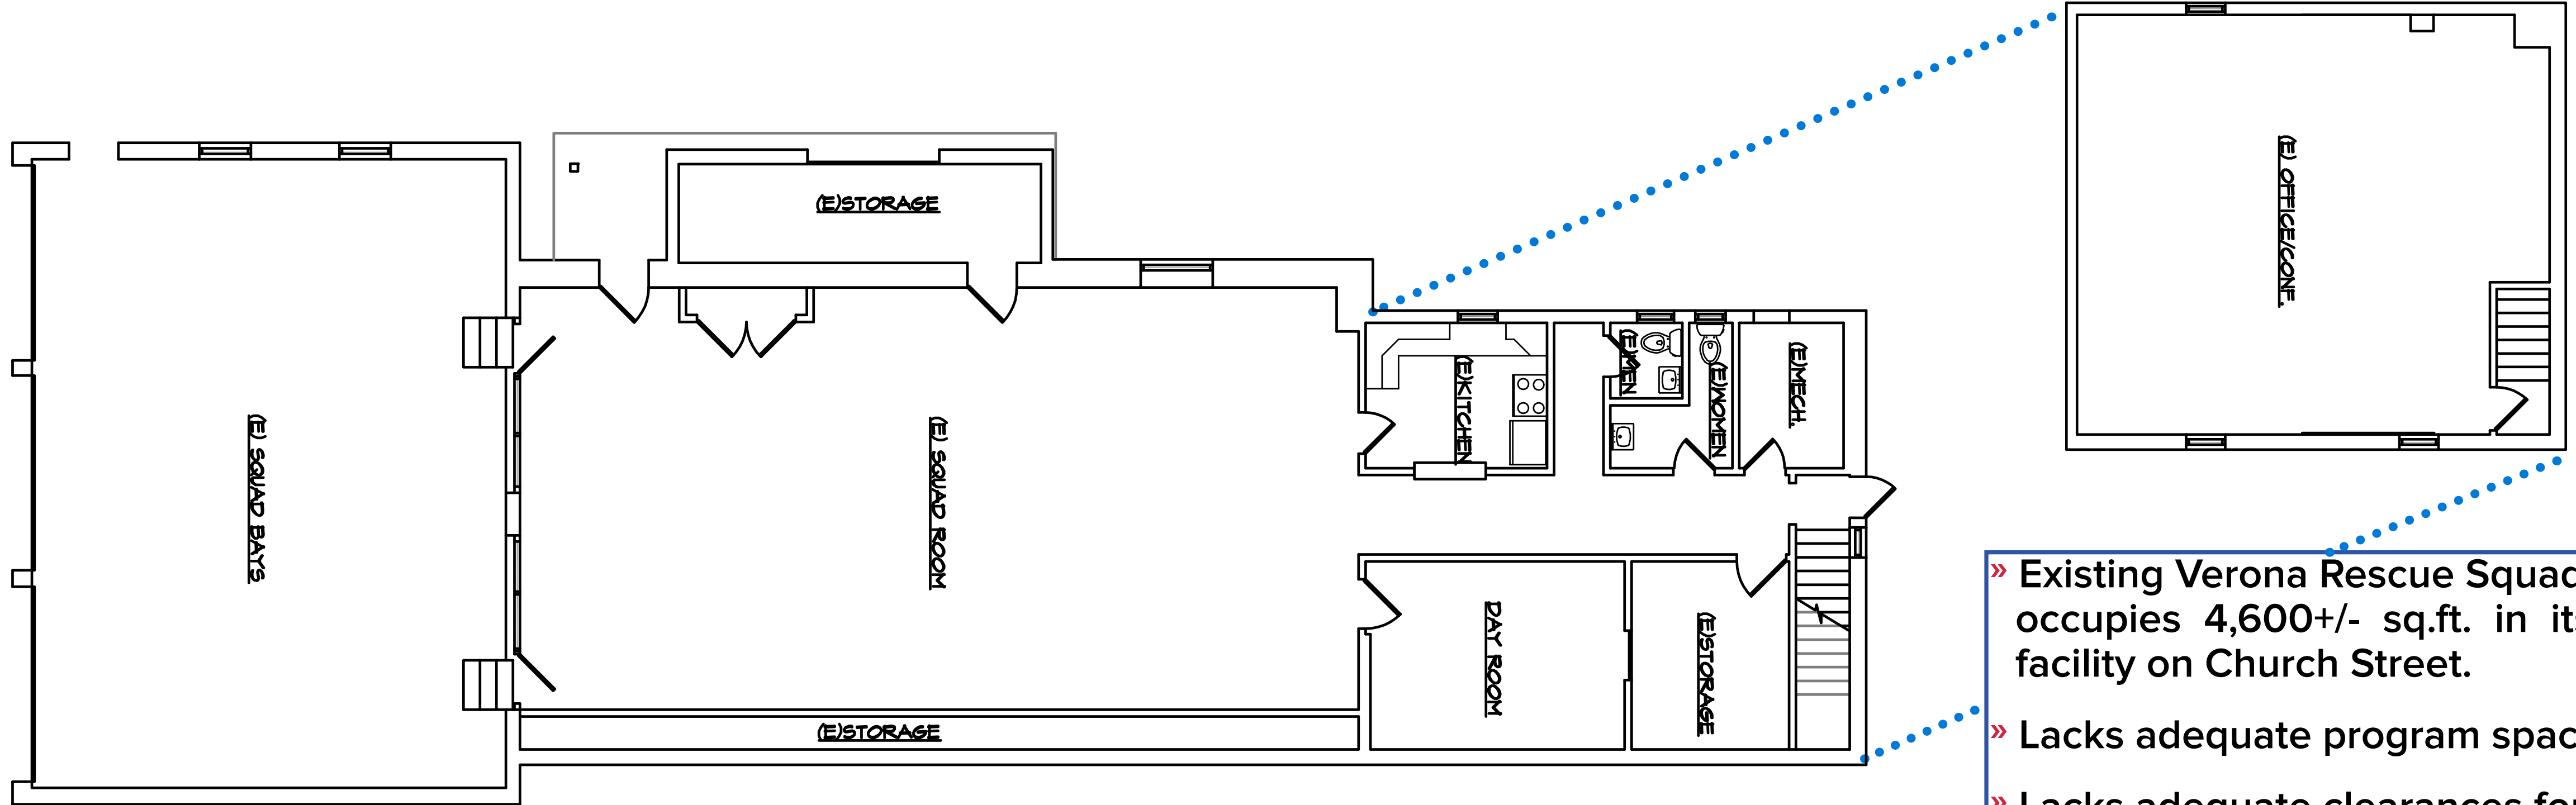
» Main Level - 4,632 sq.ft. - (3) Garage Bays, (1) Large Squad Room (no private areas for sensitive discussion), non-ADA compliant unisex toilet rooms, (1) Day Room, (1) Storage Room (1) Mechanical Room, (1) Kitchen, access to second floor office and conference space.

- » Existing Verona Rescue Squad occupies 4,600+/- sq.ft. in its own facility on Church Street.
- » Lacks adequate program spaces
- » Lacks adequate clearances for apparatus
- » Lacks efficiency and safety protocols
- » Is significantly deteriorated

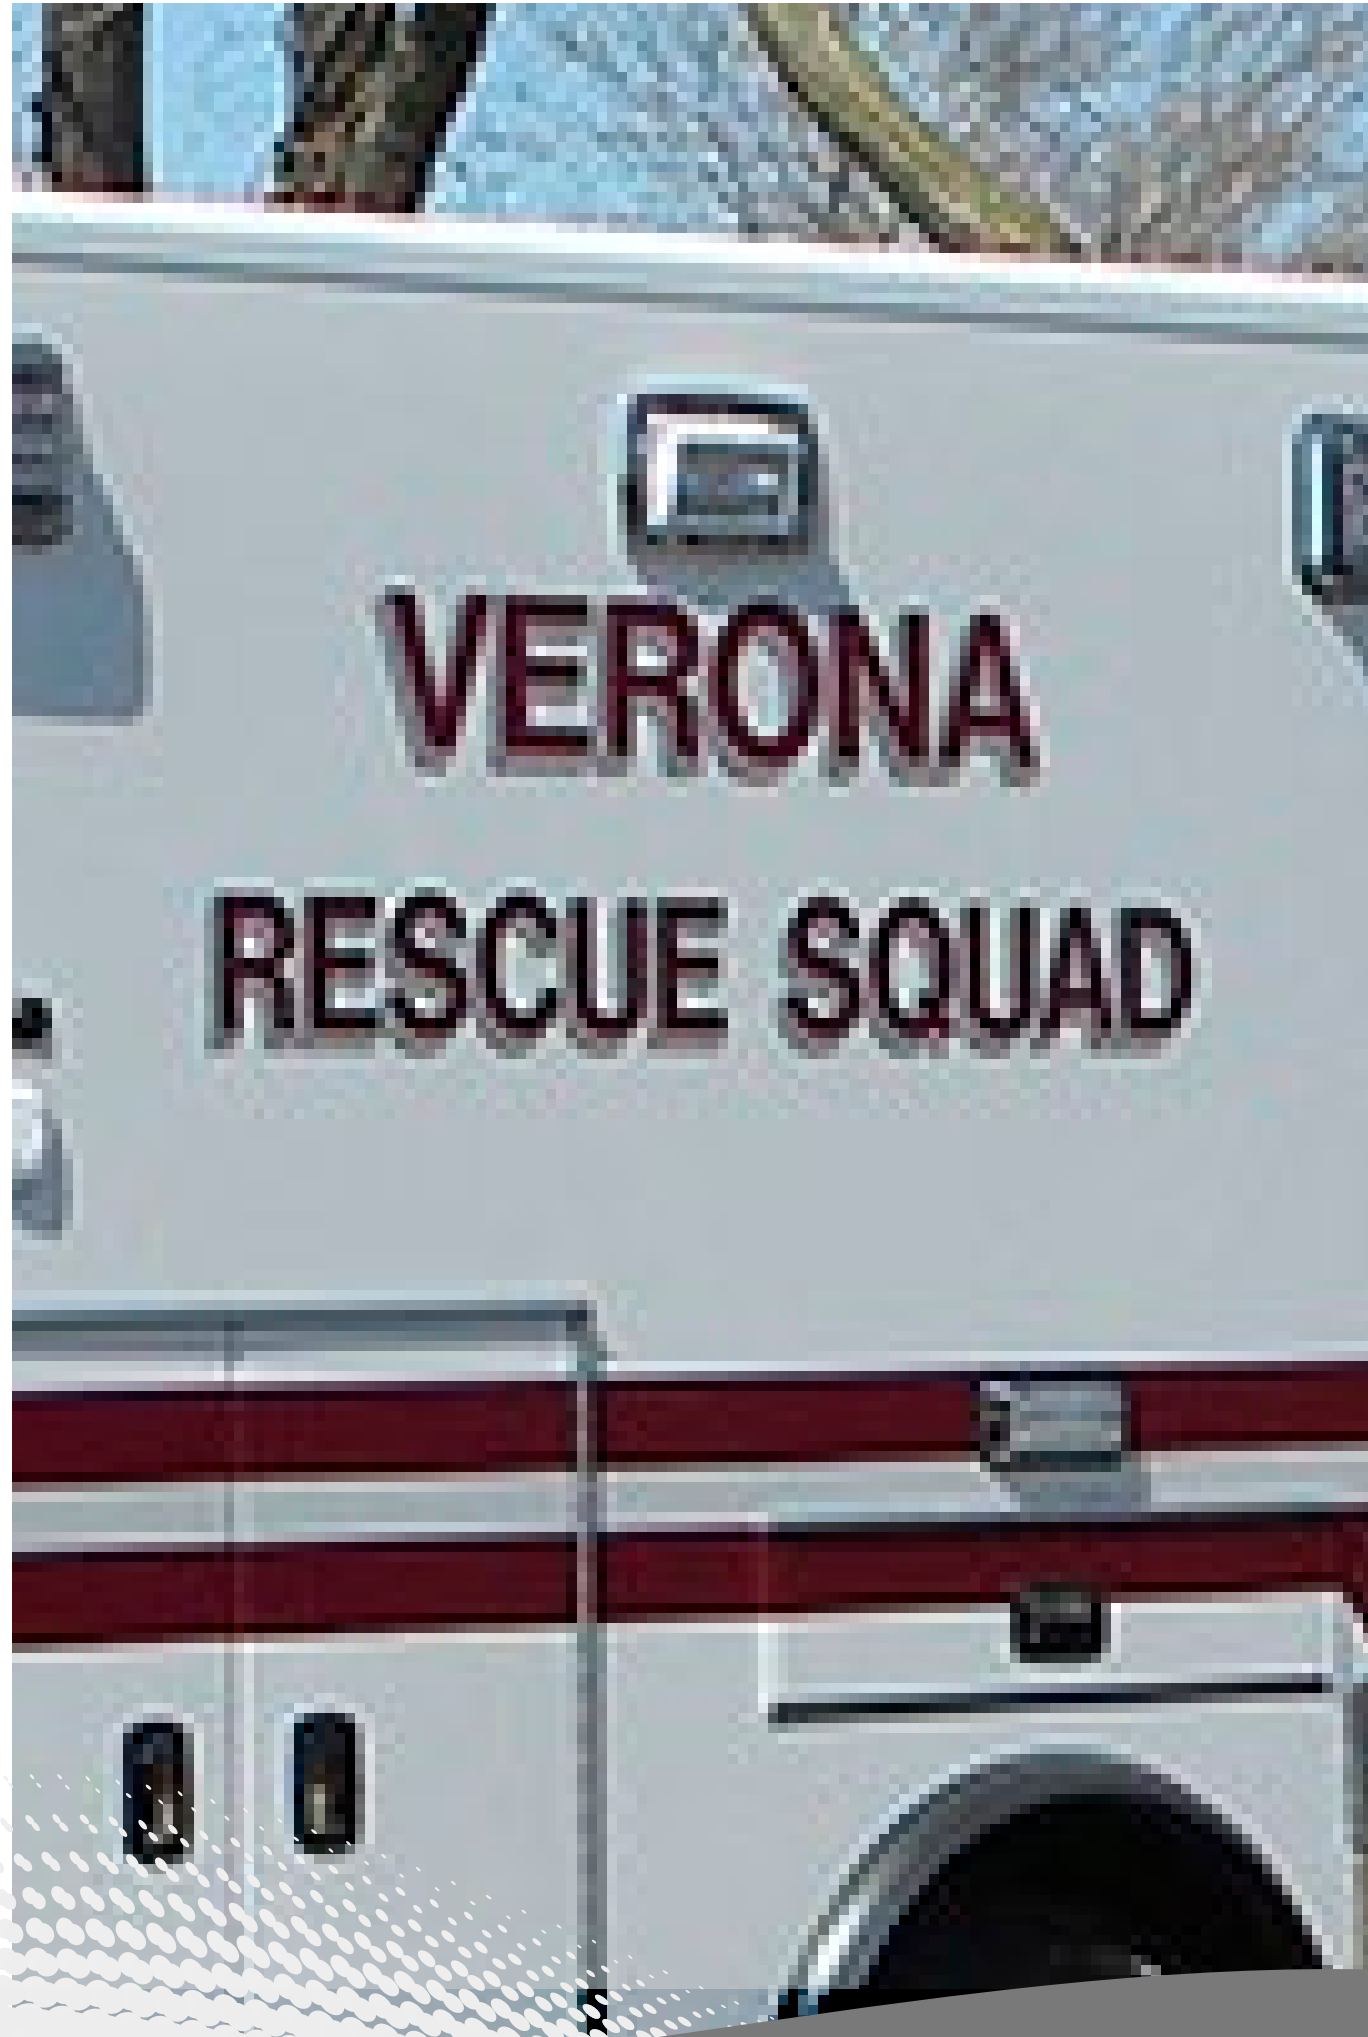
- » The existing Rescue Facility is FAILING on criteria of adequate program space:
 - » Lacks main entrance public access / ADA compliance
 - » Lacks decontamination/shower/eye wash capabilities
 - » Lacks future apparatus bays; unsafe bay clearances/height
 - » Lacks locker rooms, bunk rooms, or private space for calls that may regard sensitive HIPAA related subjects
 - » Lacks Maintenance / Work space
 - » Inadequate space for training room, office space, reporting
 - » Inadequate kitchen space
 - » Inadequate oxygen tank storage facilities
 - » Inadequate toilet facilities or shower facilities
 - » Inadequate parking for members
 - » Deteriorated infrastructure, power, lighting, plumbing
